Connell House Structural Evaluation

19 September 2016

Project 167218 – Structural Evaluation of the Arthur and Kathleen Connell House,
1170 Signal Hill Road, Pebble Beach, CA

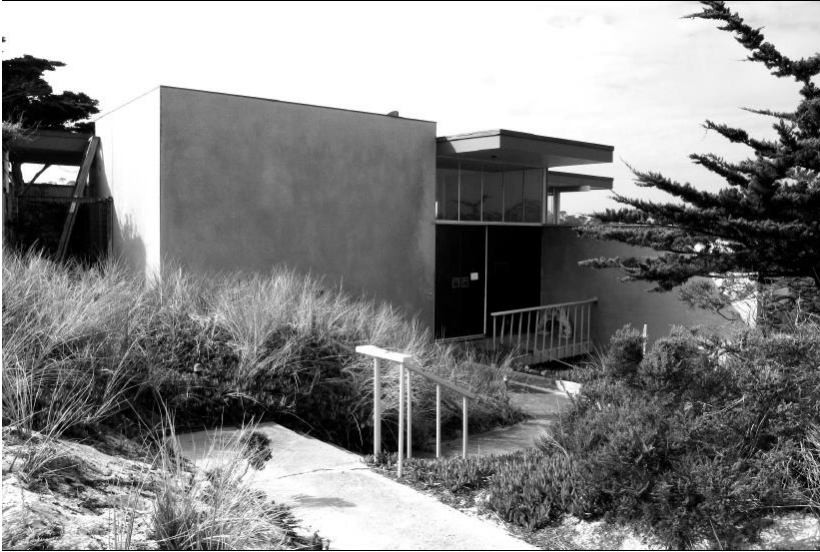
Photo 1
Kirk photo of building's north side, looking southwest, 5 October 2010.

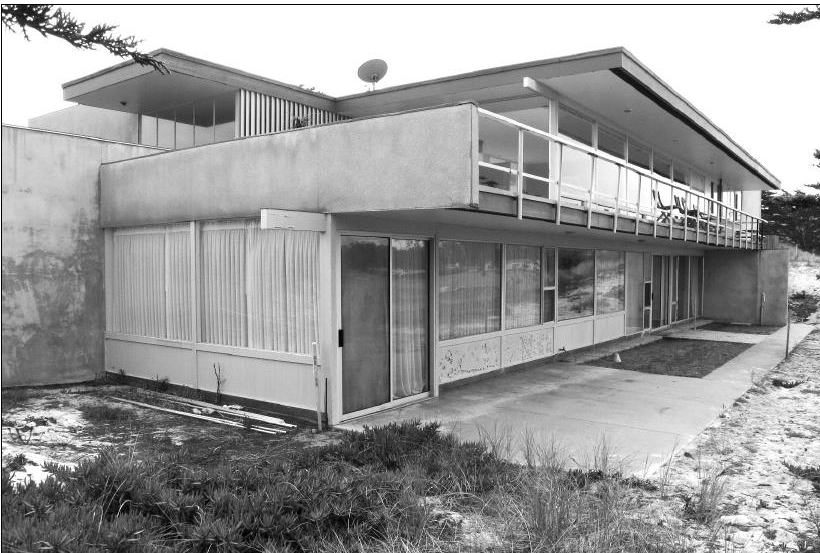
Photo 2
Kirk photo of northwest corner looking southeast, 5 October 2010.

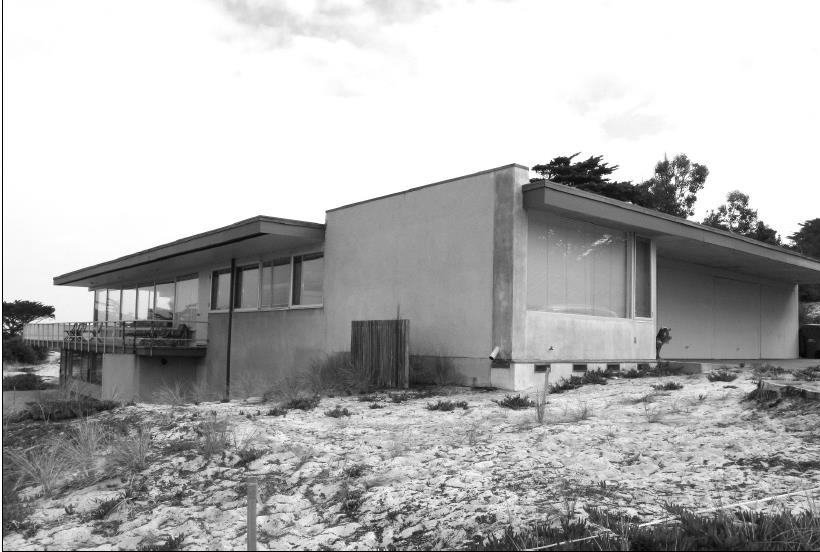
Photo 3
Kirk photo of southeast corner, looking northwest, 5 October 2010.

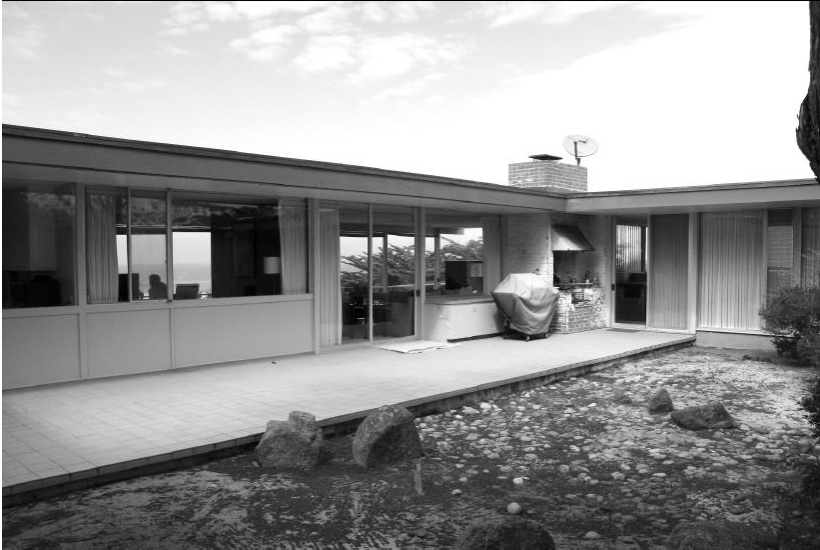
Photo 4
Kirk photo of inner courtyard, looking towards northwest, 5 October 2010.

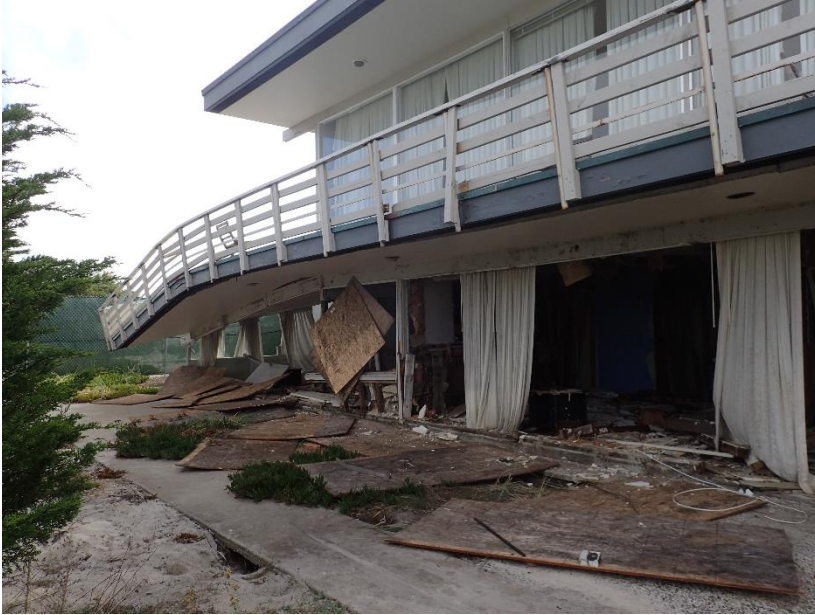
Photo 5 shows that one or more posts supporting the 4x10 along the west face of the building's upper level have either been removed or failed, allowing the northwest corner of the deck to drop. Windows at the lower level have been removed and Oriented Strand Board (OSB) sheathing has been placed at the openings, then removed. A portion of this sheathing can be seen still partially attached. Upper windows and curtains can still be seen at the upper level.

Photo 5
SWCA photo looking north
along the building's west
face.

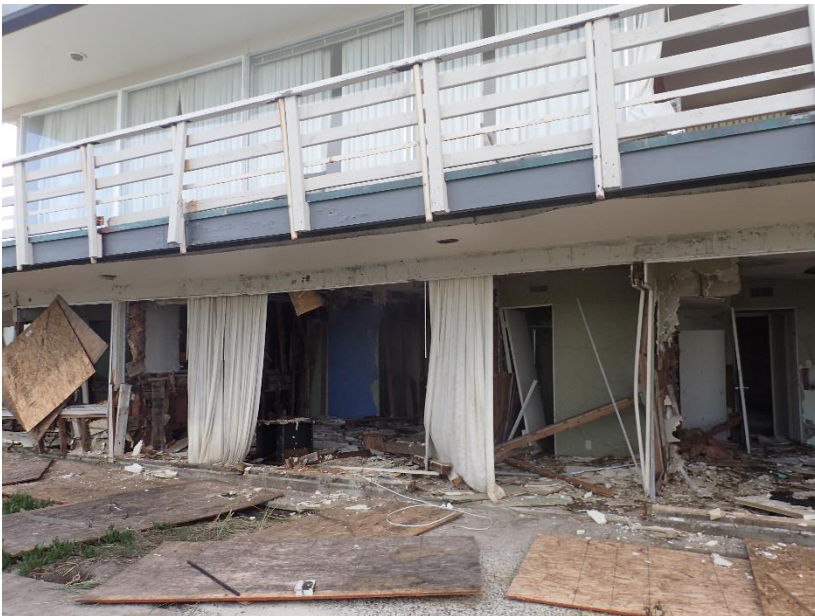
Photos 6 and 7 show extensive damage to finishes at the lower level. Portions of gypsum board partitions and ceilings are laying on the floor. Some interior doors have been removed. Some framing for the upper floor has evidently been taken down or fallen.

Photo 6
SWCA photo looking east
from the lower level, west
side.

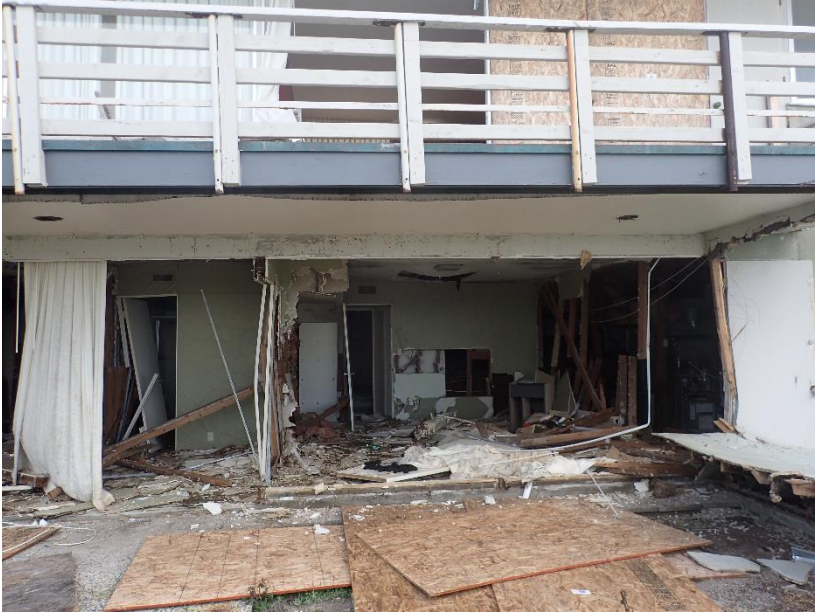
Photo 7
SWCA photo looking east
from building's lower level,
west side.

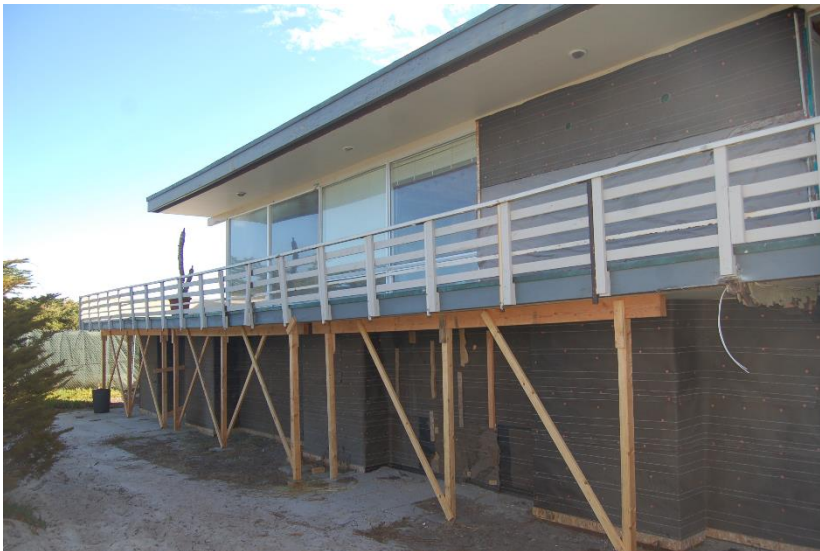
1. Exterior shoring consisting of untreated wood posts, headers and cross braces have been installed beneath the west edge of the cantilevered deck, raising the previously collapsed section back into approximate alignment. The shoring system does not appear to be engineered. Posts bear directly against site paving. Framing attachment is made with nails. (Photo 8).
2. Exterior windows have been removed from the lower level. Openings are enclosed with lightly nailed OSB with building paper on the exterior (Photo 8).

Photo 8
Exterior shoring present
under west edge of deck.

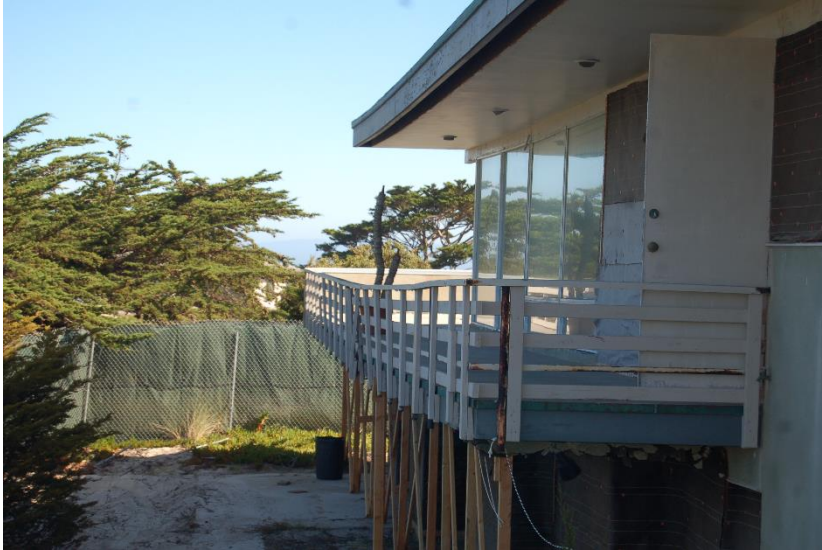
3. The deck along the western edge of the upper level is misaligned and sagging (Photo 9). The original steel railing is extensively corroded and had excessive spacing of rails and posts. Some replacement wood handrail posts are poorly attached and failing. (Photo 10).

Photo 9
Sagging deck and handrail
along upper level west face.

- The upper level floor system in the west wing, including the cantilevered deck and handrail will need to be replaced in its entirety. Since stacked construction is used, with the upper story walls constructed atop the upper floor platform framing, reconstruction of this floor will require dismantling of the upper level walls in this area, and replacement or reconstruction.

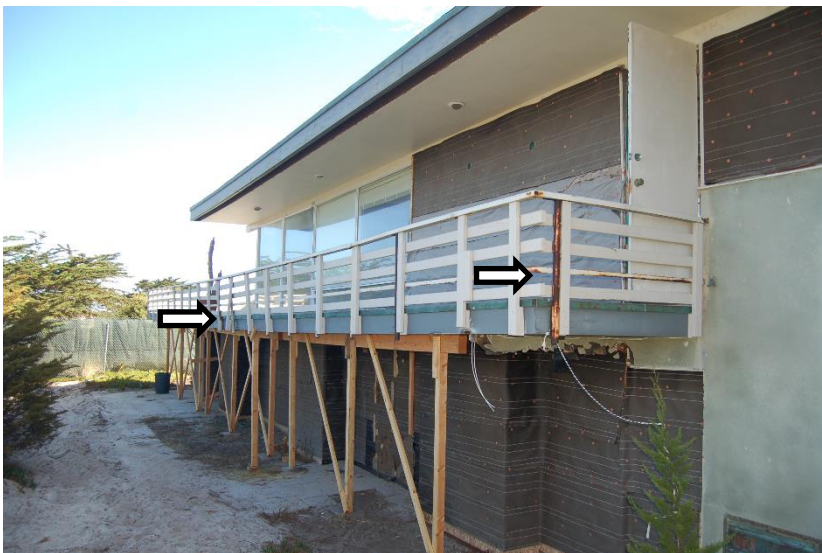
Photo 10
Rusted steel hand rail posts
and wood replacement posts
that are failing in some
locations.

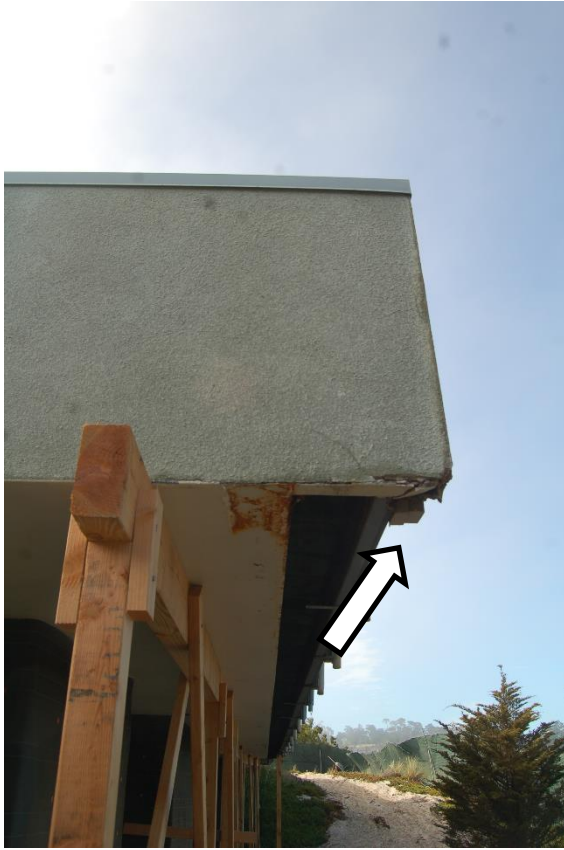
4. Wood deterioration is evident in framing at the northwest corner of the deck (Photos 11 and 12). This is likely due to impact damage in the collapse.

Photo 11
Framing deterioration is evident at the northwest corner of the deck.

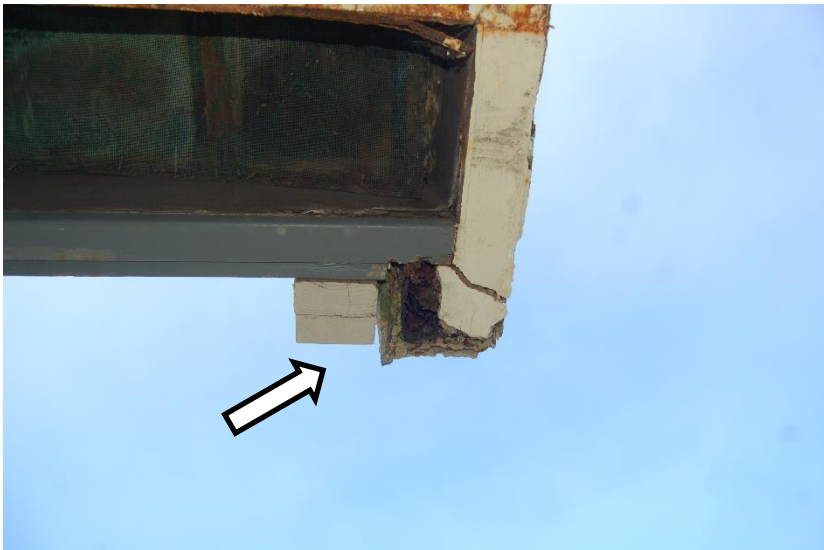
Photo 12
Framing deterioration at northwest corner of deck.

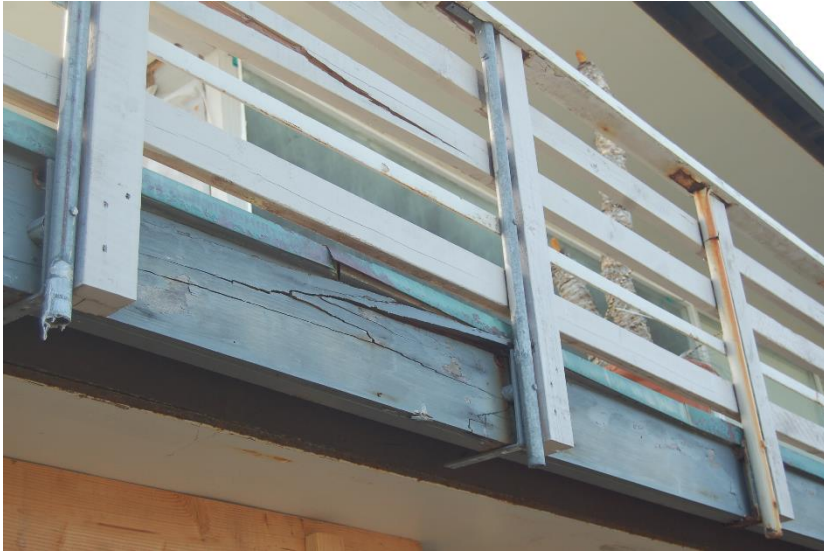
5. Framing deterioration is evident in the fascia beam at the deck edge (Photo 13).
6. Stucco at the top of the north buttress wall has been removed where the wall abuts the building (Photo 14). This appears related to the earlier collapse, now temporarily repaired of the deck at the northwest corner (Photo 5).

Photo 13
Deterioration and splitting at
deck edge.

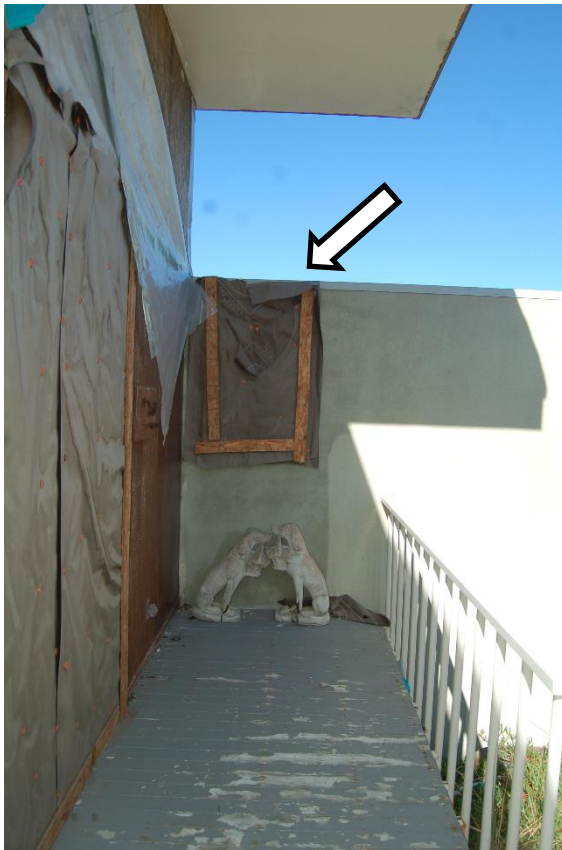
Photo 14
Damaged stucco at north
buttress wall, adjacent to
house.

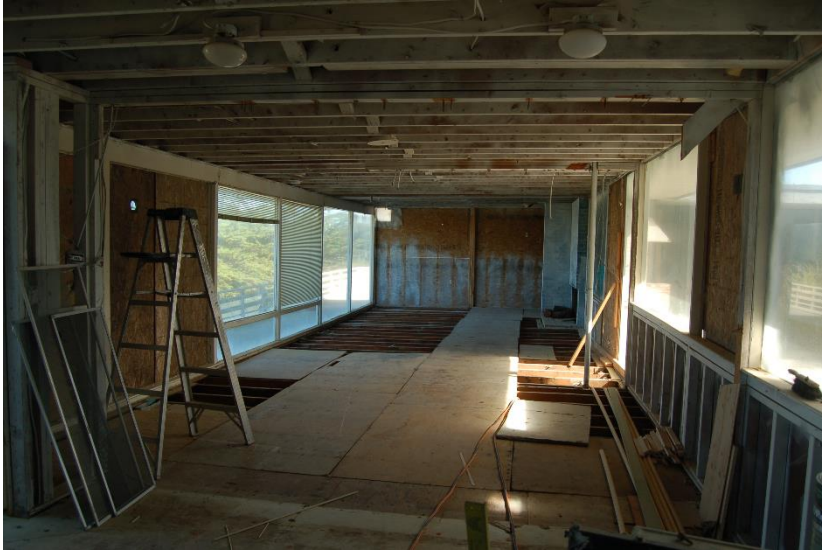
7. The upper level interior has been gutted. Most interior partitions have been removed. Much of the plywood sheathing on the first floor has been removed and other sheets are laying loose across the joists. Many windows have been removed, and replaced with OSB (Photo 15). The ceiling, and few gypsum board wall finishes have been removed in the original building, but remain in place in the addition (Photo 16).

Photo 15
The interior of the upper level has been gutted with much of the flooring removed.

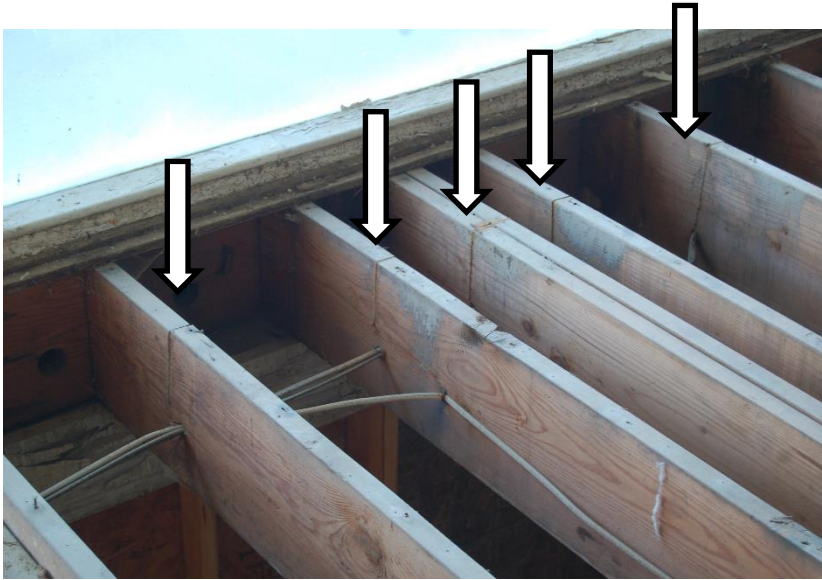
Photo 17

8. Many of the floor joists along the west (Photo 17) and east (Photo 18) sides of the upper level have been sawn through and are no longer effectively supported by the original wall lines. Shoring below provides support (Photo 19). Along the east side, this shoring has raised the joist edges above their original level.

Floor joists along the upper level west side have been saw cut adjacent to the supporting wall.

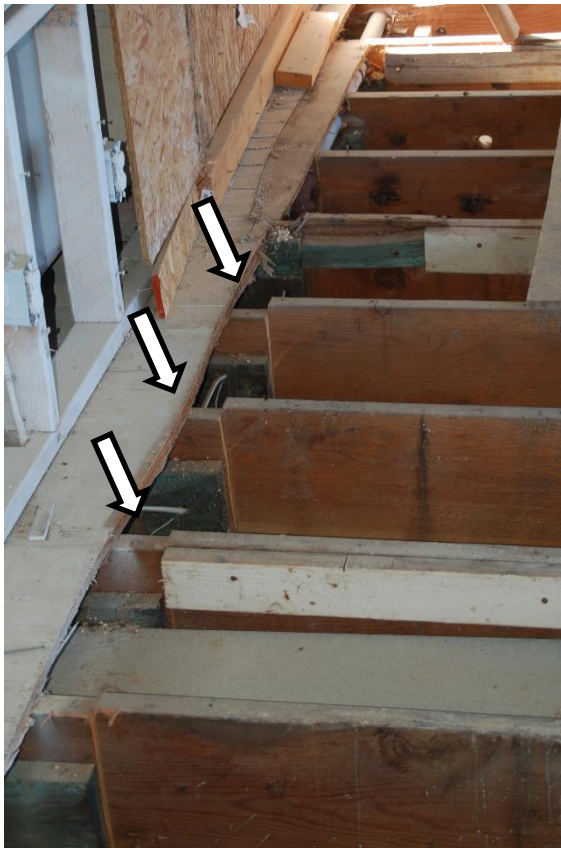
Photo 18

Floor joists along the upper level east side have been sawn through and displaced vertically by the shoring below.

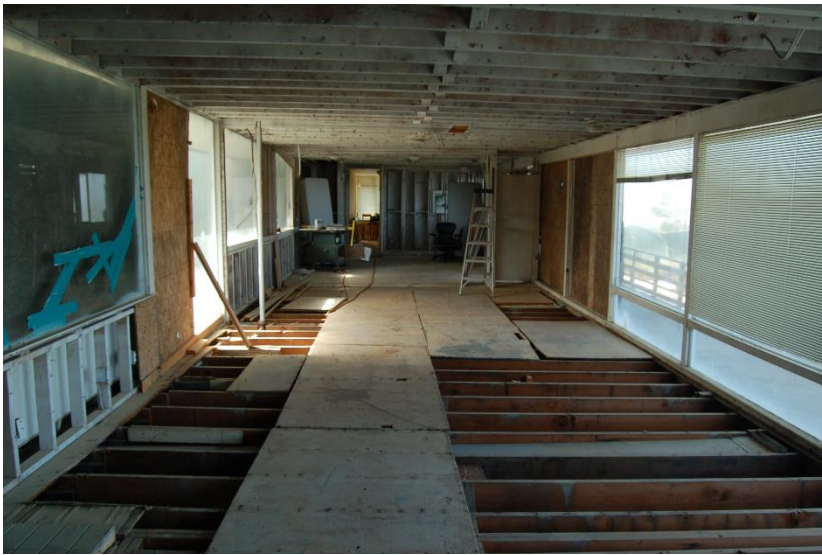
Photo 19
Upper level floor framing, saw cut at both ends and supported by shoring below.

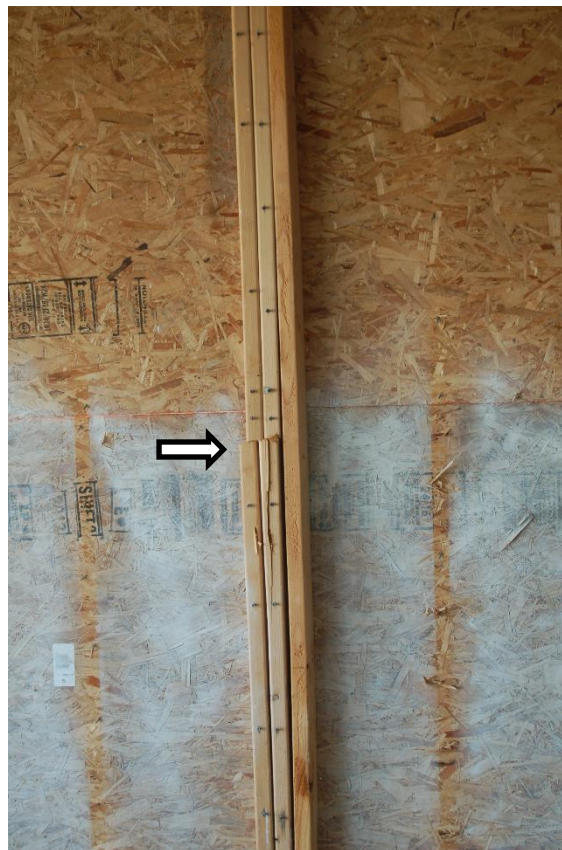
9. Temporary framing, installed at the north window wall at the upper level has failed, and been reinforced with a sister 2x member (Photo 20).
10. Gypsum sheathing in the upper level north wing has been removed as have windows, electrical wiring and fixtures, and, the ceiling. Diagonal wood roof sheathing and joists are evident (Photo 21). Exposed building paper, serving as backing for stucco, and let-in braces are evident in the northeast corner of the den (Photo 22).

Photo 20
Failed shoring post placed at upper level north windows. New 2x member is placed adjacent to failed members.

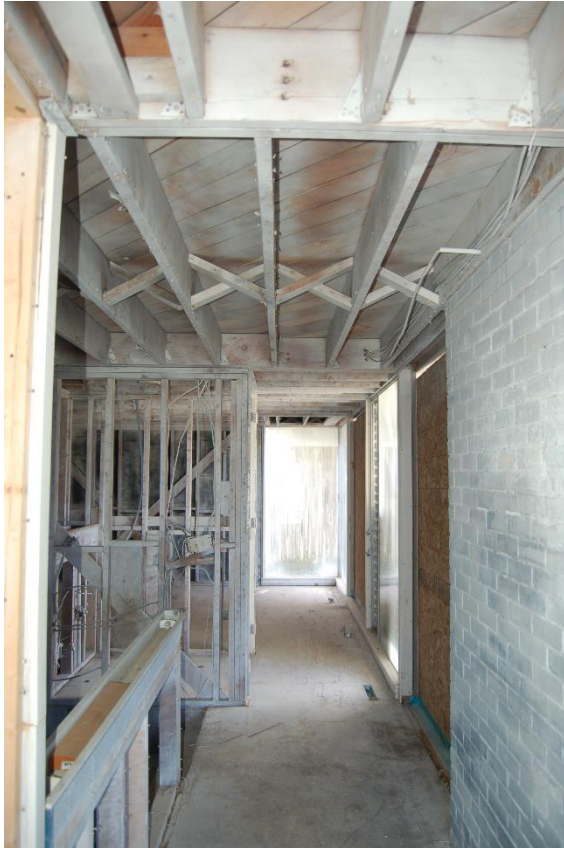
Photo 21
Demolished finishes in the
upper level north wing.

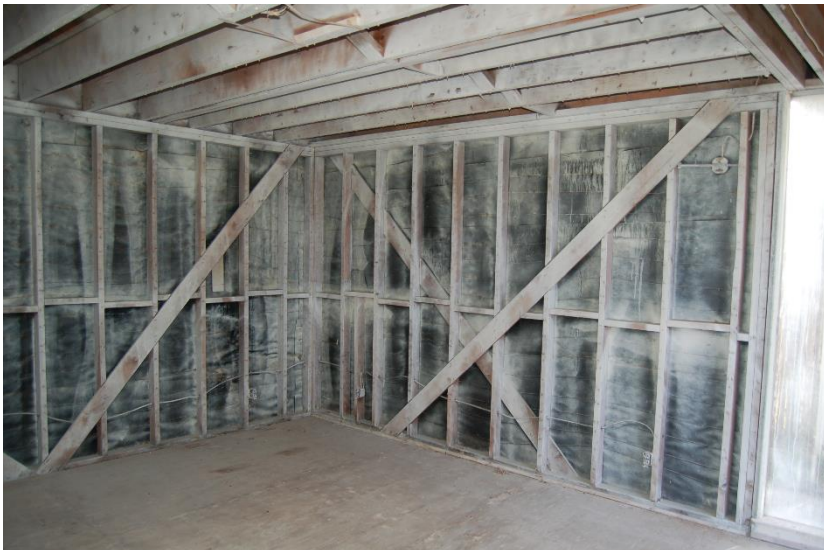
Photo 22
Interior view of upper level
northeast corner.

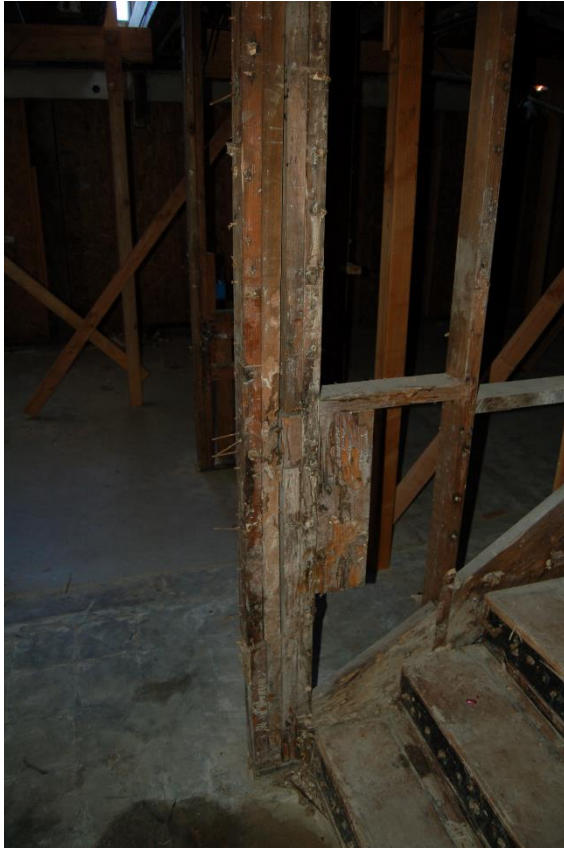
11. Much of the original first level framing has been removed. Some of the few remaining posts and joists show deterioration due to water damage (Photo 23).

Photo 23
Water staining and damage
to wood framing at lower stair.

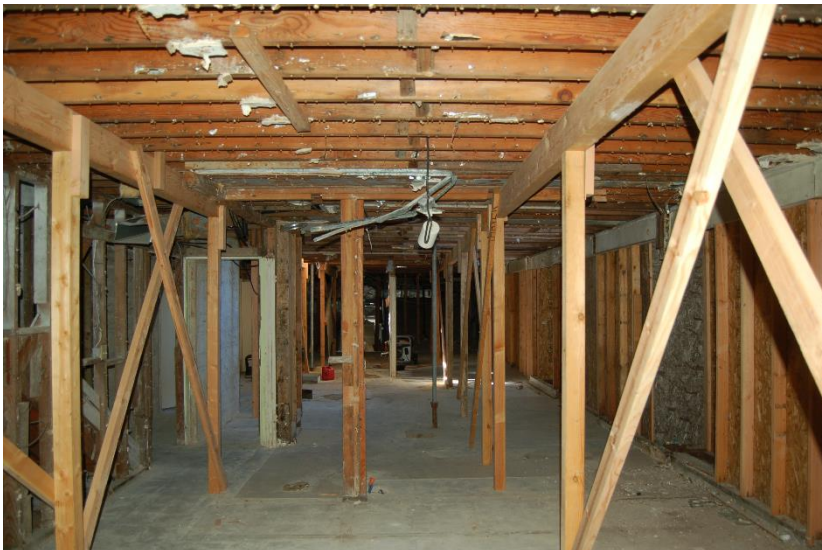
12. Many interior partitions in the lower level have been removed, as have all finishes (Photo 24). The upper level floor rests on two rows of shoring, running north-to-south.

Photo 24
Lower level has been gutted
of all finishes and the upper
level floor is supported on two
rows of wood shores.

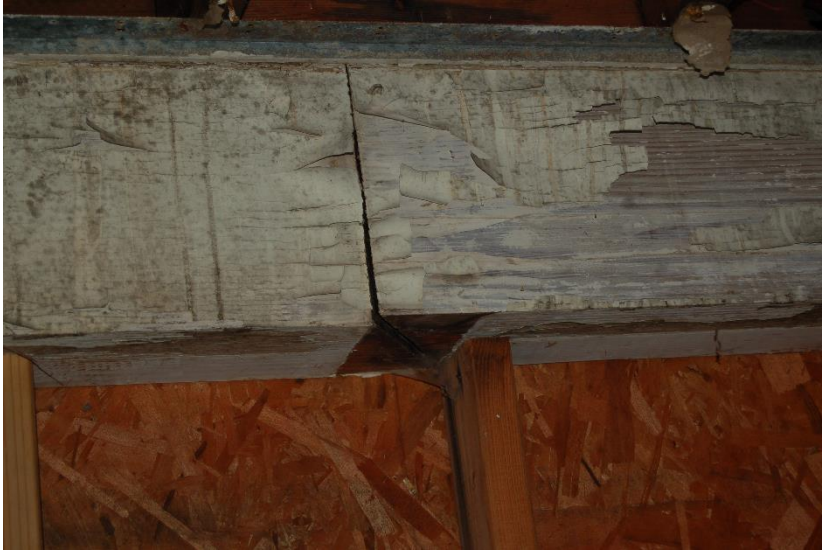
Photo 25

13. Many of the original posts along the west wall of the lower level have been removed. The 4x10 framing is supported on newly installed 2x4 shores (Photo 25).

Many of the original lower level support posts have been removed. The outer line of 4x10 beams are supported by 2x4 shores.

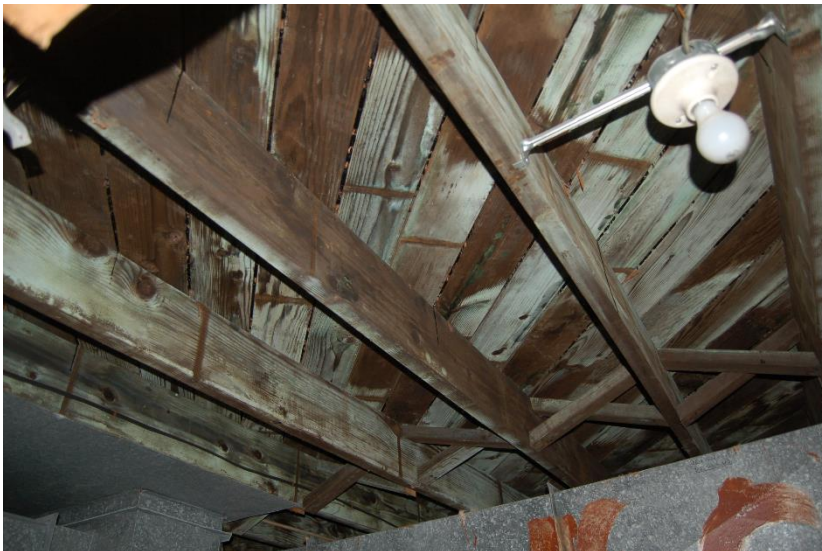
Photo 26

14. Water-related staining and deterioration is evident on the diagonal sheathing beneath the first floor (Photo 26).
15. Portions of the mechanical duct that remain are corroded (Figure 27). In mechanical areas of the lower basement, no floor slab is present.

Water staining and deterioration on diagonal wood sheathing and upper level floor framing.

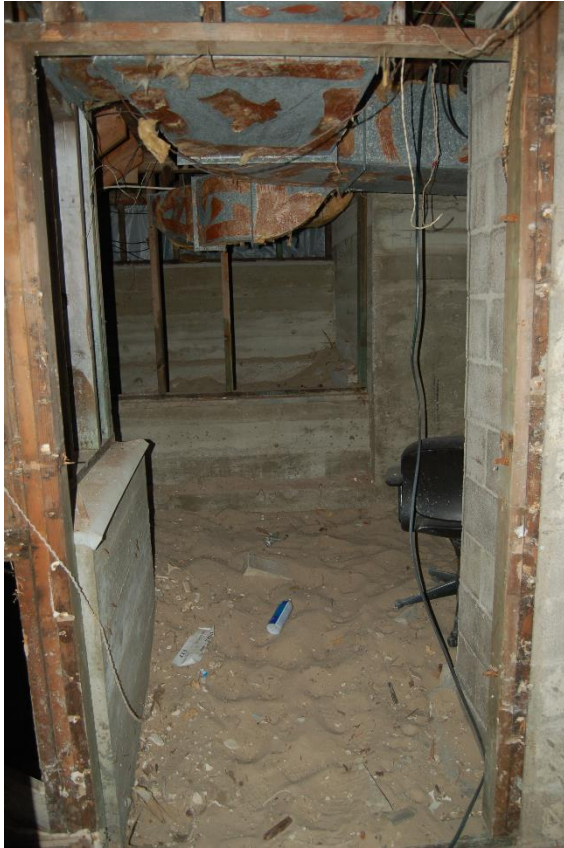
Photo 27
Rusted ventilation system ducts. Note that floor slab is not present in mechanical areas.

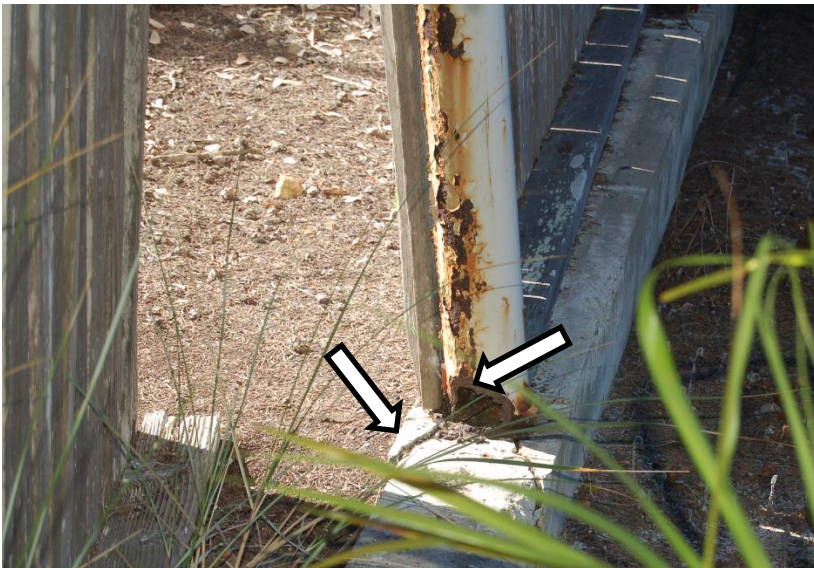
16. Cantilevered pipe columns supporting the grape stake fence along the east side of the courtyard have corroded through at their bases (Photo 28) and the corrosion has spalled

Photo 28
Hole at base of cantilever pipe fence support and spalling of concrete curb.

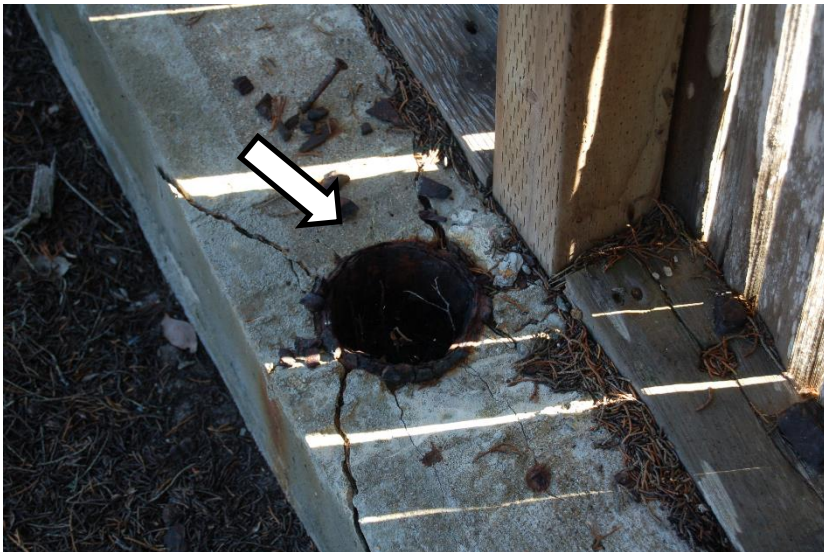
the concrete curb wall they are mounted in. One support pipe has been removed (Photo 29).

Photo 29
Location of removed fence support post.
