Tree Resources Assessment/Arborist Report

Pebble Beach Company

July 29, 2013

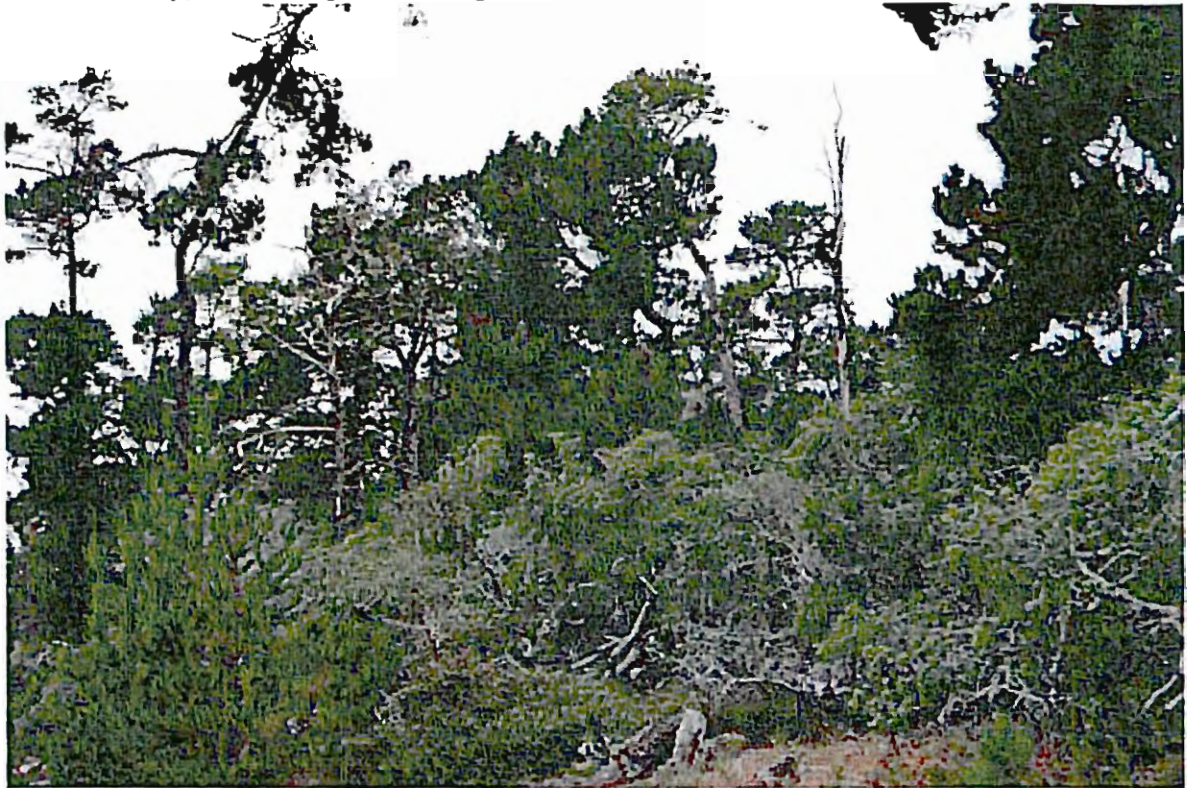
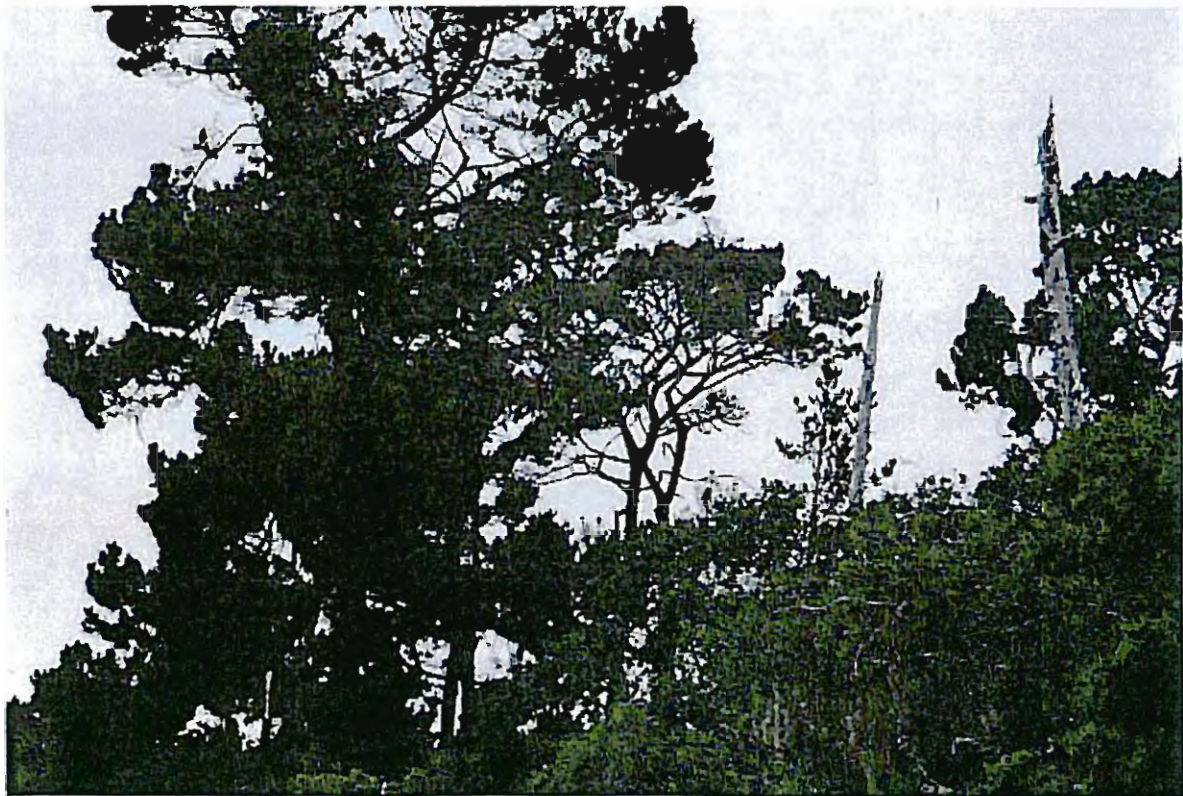
View of canopy from Congress looking east.

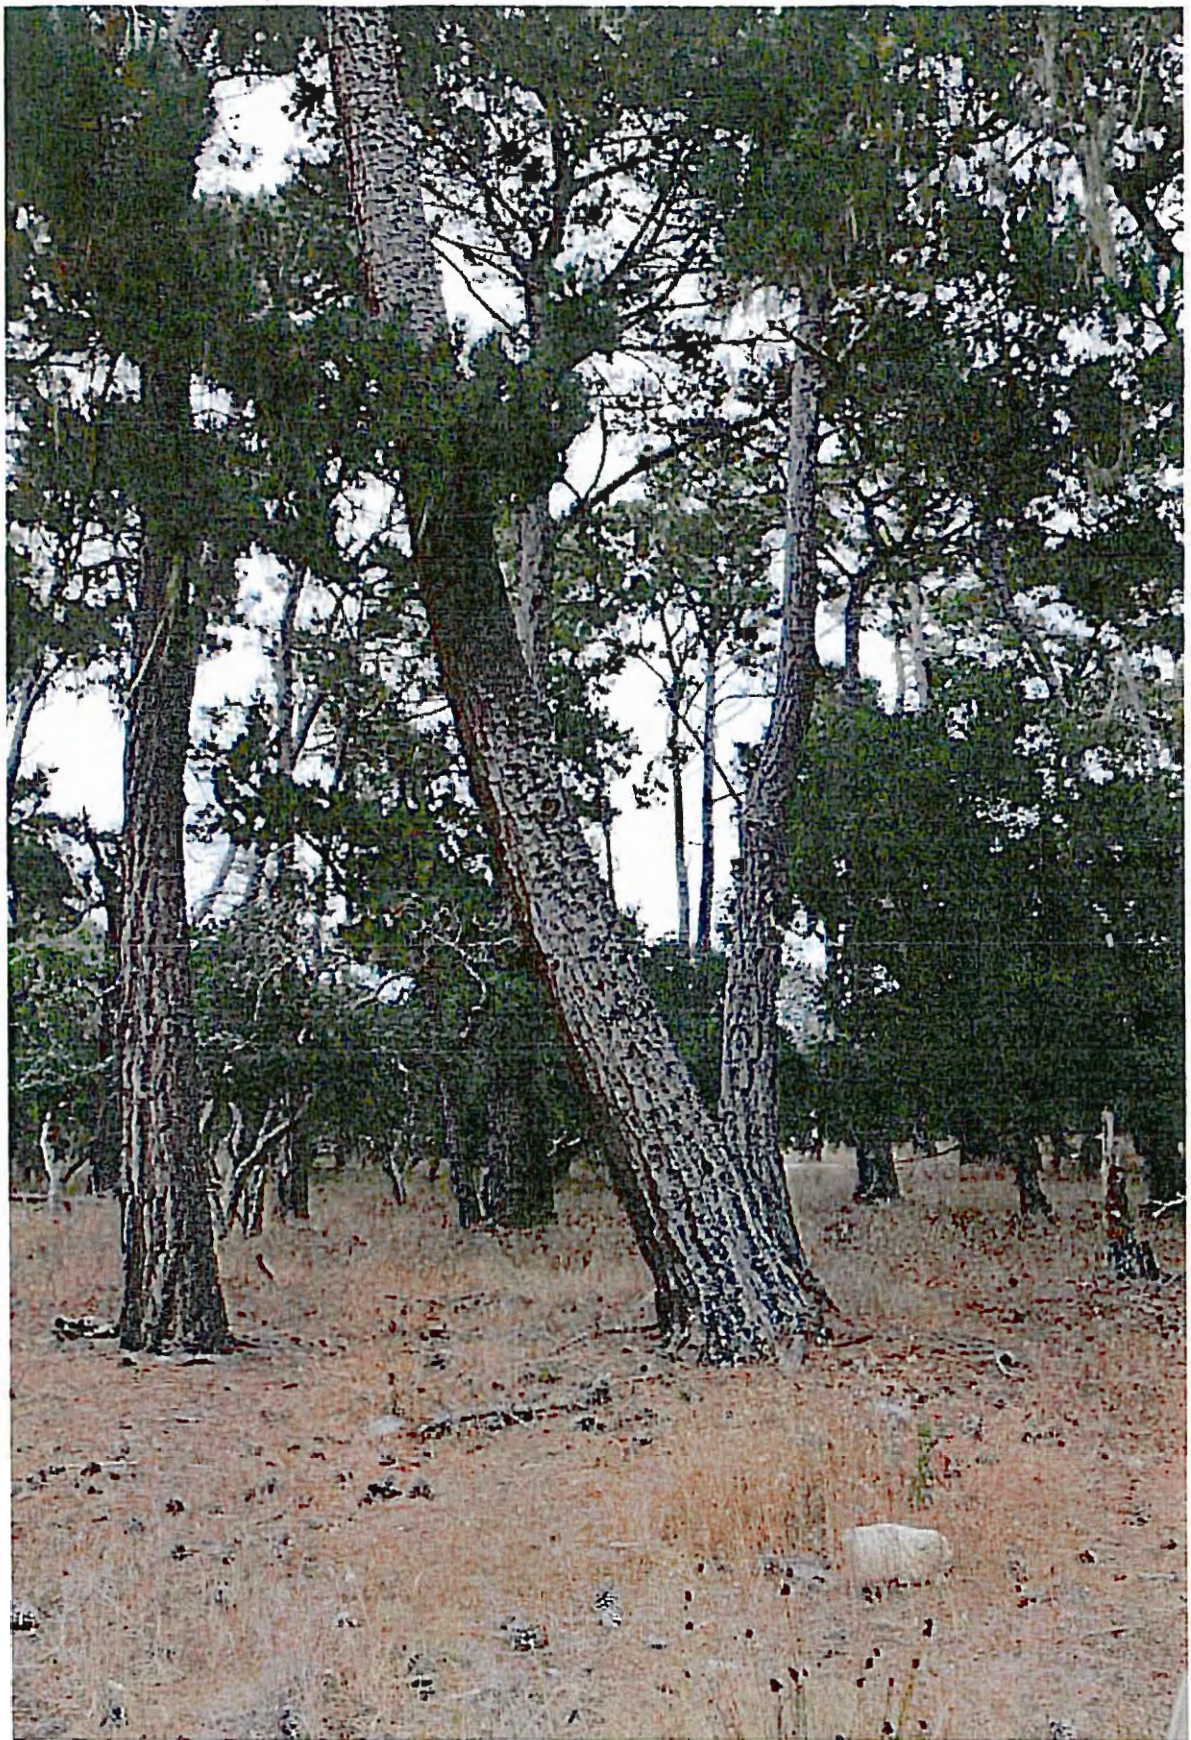
View of canopy looking west
