**TREE RESOURCE EVALUATION  
CONSTRUCTION IMPACT ANALYSIS  
1170 SIGNAL HILL ROAD, PEBBLE BEACH**

**Prepared for  
Massy Mehdipour**

**June 27, 2011**

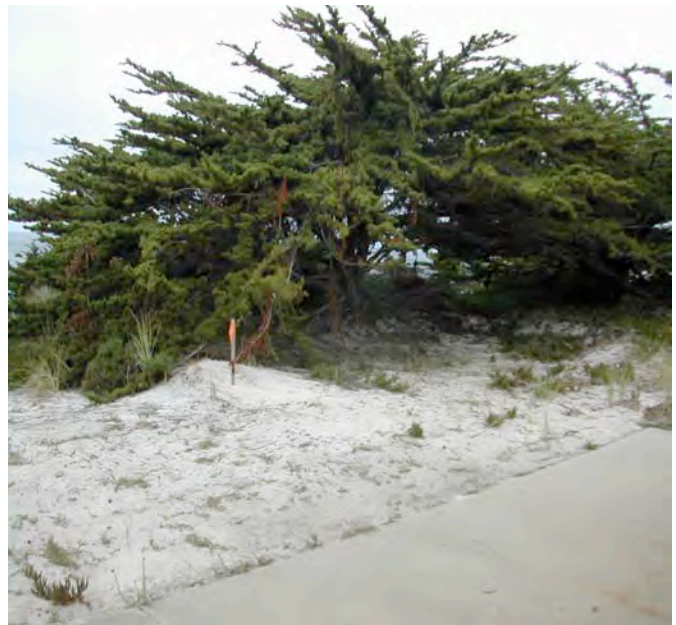
Trees #1, #3 and #4 are remnants of the native cypress forest. Tree #3 is pictured at right. It consists of multiple large diameter stems with a short, broad spreading canopy. This form is typical of the species when it develops in a low nutrient, windy environment.

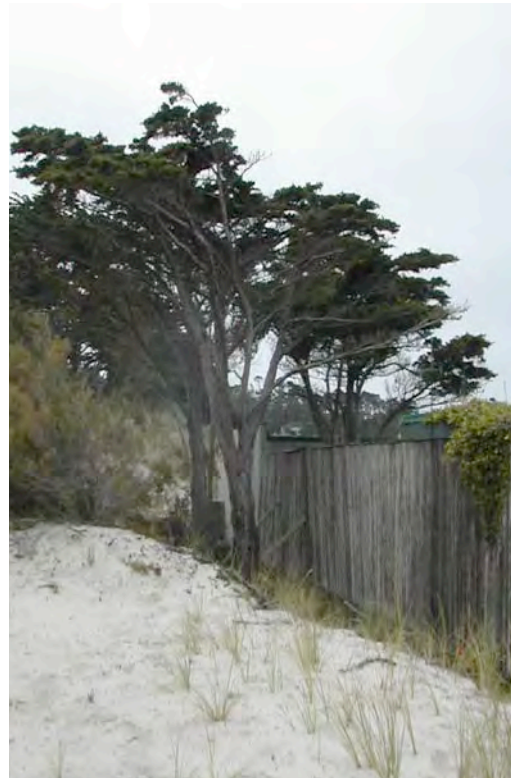
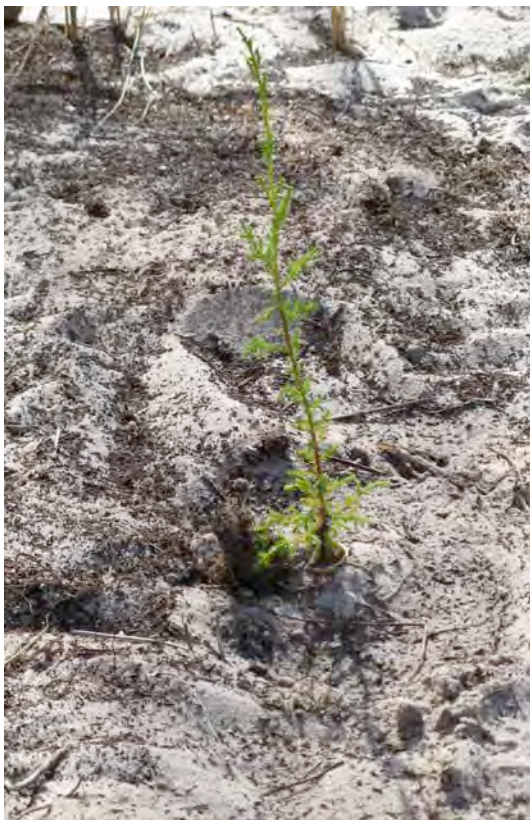
Similar trunk diameters and the single trunk form indicate that the plants were generated at a nursery and planted during the same time period. Tree #5 is pictured below at right.

These trees are in poor vigor. The canopies are thinning and small to medium size dead branching is visible. This could be caused by exposure to extensive salt spray and wind. The dead and discolored foliage is a symptom of cypress canker (*Seiridium cardinale*) a disease common to the species.

The tree removal that is proposed for the new development includes three planted Monterey cypress (trees #5, #6 and #8) trees that are not components of the native habitat. Replanting three cypress trees from 36 inch box nursery stock as replacements is recommended. The trees shall be planted between the public road and the new residence.
