## Structural Survey

On March 5<sup>th</sup> 2012 I conducted a visual inspection, photographed, and documented structural deficiencies at the residence located at 1170 Signal Hill Road, Pebble Beach, California. This was done at the request of the property's owner, Massy Mehdipour.

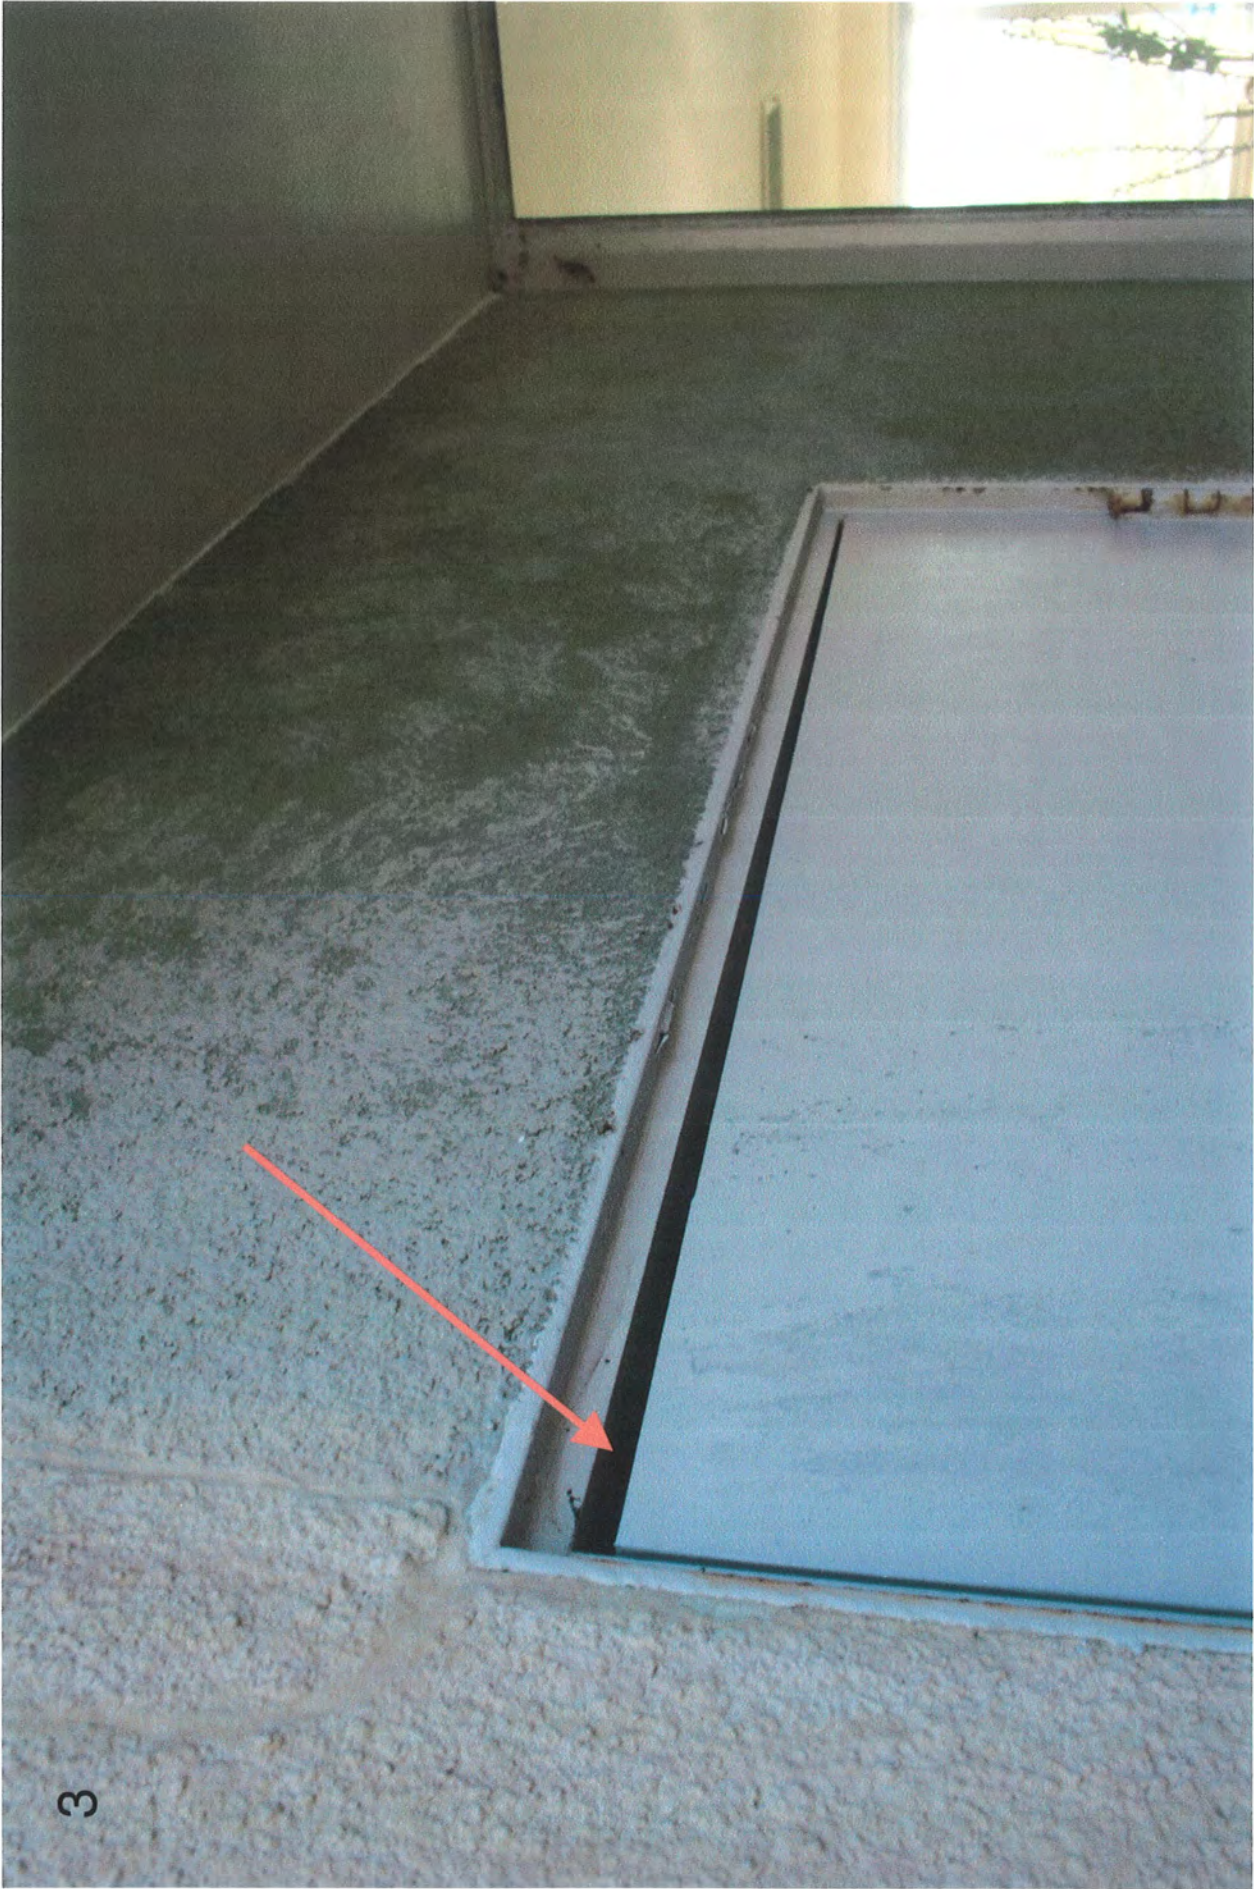
3

Elevations were shot using a transit at all the courtyard and deck locations. The south facing roof overhang at the courtyard showed considerable sagging. At one time a four by four post was added to attempt to correct the problem. (photo #8)  
The front deck shows one inch drop from the north end to the south end. Signs of settling are also evident at the exterior door from the kitchen area to the courtyard. (photo #3)

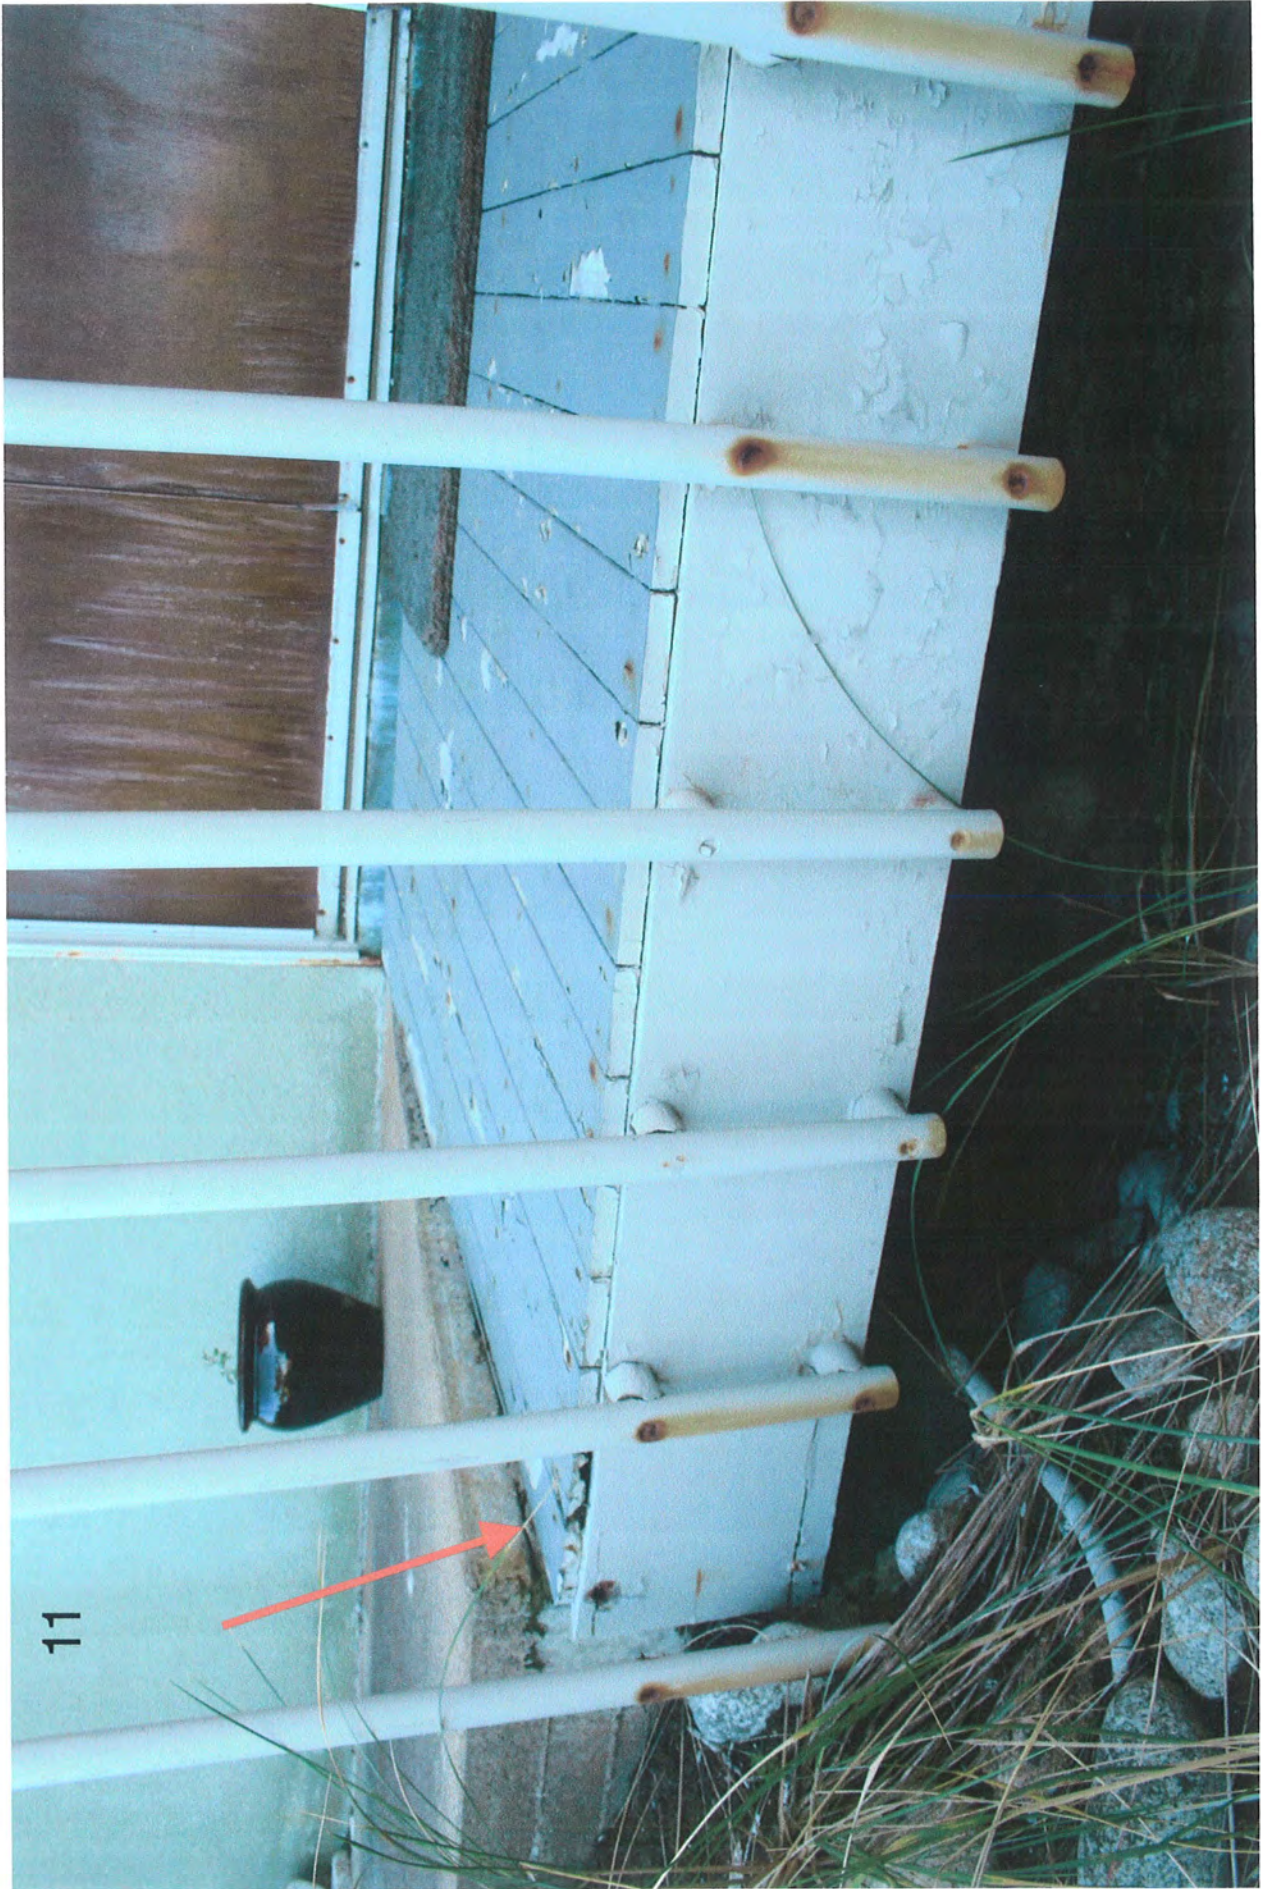
11

The front entry deck framing has failed causing the deck to settle. (photo #11)
