**Monterey County Water Resources Agency**

# **Nacimiento Dam and San Antonio Dam Spillway Condition Assessment**

Chris Moss, P.E.  
Senior Water Resources Engineer

July 26, 2018  
Reservoir Operations Advisory Committee Meeting

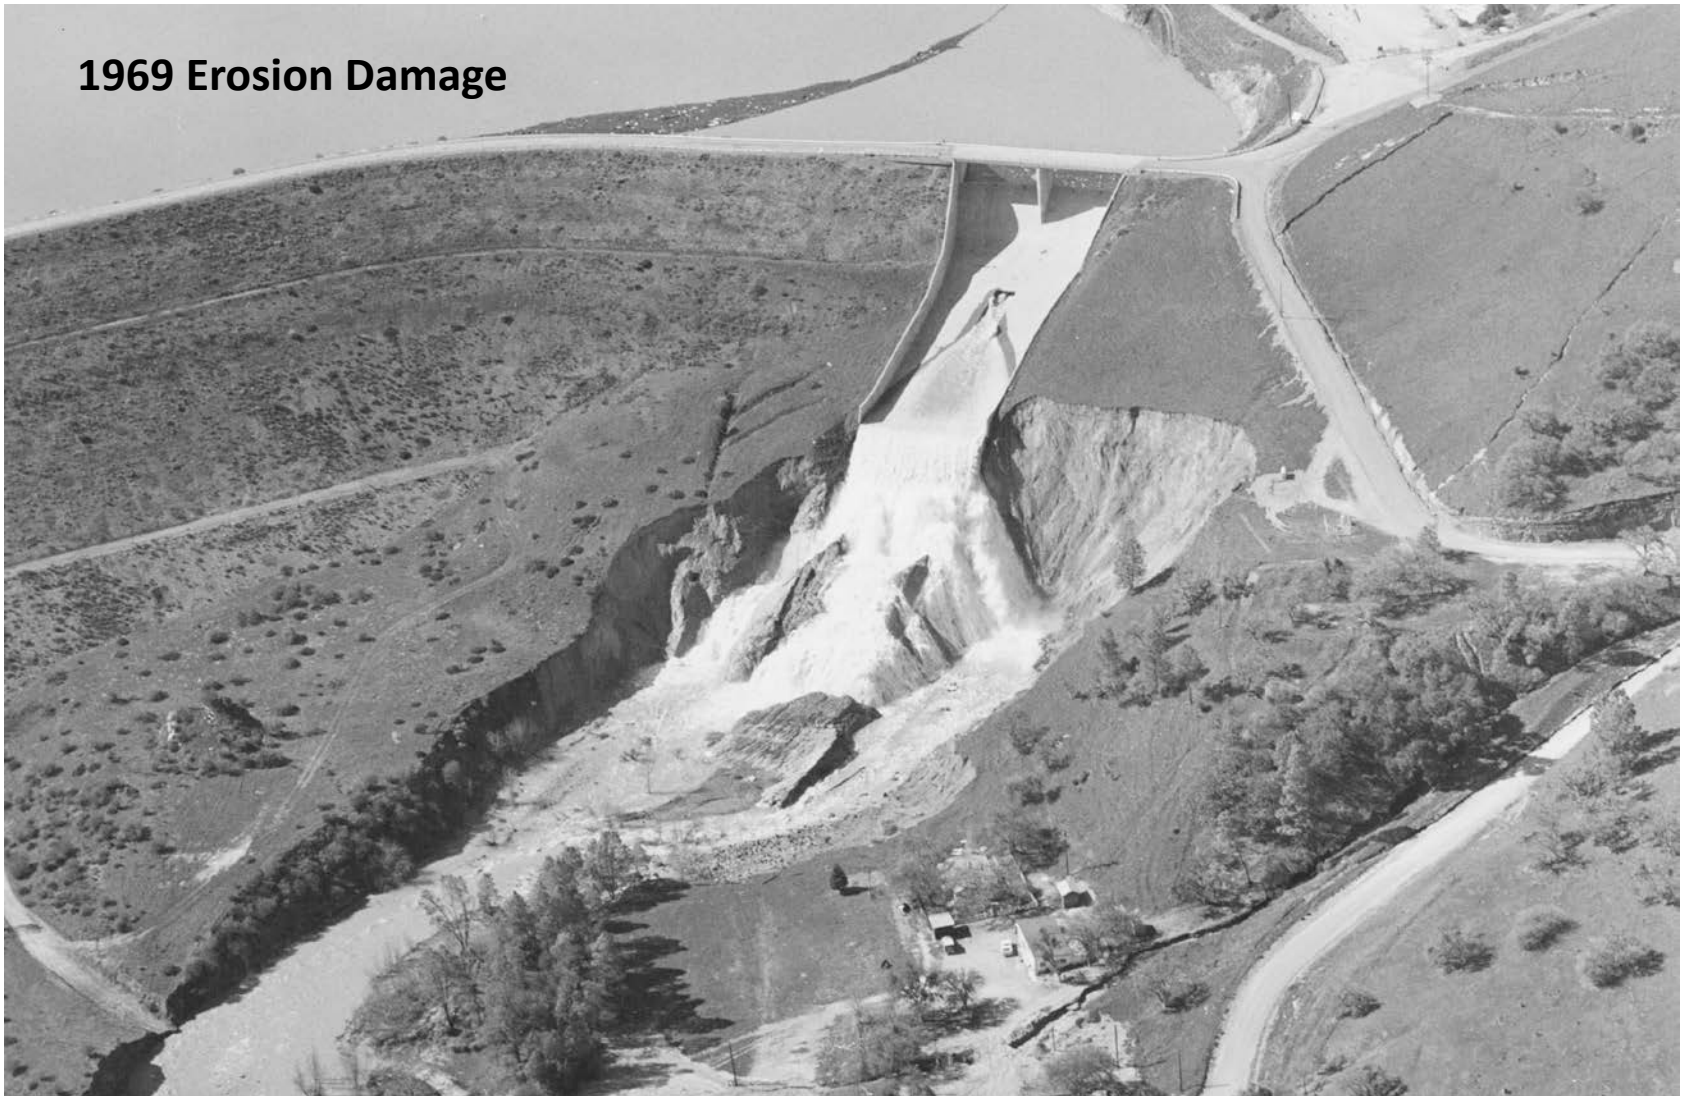
1969 Erosion Damage

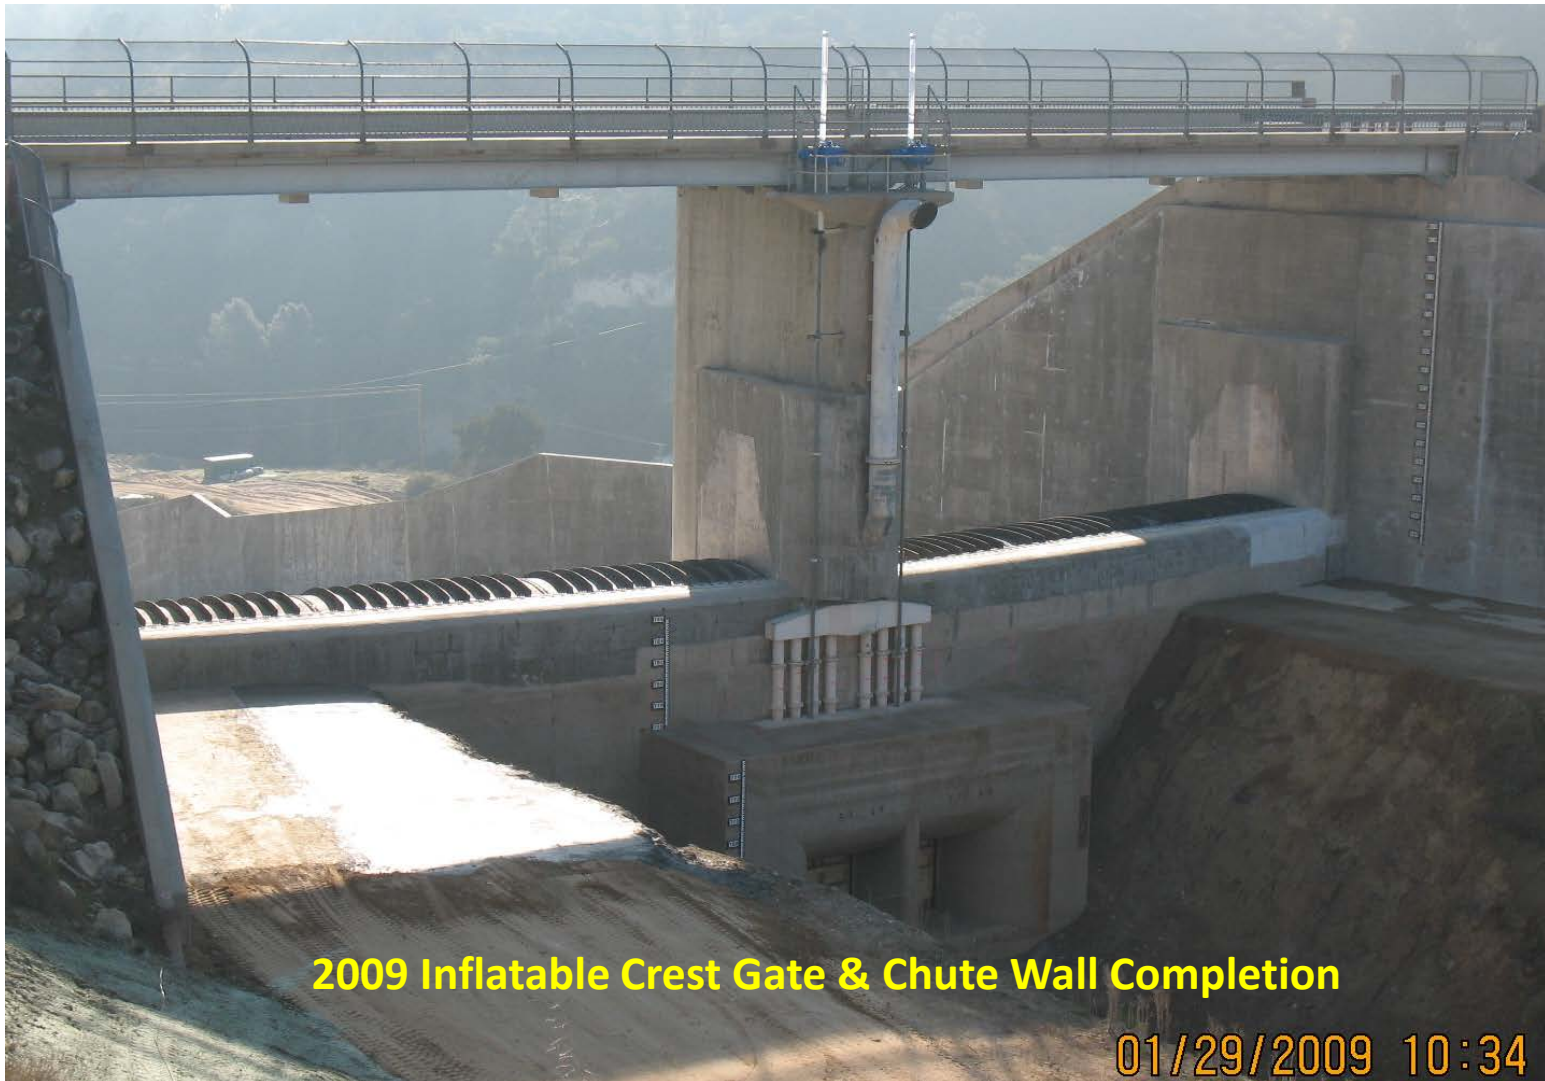
**01/29/2009 10:34**

**2009 Inflatable Crest Gate & Chute Wall Completion**

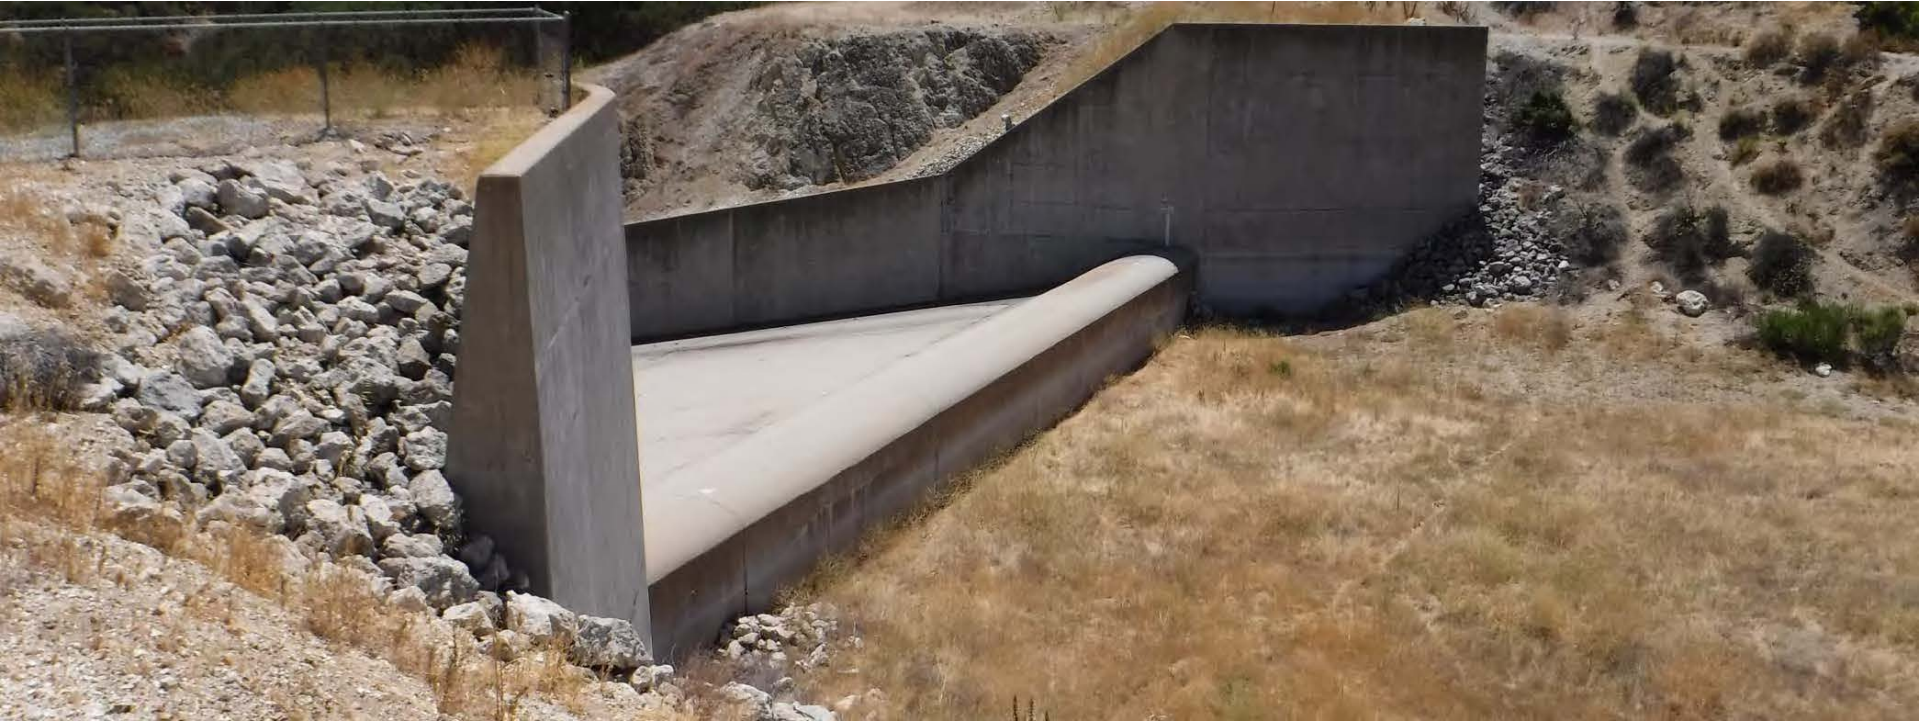
Concrete Ogee Weir

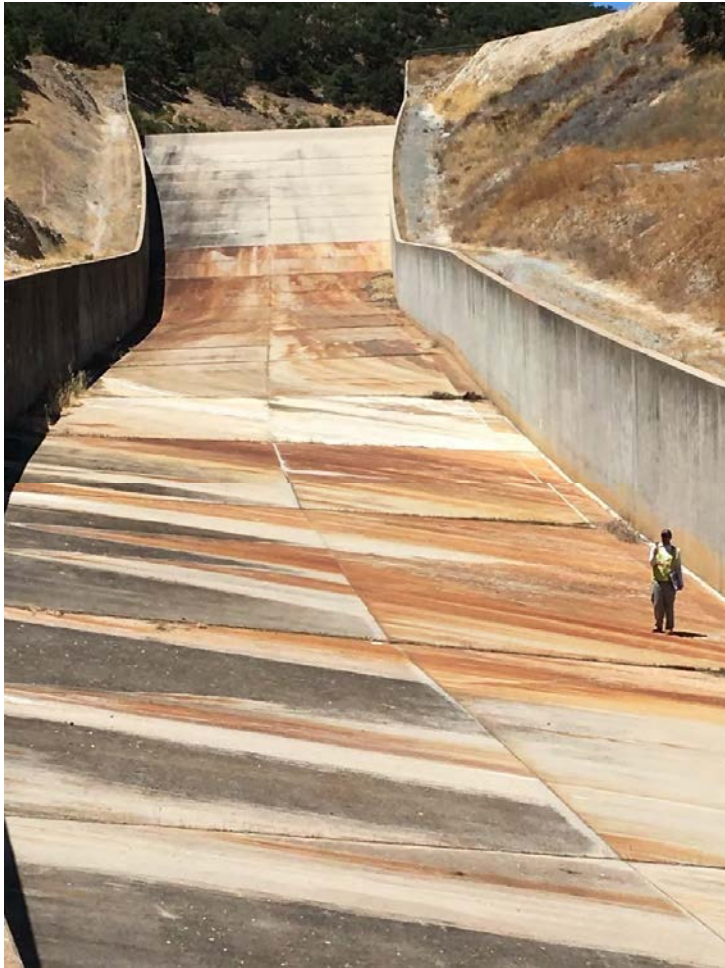
Upstream Portion Spillway Chute

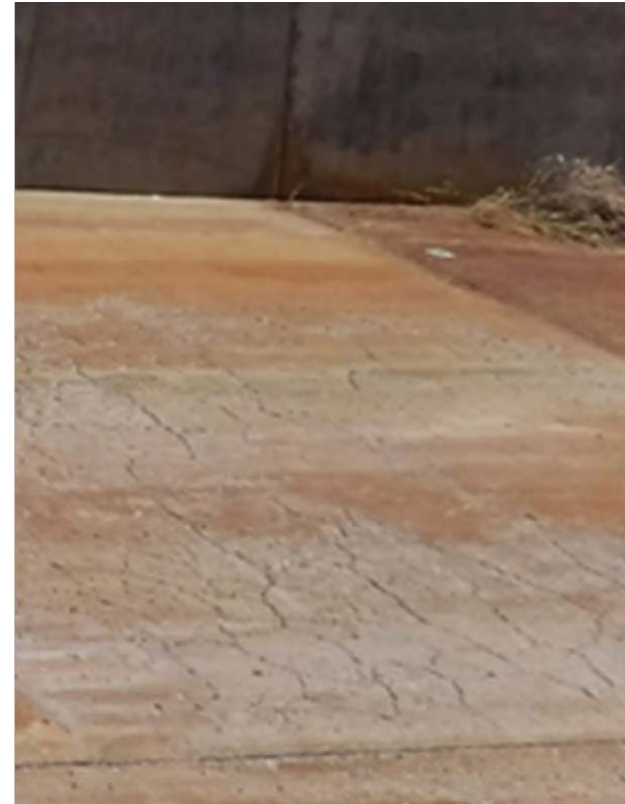
Example Concrete Condition

- R4 – Repair chute slab and wall concrete spalls, delaminations, deteriorated locations
  - R5 – (a) Perform water quality testing of seepage water and reservoir water to determine source of seepage water

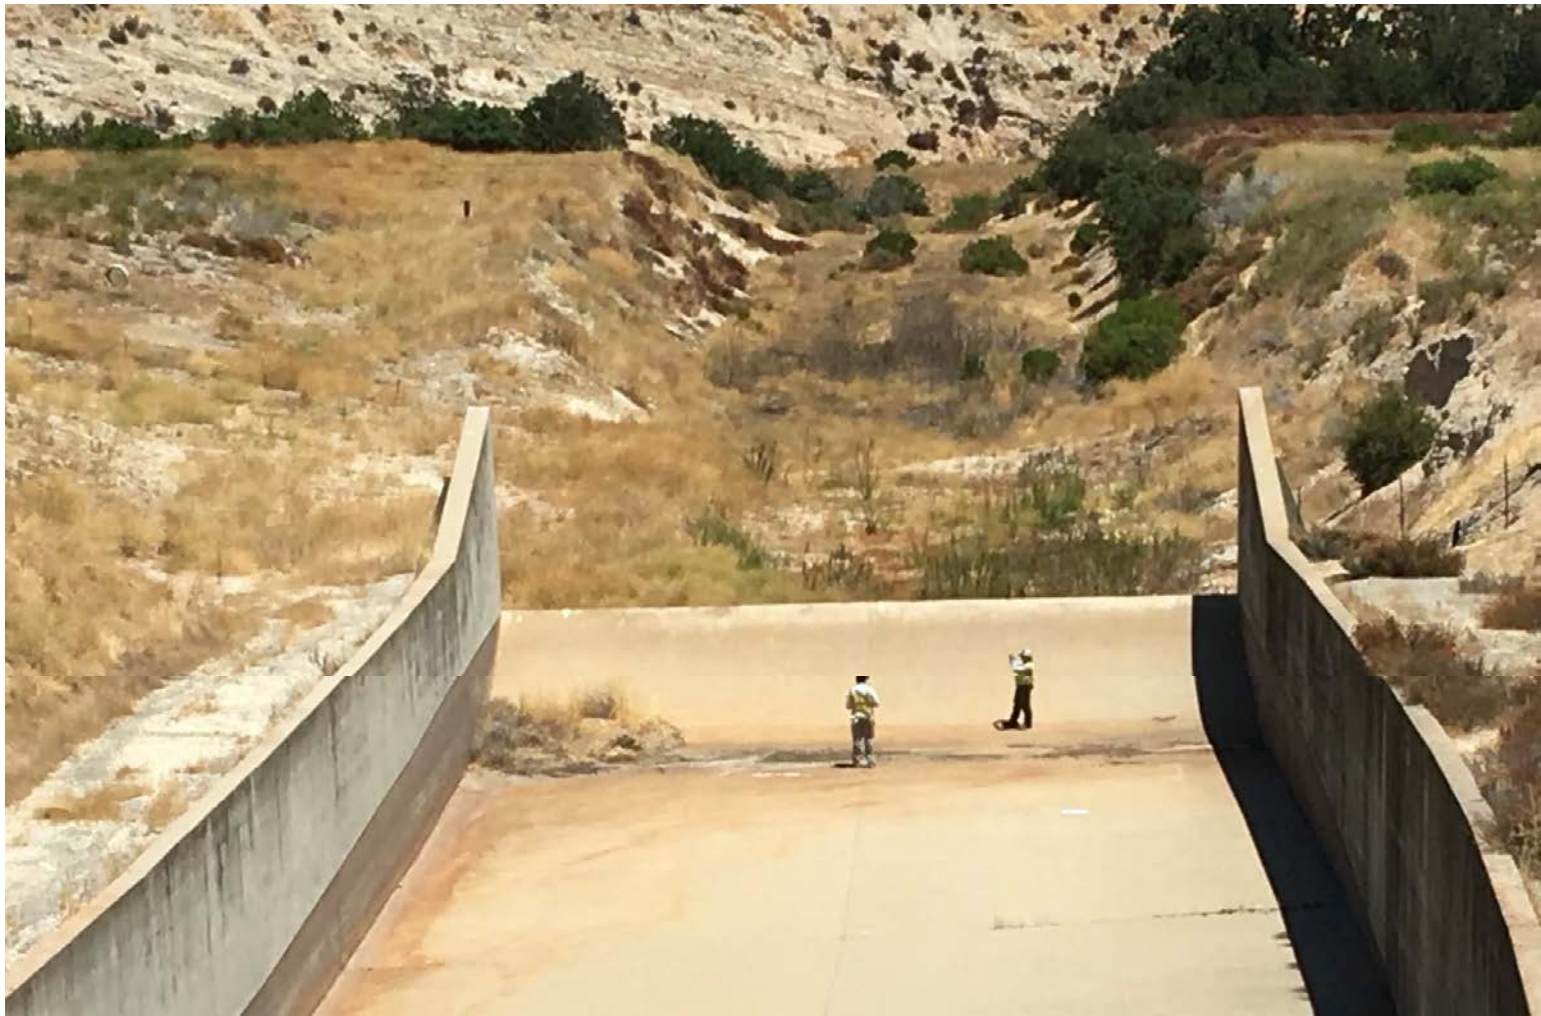
Flip Bucket and Exit Channel

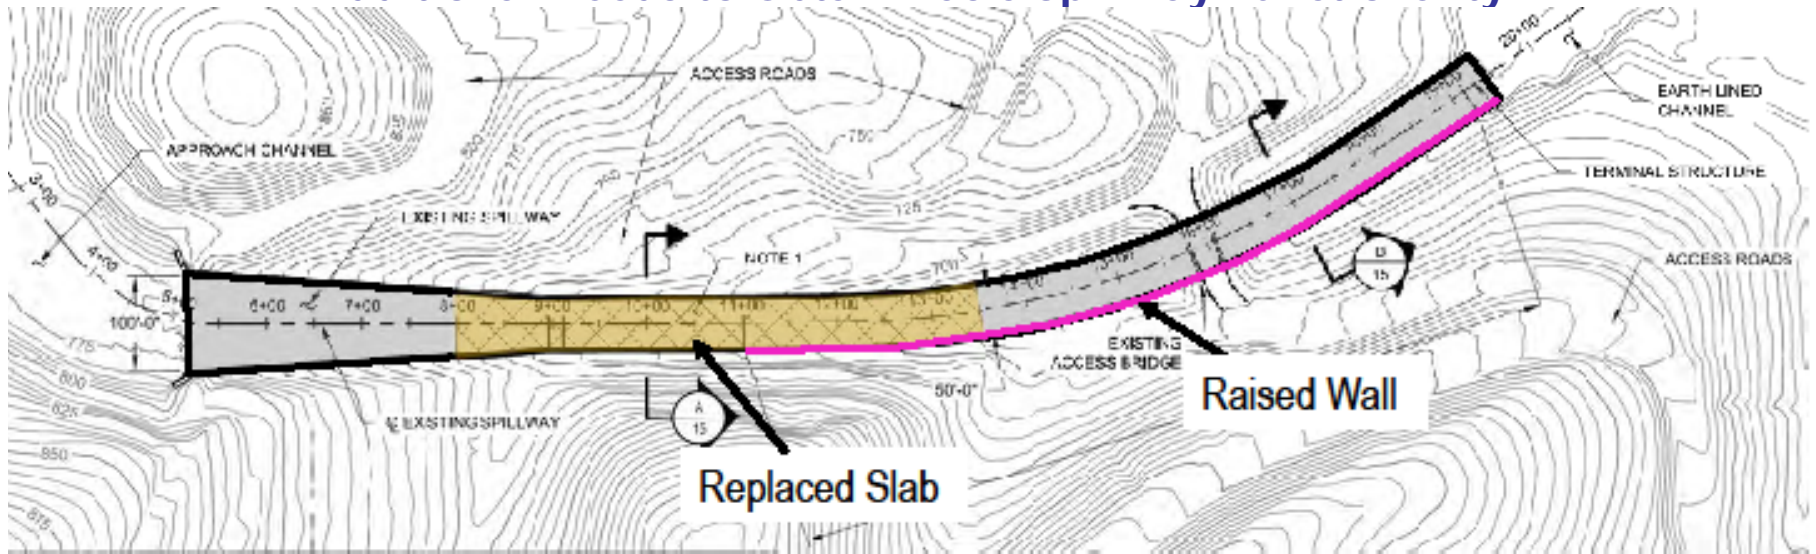
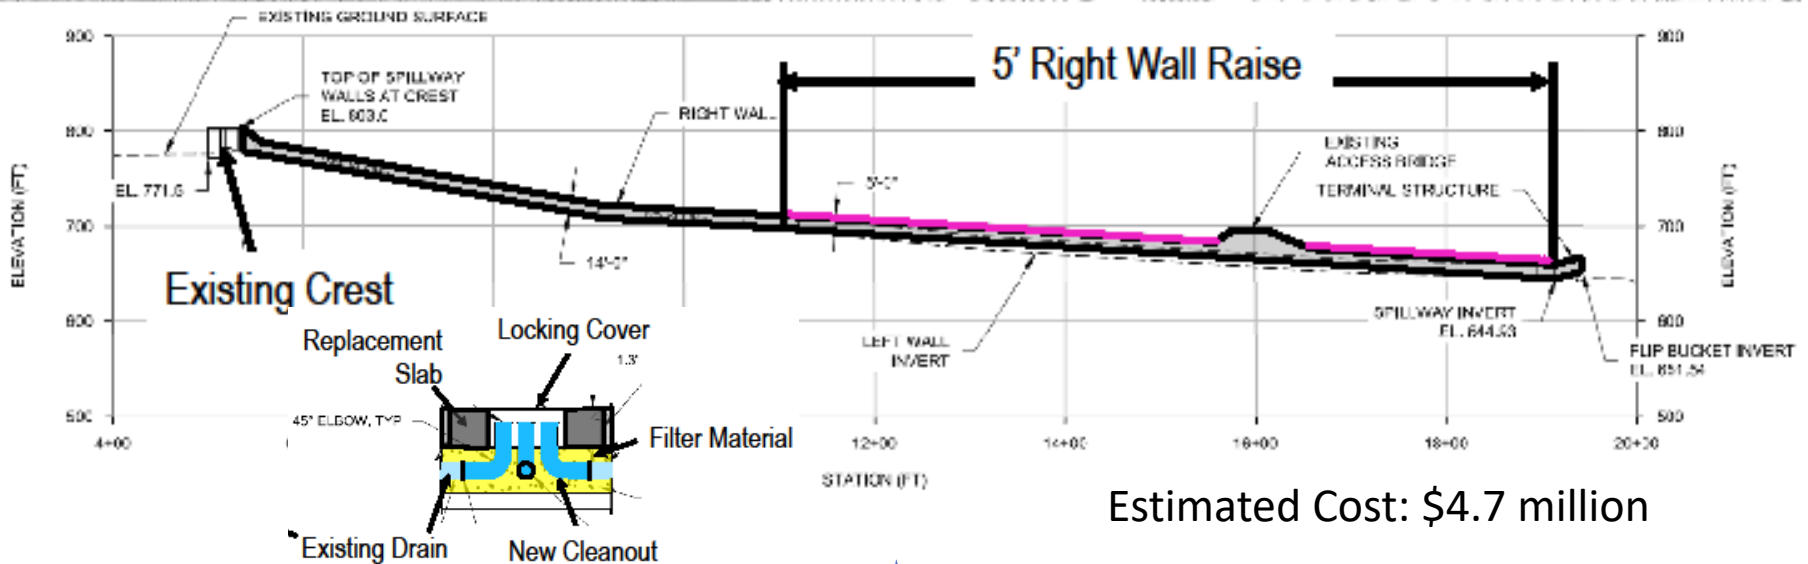
## Additional Needs to Obtain Basic Spillway Functionality

Estimated Cost: \$4.7 million
