19 September 2016

Project 167218 – Structural Evaluation of the Arthur and Kathleen Connell House,
1170 Signal Hill Road, Pebble Beach, CA

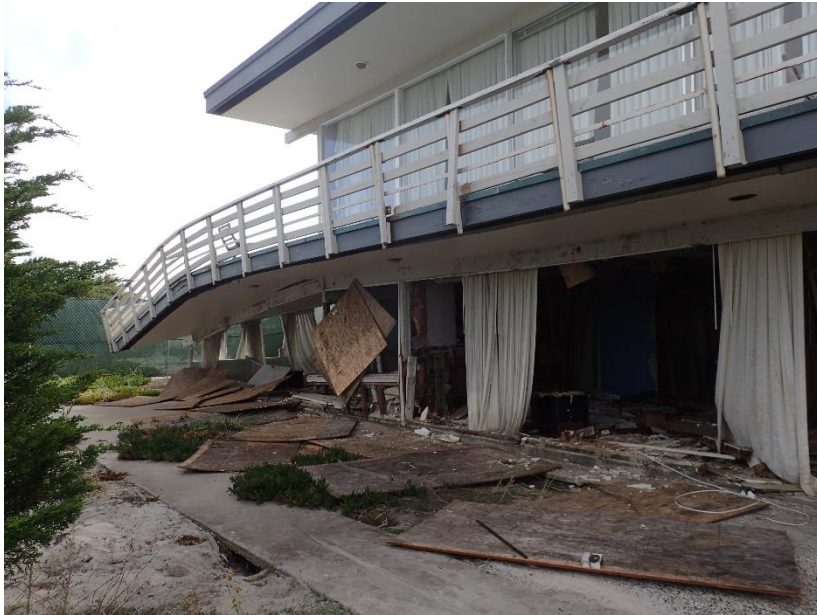
Photo 5 shows that one or more posts supporting the 4x10 along the west face of the building's upper level have either been removed or failed, allowing the northwest corner of the deck to drop. Windows at the lower level have been removed and Oriented Strand Board (OSB) sheathing has been placed at the openings, then removed. A portion of this sheathing can be seen still partially attached. Upper windows and curtains can still be seen at the upper level.

5. Framing deterioration is evident in the fascia beam at the deck edge (Photo 13).
6. Stucco at the top of the north buttress wall has been removed where the wall abuts the building (Photo 14). This appears related to the earlier collapse, now temporarily repaired of the deck at the northwest corner (Photo 5).

Photo 5
SWCA photo looking north
along the building's west
face.

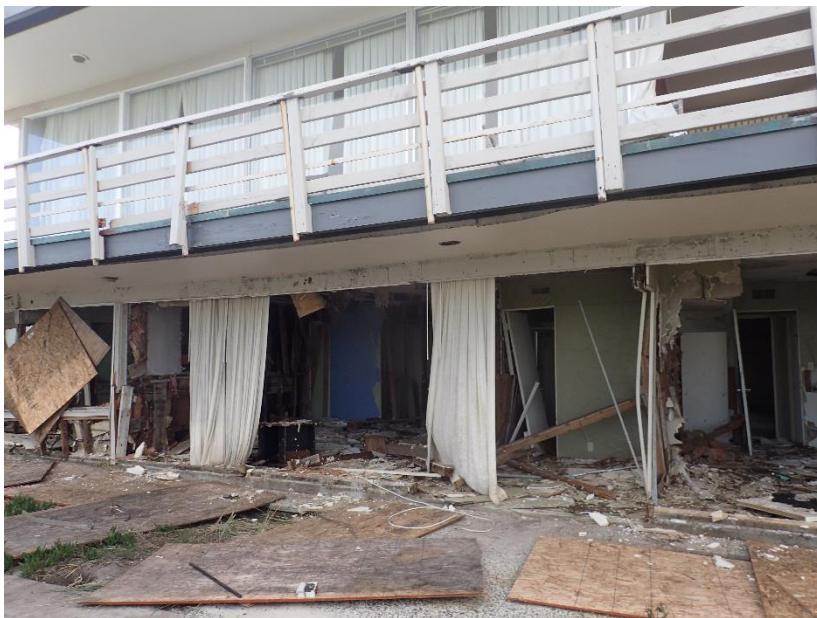
Photos 6 and 7 show extensive damage to finishes at the lower level. Portions of gypsum board partitions and ceilings are laying on the floor. Some interior doors have been removed. Some framing for the upper floor has evidently been taken down or fallen.

Photo 6
SWCA photo looking east
from the lower level, west
side.

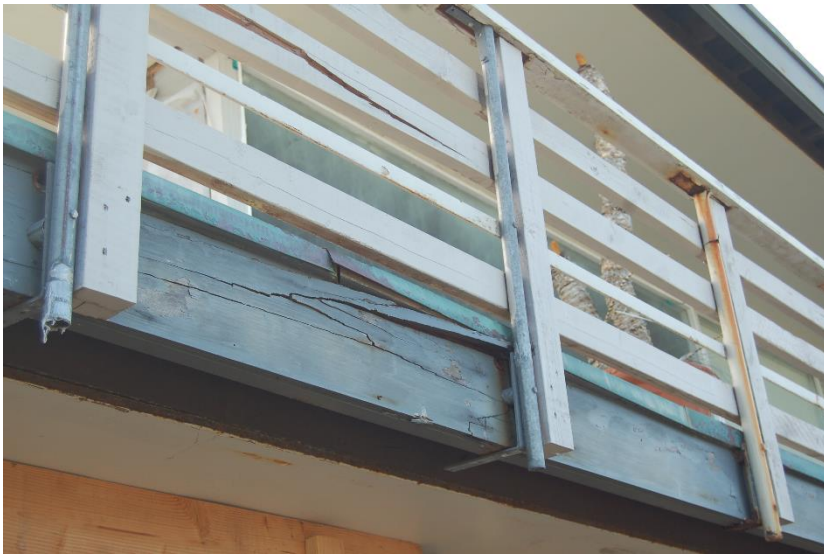
Photo 13
Deterioration and splitting at deck edge.

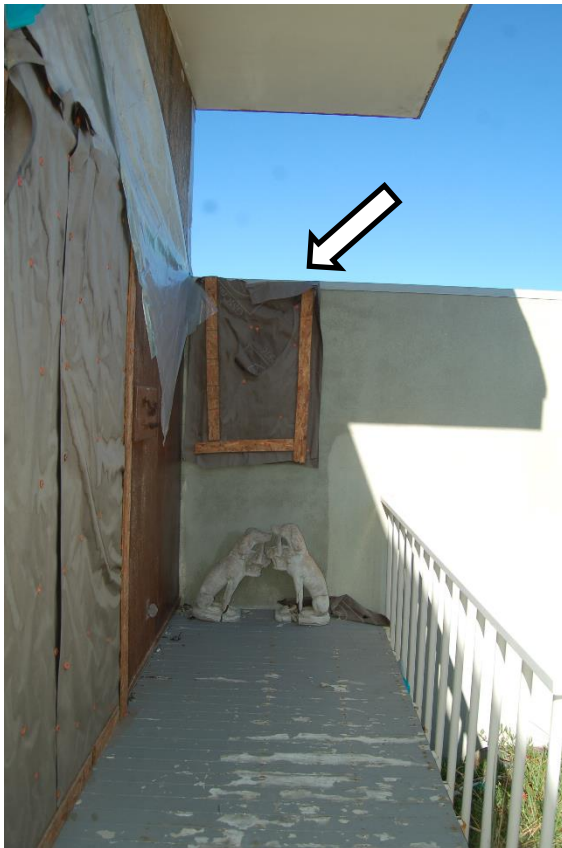
Photo 14
Damaged stucco at north buttress wall, adjacent to house.

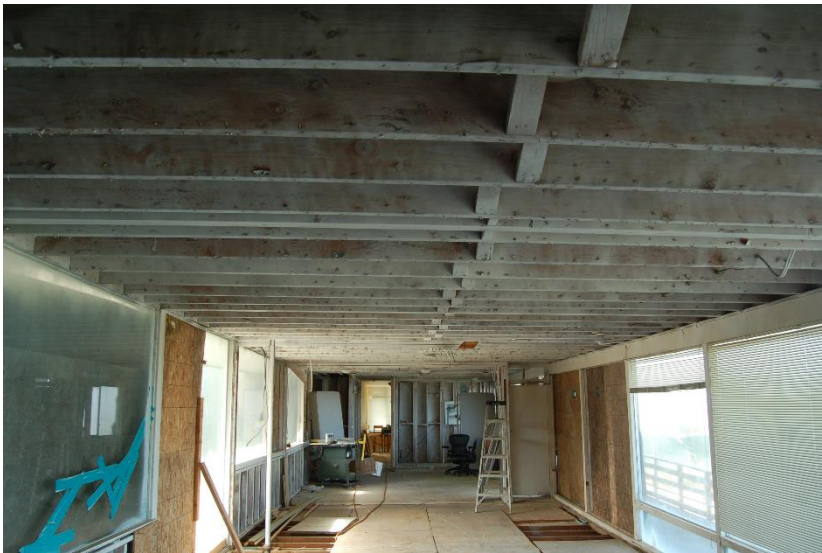
7. The upper level interior has been gutted. Most interior partitions have been removed. Much of the plywood sheathing on the first floor has been removed and other sheets are laying loose across the joists. Many windows have been removed, and replaced with OSB (Photo 15). The ceiling, and few gypsum board wall finishes have been removed in the original building, but remain in place in the addition (Photo 16).

Photo 16
Finishes removed around the upper level bath, but still in place in the addition, visible to the rear left.

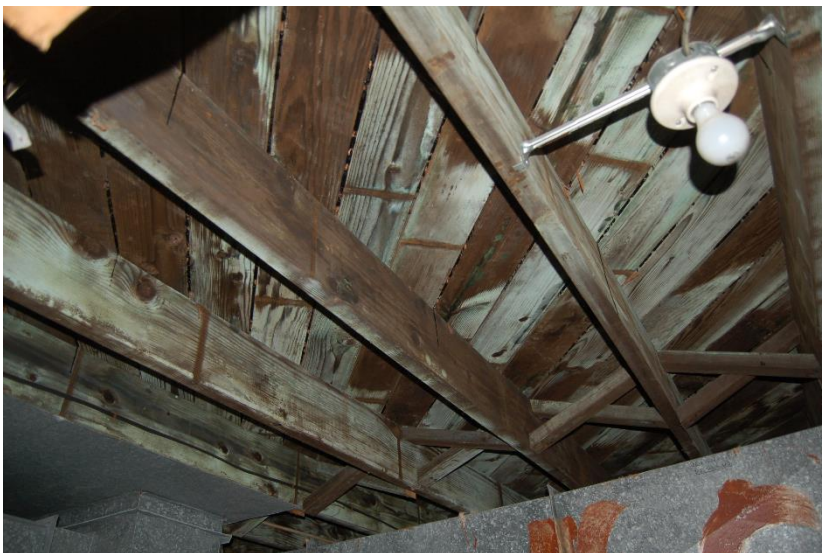
Photo 26

14. Water-related staining and deterioration is evident on the diagonal sheathing beneath the first floor (Photo 26).
15. Portions of the mechanical duct that remain are corroded (Figure 27). In mechanical areas of the lower basement, no floor slab is present.

Water staining and deterioration on diagonal wood sheathing and upper level floor framing.

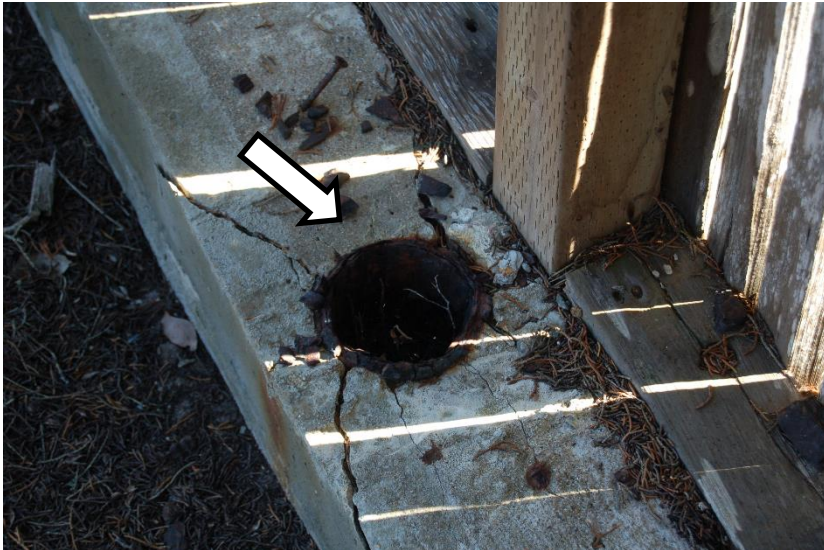
the concrete curb wall they are mounted in. One support pipe has been removed (Photo 29).

Photo 29
Location of removed fence support post.
