# GEOLOGIC AND SOIL ENGINEERING FEASIBILITY REPORT FOR PARAISO HOT SPRINGS SPA RESORT MONTEREY COUNTY, CALIFORNIA

PROJECT LSW-0337-01

DECEMBER 2004

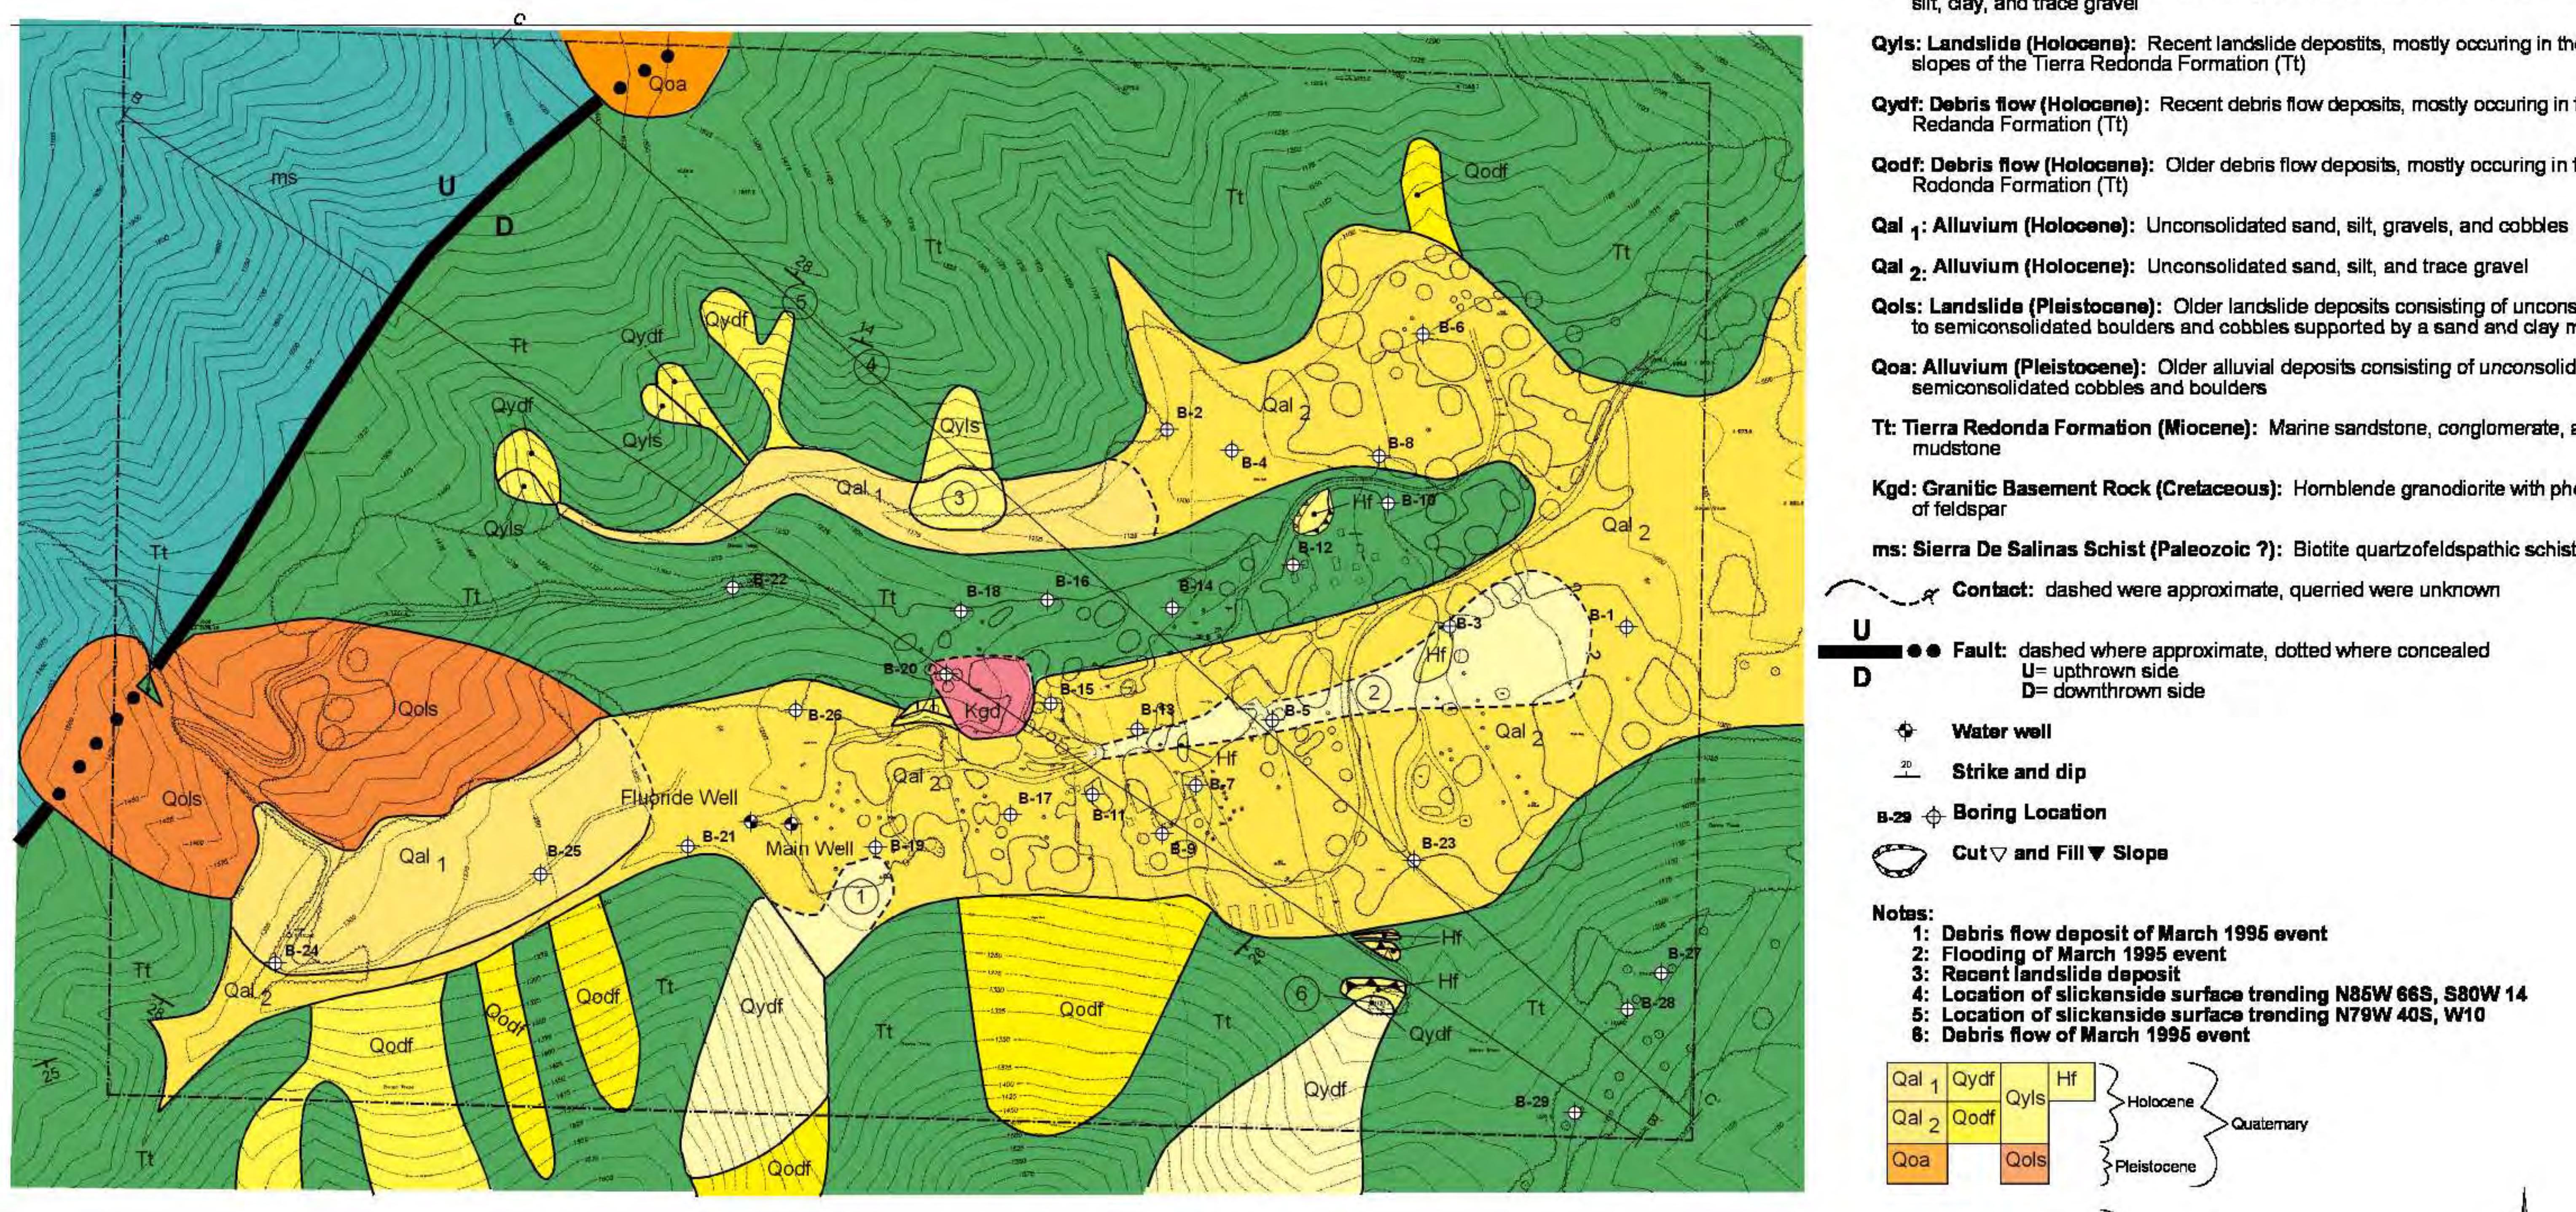
Landsliding on site consists of the debris avalanche and small rock slump type failures concentrated in the Tierra Redonda Formation (Tt), with one large debris slide off of the Sierra De Salinas Schist (ms). Slope failures are found on the steep northern slopes of Indian Valley, the steep southern slopes of Paraiso Springs Valley, and the northwestern slope of the western extent of Paraiso Springs Valley (Sheet 1).

Slope failures along the northern slope of Indian valley are of the debris avalanche (Qydf &Qodf) and small rock slump (Qyls) type, as classified by Varnes, 1978. The slides mapped were found during aerial photo review and during field mapping. Relative ages of slope failures were given based on geomorphic evidence. Young debris avalanche failures (Qydf) are expressed as elongate, shallow failures that expose unvegetated bedrock. Older debris flow avalanche failures (Qodf) are also expressed as elongate, shallow failures, but show regrowth of vegetation and softening of geomorphic features. Recent rock slump failures (Qyls) are expressed as lobate failures with rotated, intact blocks. These failures are shallow and lack regrowth of vegetation in the scarp areas.

Landsliding on the southern slopes of Paraiso Springs Valley consists entirely of the debris avalanche type (Qydf &Qodf). Relative ages of the slides were given using the criteria outlined above. Failures in this area are more extensive than those of Indian Valley in width and depth. The younger debris avalanches (Qydf) mapped are recent failures from March of 1995 (locality 1 and 6, Sheet 1). These events were rapid, and occurred on steep vegetated slopes after heavy rains for multiple days. Deposits on the valley floor were approximately 0.5 to 1.0 foot of mud and sand.

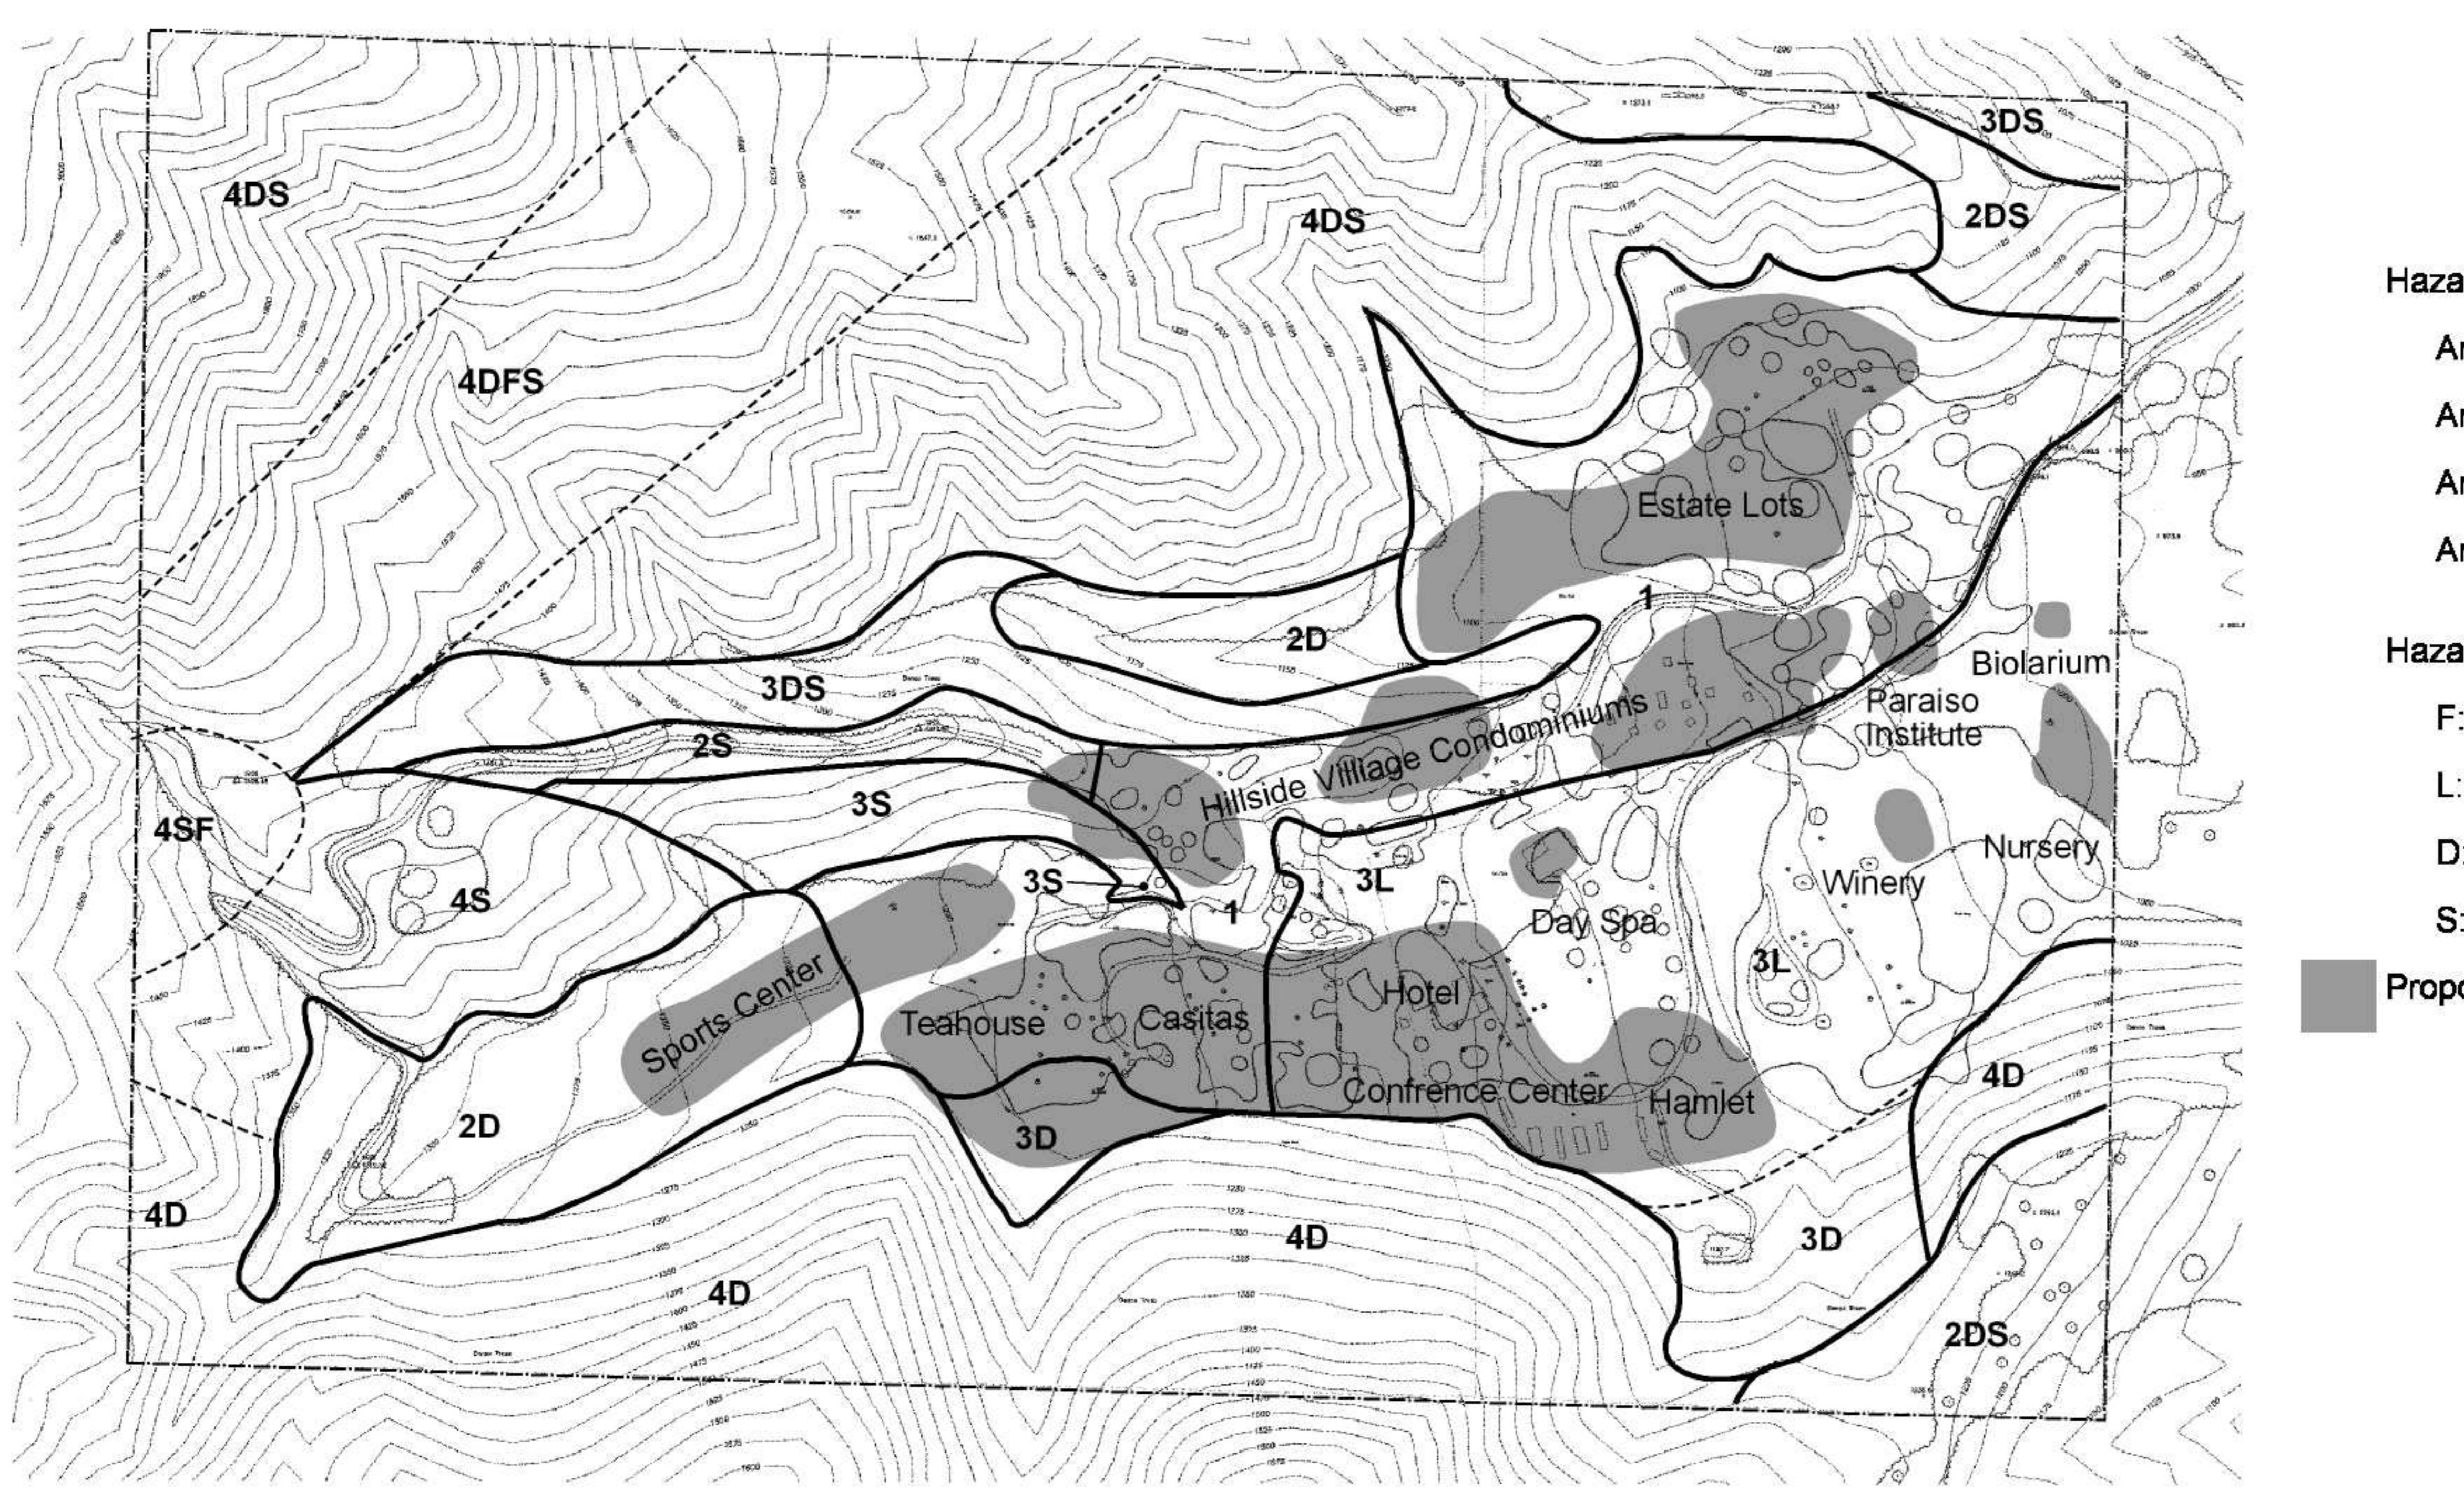
RELATIVE GEOLOGIC HAZARDS MAP Paraiso Hot Springs Resort Paraiso Springs Road Soledad/Greenfield Area, Monterey County, CA

For purposes of zoning for our relative geologic hazard map, areas with identified landsliding were given the designation of zone 4 (High Geologic Hazard Potential). The steep slopes surrounding the areas of landsliding that do not show evidence of slope failure was also designated zone 4. These areas were classified as zone 4 due to similar earth materials and slope gradients.

Dynamic compaction occurs when loose, unsaturated soils densify in response to ground shaking during a seismic event. Because loose soils were encountered on the site, it is our opinion that the potential for dynamic compaction is high in areas designated as Zone 3L.
