Tree Resource Assessment/ Arborist Report

Pebble Beach Company

July 29, 2013

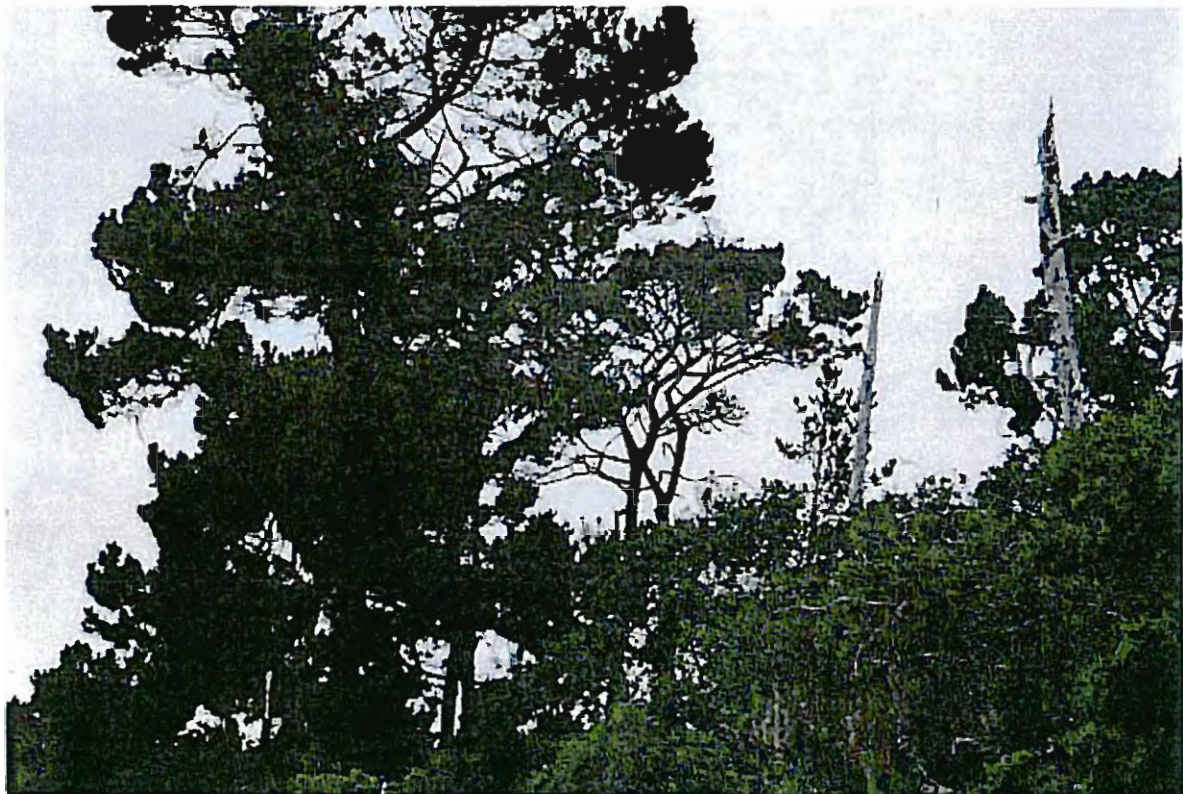
View of canopy from Congress looking east.
