PAGE & TURNBULL PRELIMINARY OPINION OF HISTORIC
SIGNIFICANCE – MID-VALLEY SHOPPING CENTER
(DATED OCTOBER 29, 2019)

PROJECT Mid Valley Shopping Center, Carme Valley

REGARDING: Preliminary Opinion of Historic Significance – Mid Valley Shopping Center, Carmel

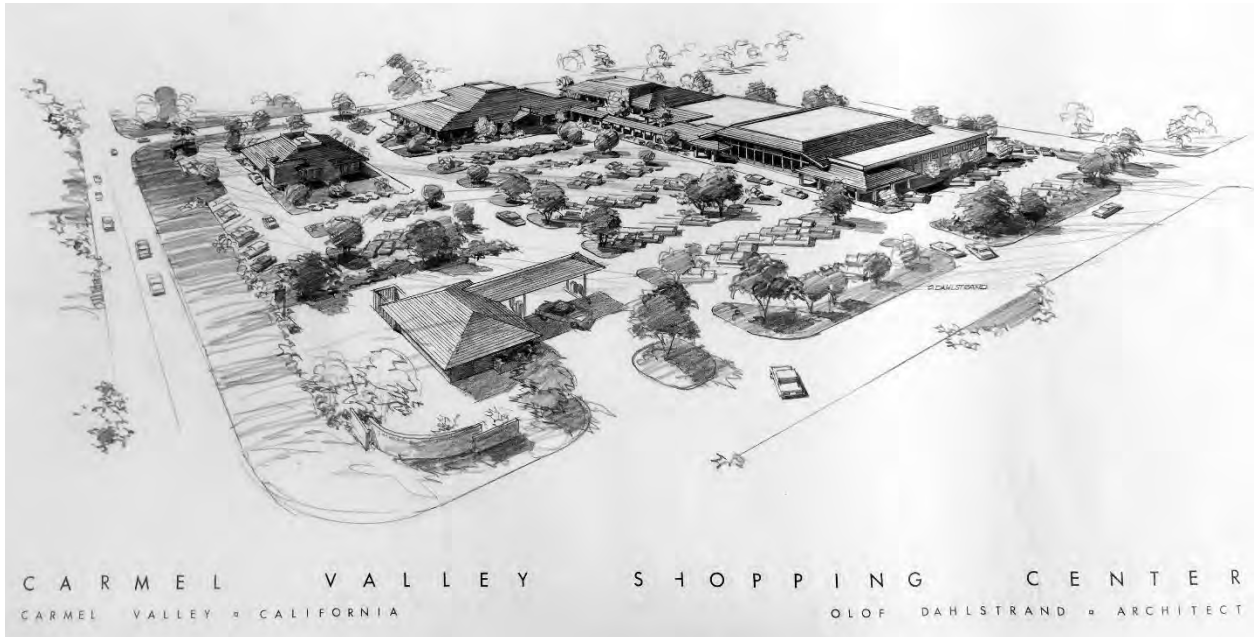
Figure 1. Undated oblique aerial view drawn by Olof Dahlstrand.
Source: Environmental Design Archives, UC Berkeley.

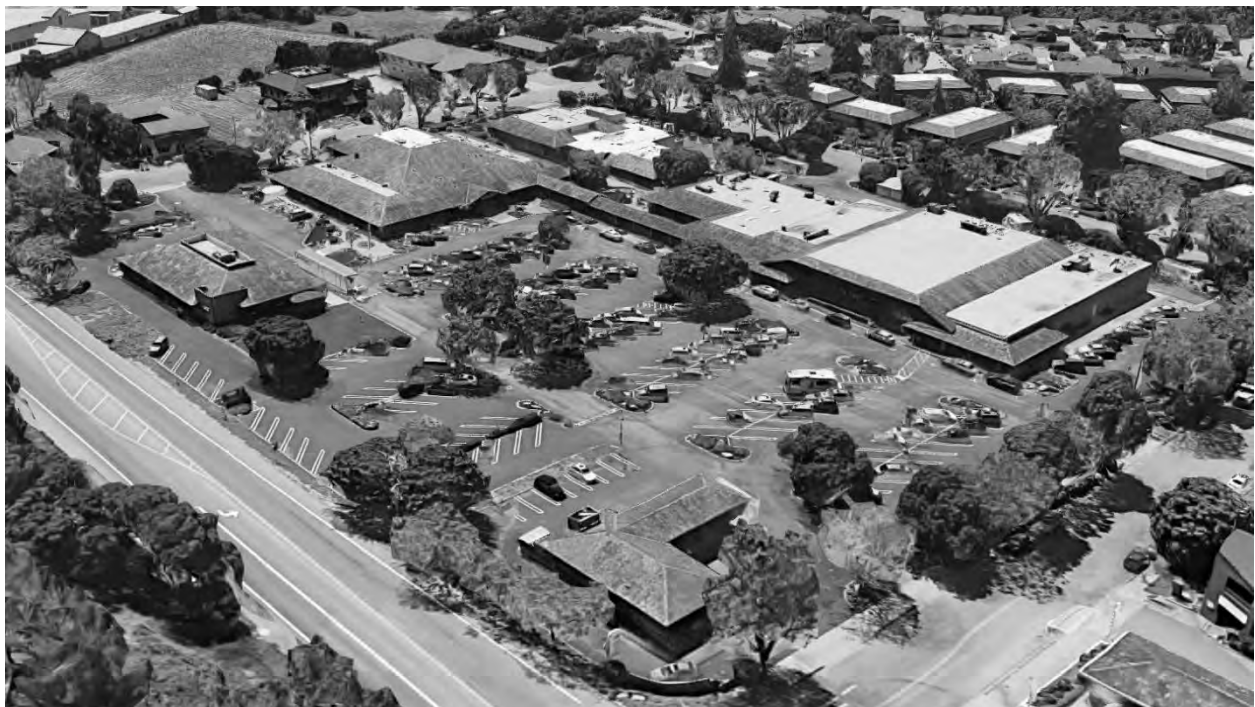
Figure 2. Oblique aerial view of Mid Valley Shopping Center, 2019. Source: Google Earth.

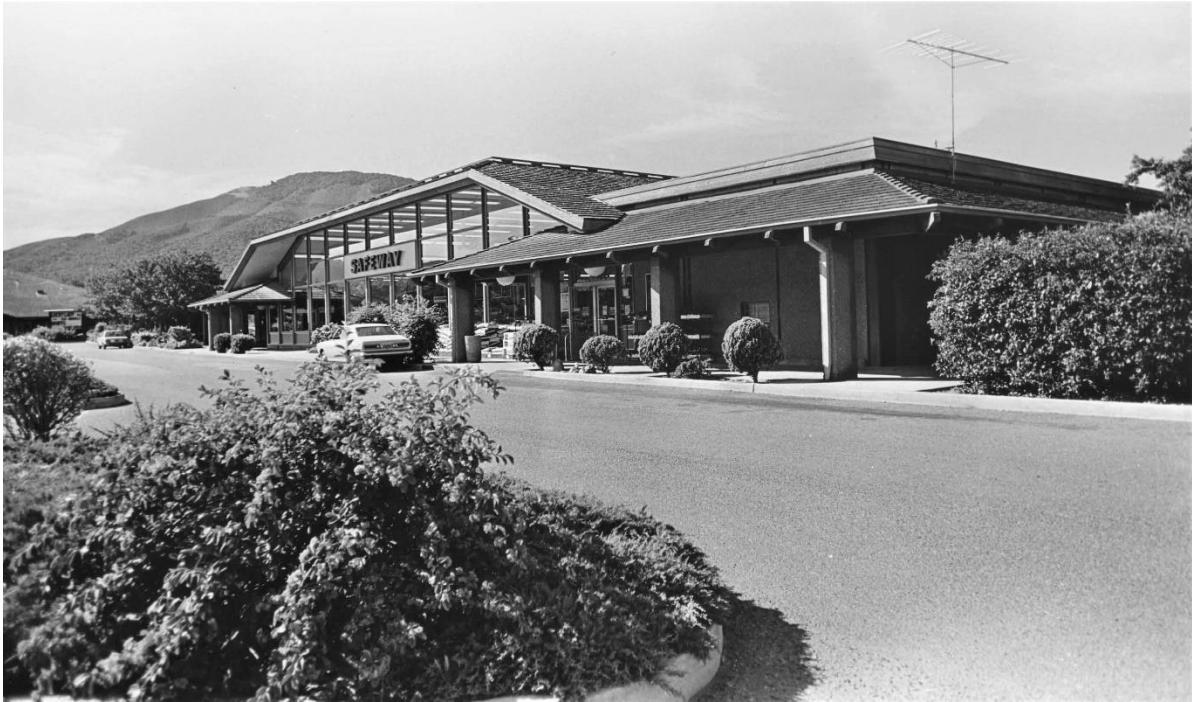
**Figure 3. ca. 1975 photograph of Safeway, Mid Valley Shopping Center.
Source: Environmental Design Archives, UC Berkeley.**

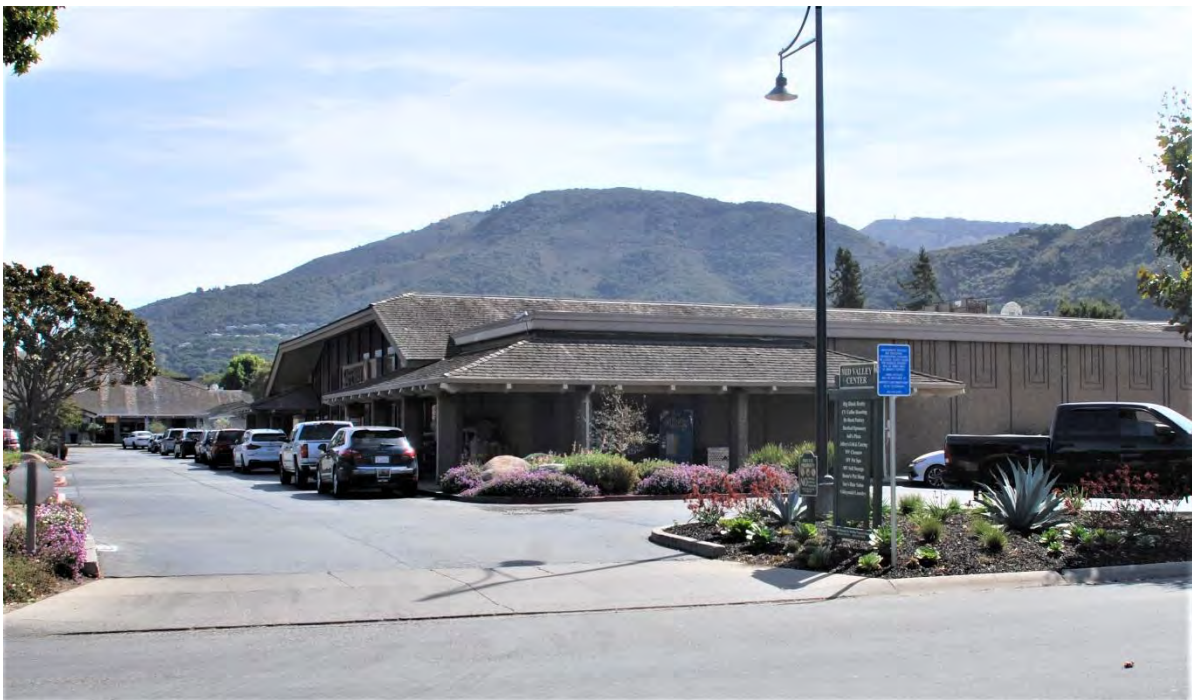
Figure 4. Safeway, Mid Valley Shopping Center, 2019. Source: Page & Turnbull

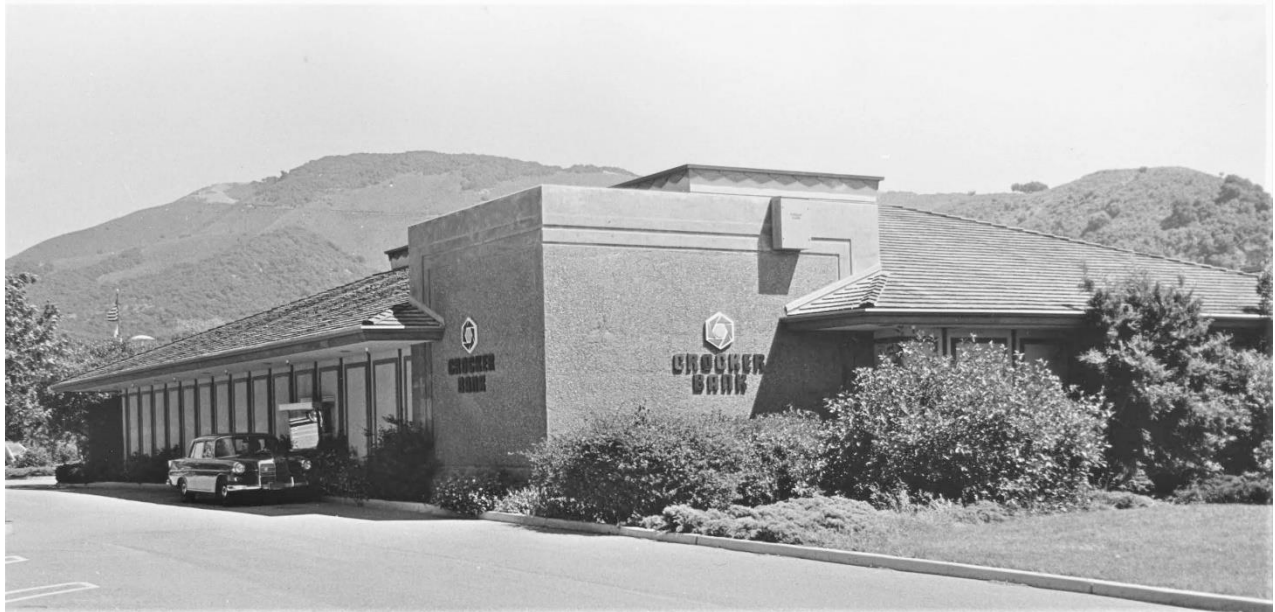
Figure 5. ca. 1970s photograph of Crocker-Citizens Bank building, view southeast.
Source: Environmental Design Archives, UC Berkeley.

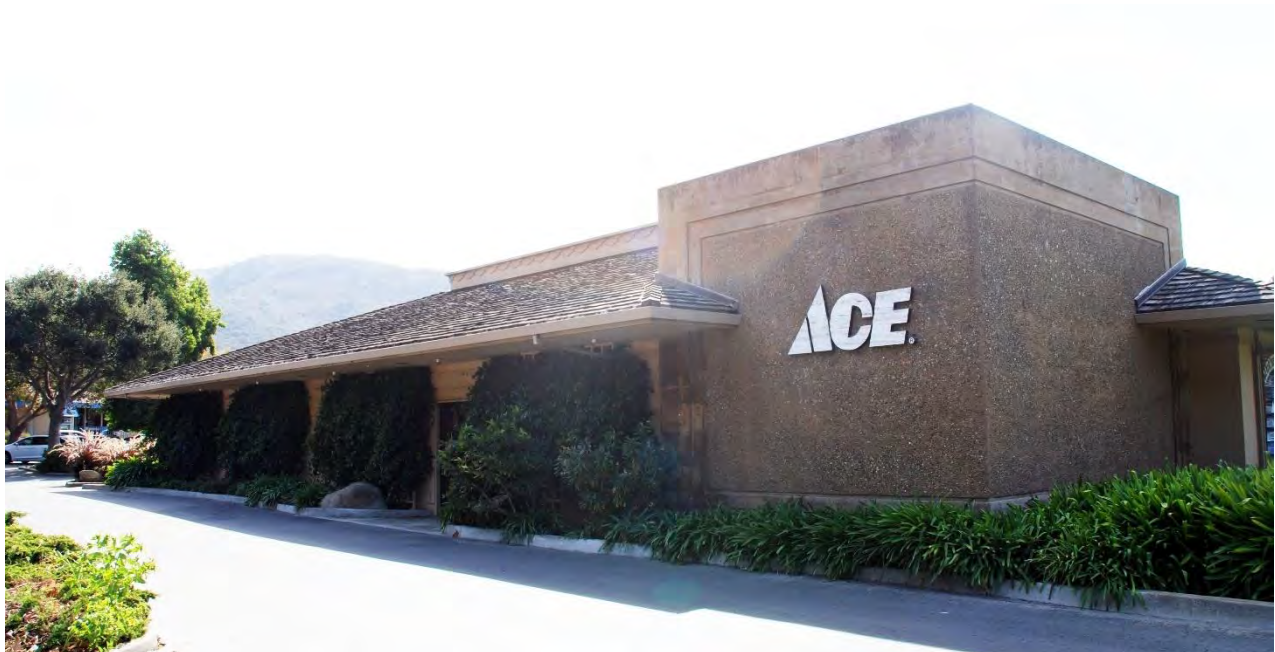
Figure 6. Ace Hardware store (former Crocker-Citizens Bank), 2019, view southeast.
Source: Page & Turnbull

Despite alterations to the theater entrance and former bank building, as well as the recent painting of concrete pillars and some exterior facades with an incompatible white color, the center continues in its original use as a retail and service complex, retains the vehicle and pedestrian circulation patterns of its date of construction, and is able to effectively convey its original design.

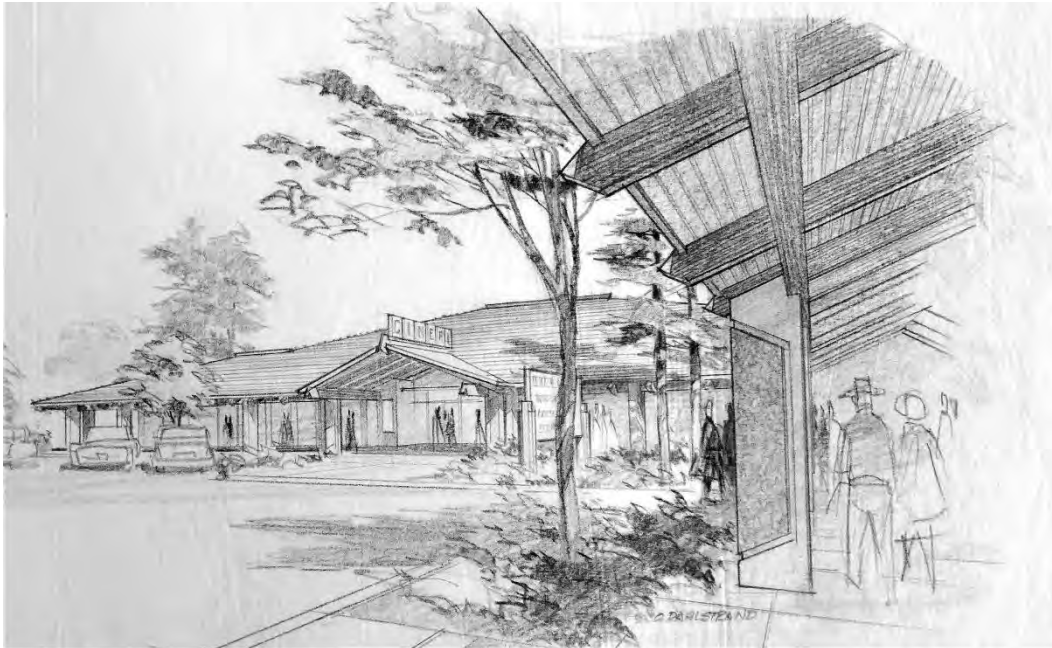
**Figure 7. 1965 drawing for Mid Valley Shopping Center Cinema, by Olof Dahlstrand.
Source: Environmental Design Archives, UC Berkeley.**

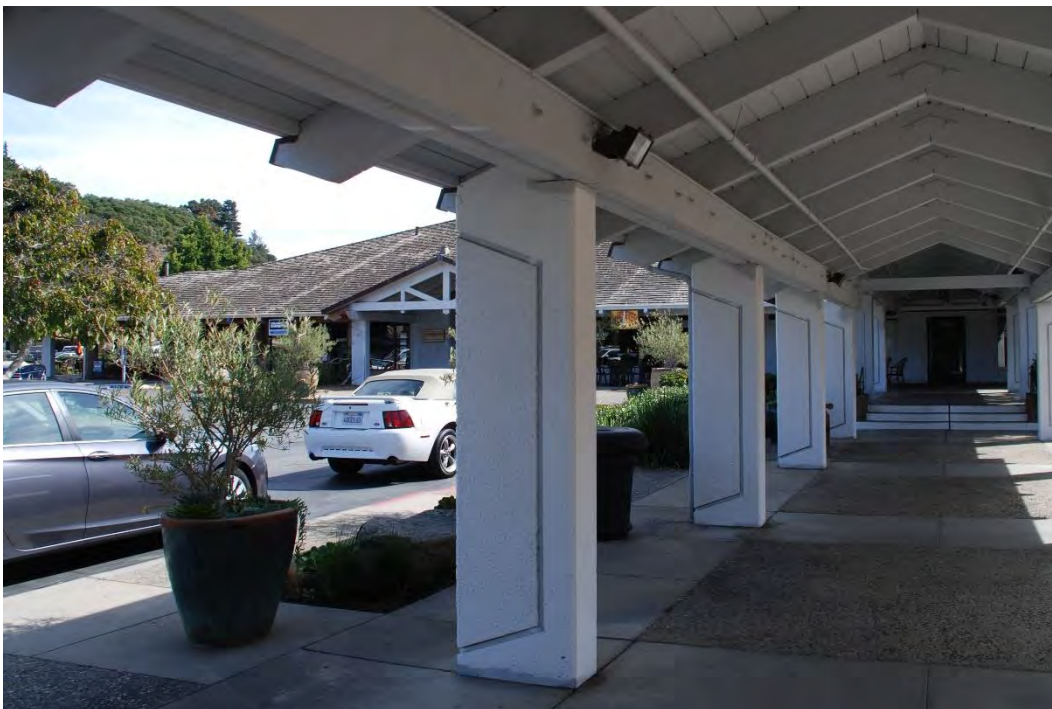
**Figure 8. 2019 view of former cinema portion of Mid Valley Shopping Center, from covered walkway.
Source: Page & Turnbull**

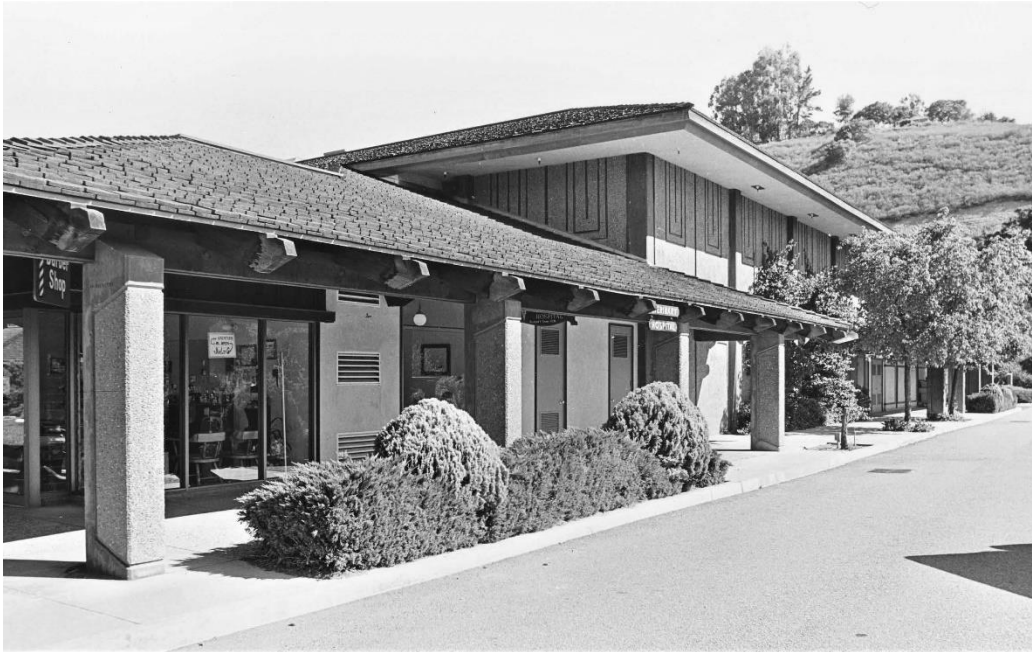
**Figure 9. ca. 1970s photograph of rear of cinema and shopping center, view northwest.
Source Environmental Design Archives, UC Berkeley.**

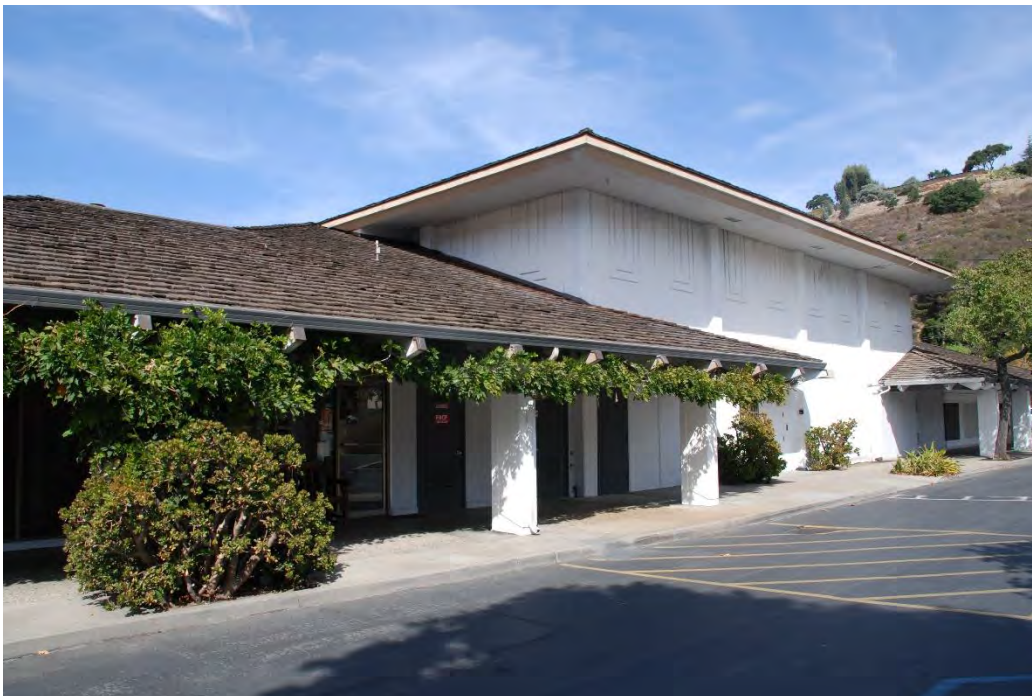
**Figure 10. 2019 view rear of former cinema and shopping center, view northwest.
Source: Page & Turnbull**

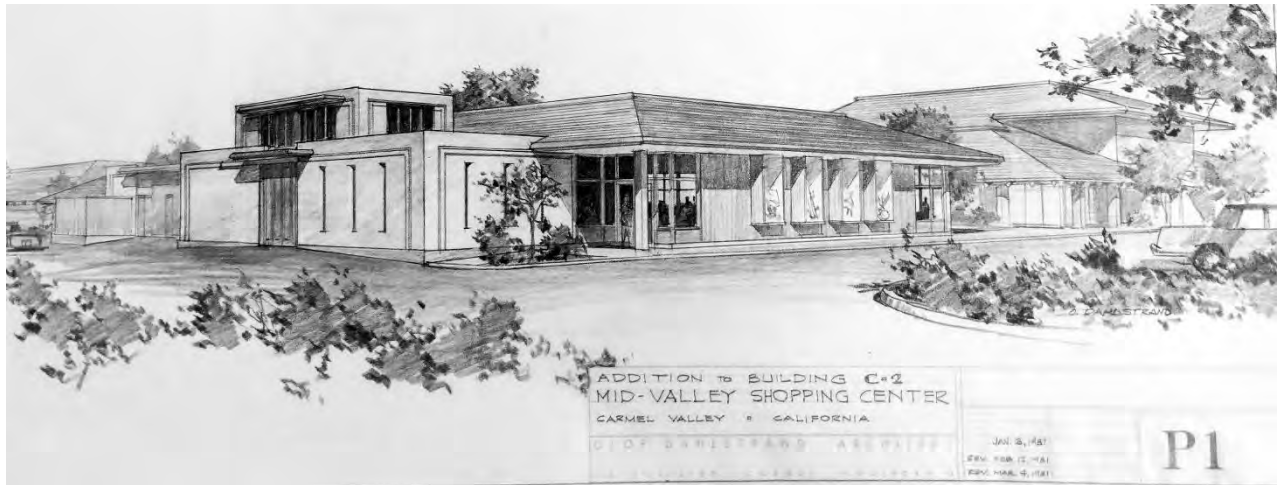
Figure 11. 1981 drawing by Olof Dahlstrand for addition to Mid Valley Shopping Center, view northwest.
Source: Environmental Design Archives, UC Berkeley.

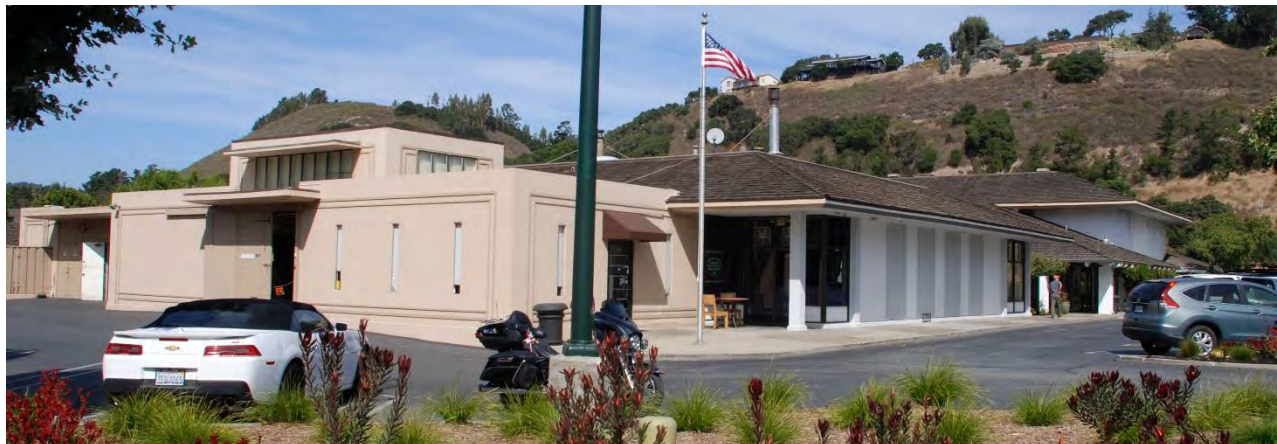
Figure 12. 2019 view of ca. 1982 addition to Mid Valley Shopping Center, view northwest.
Source: Page & Turnbull
