DR. LAURA JONES MID VALLEY SHOPPING CENTER REVIEW OF  
HISTORIC SIGNIFICANCE FINDINGS  
(DATED OCTOBER 16, 2020)

MID VALLEY SHOPPING CENTER,  
9550 CARMEL VALLEY ROAD  
COUNTY OF MONTEREY  
REVIEW OF HISTORIC SIGNIFICANCE FINDINGS

LAURA JONES, PHD  
HERITAGE RESOURCES CONSULTING

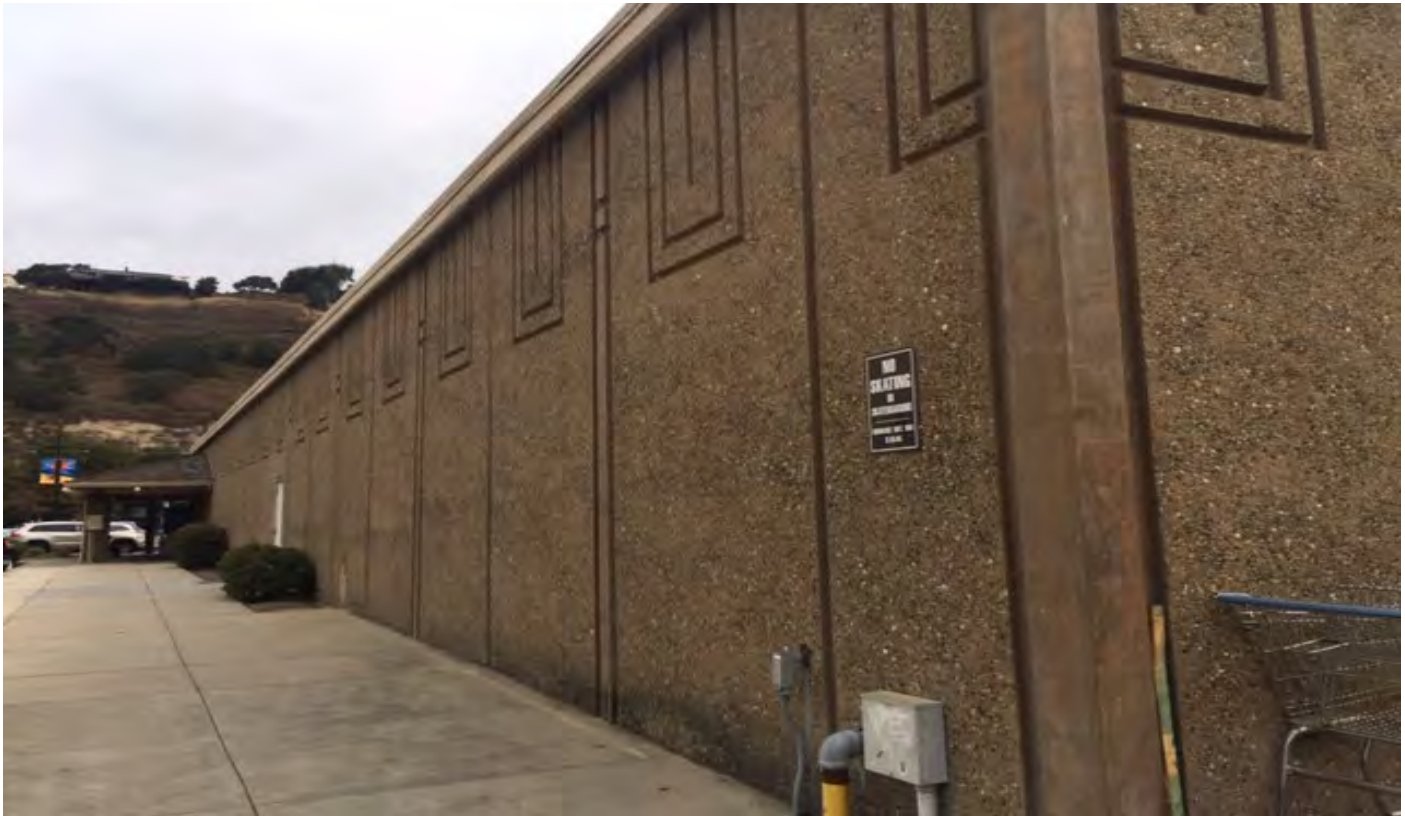
*Figure 4. The blank wall along the west elevation*

The stepped roof and arcade on the west side appears to have been reduced to the northern third of the building before construction (Figure 4). A 1974 photograph of the Safeway store shows a mounted sign in front of the glass and it is unclear whether the neon sign was ever installed. These alterations diminish fidelity to Dahlstrand's design vision – the deletion of the wrap-around arcade in particular is a significant change in design concept. The welcoming feeling created by the glass lantern with its framing sheltered arcades has been lost.

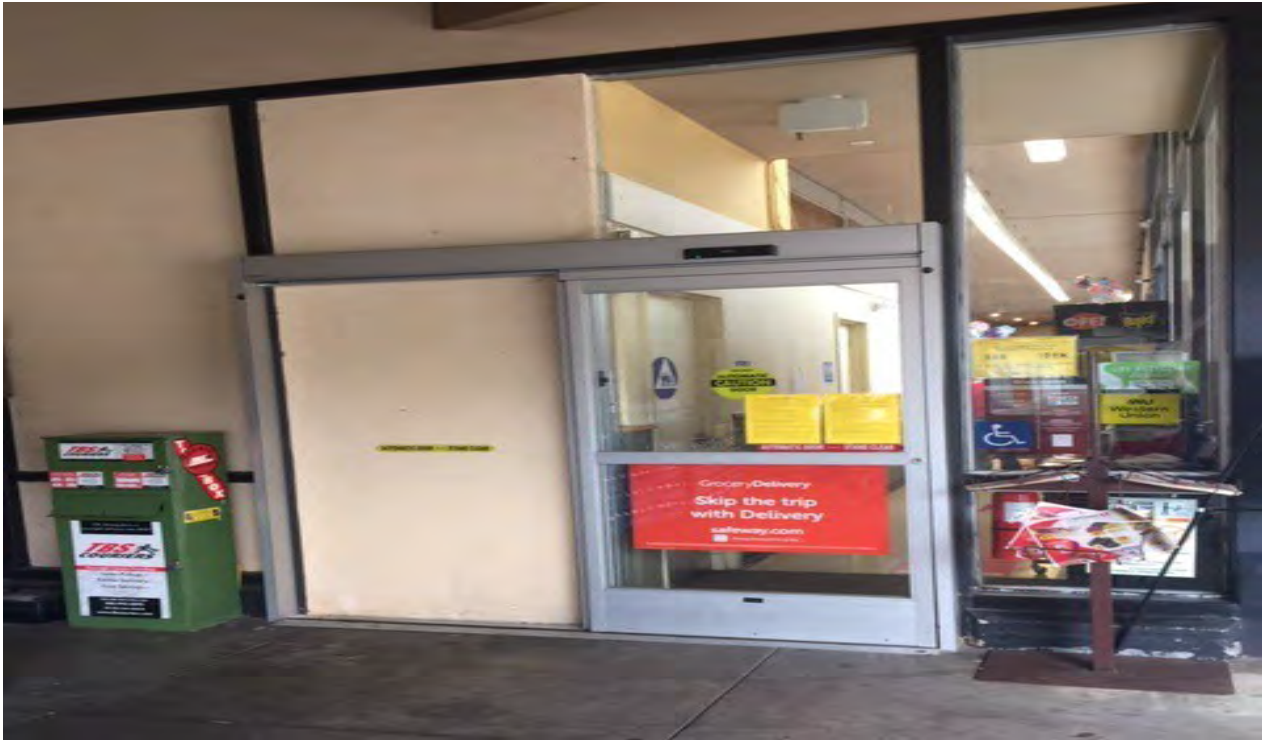
Figure 6. Infill of glass wall at east entry to store

alterations include the partial infill of the glass curtain wall at the eastern entrance to the store (Figure 6), removal of portions of the arcade roof, and painting over of stained wood surfaces (Figure 7).

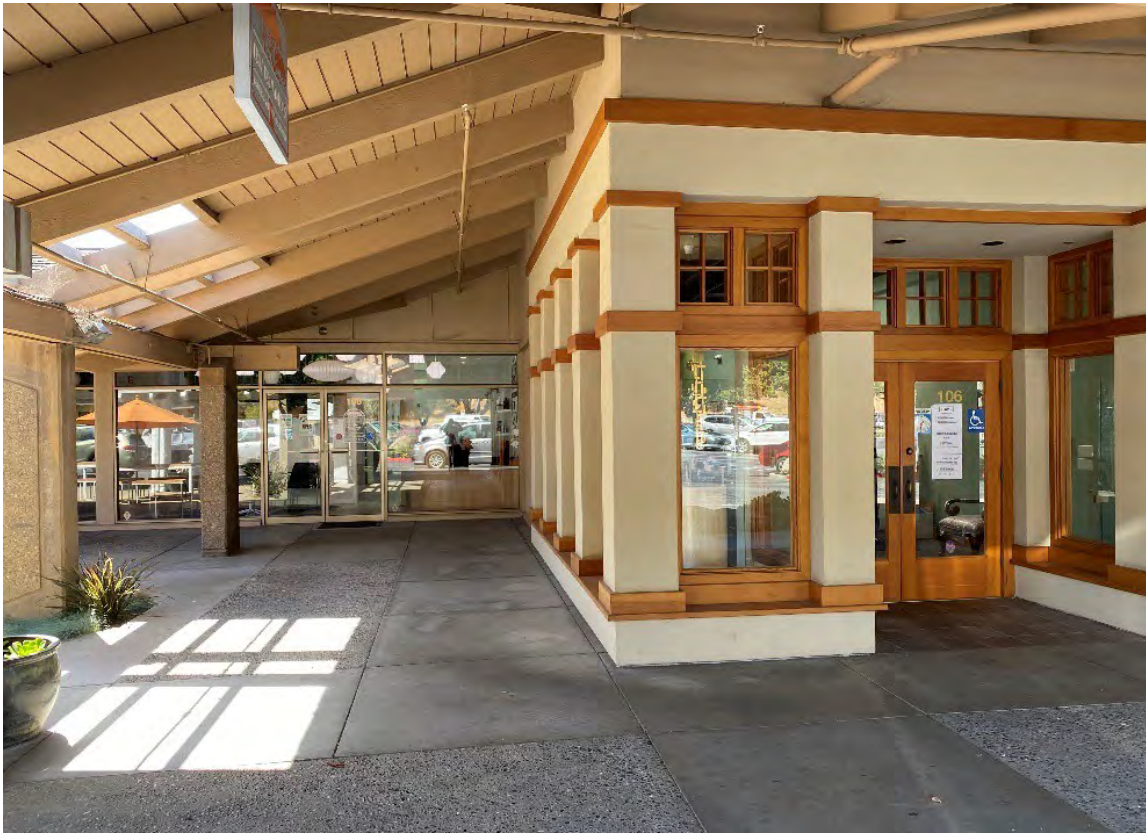
*Figure 10. North elevation of former pharmacy at right*

This section of Building B has been entirely re clad in oak-framed glass and creamy white stucco, and has lost integrity of design, materials and workmanship (Figure 10).

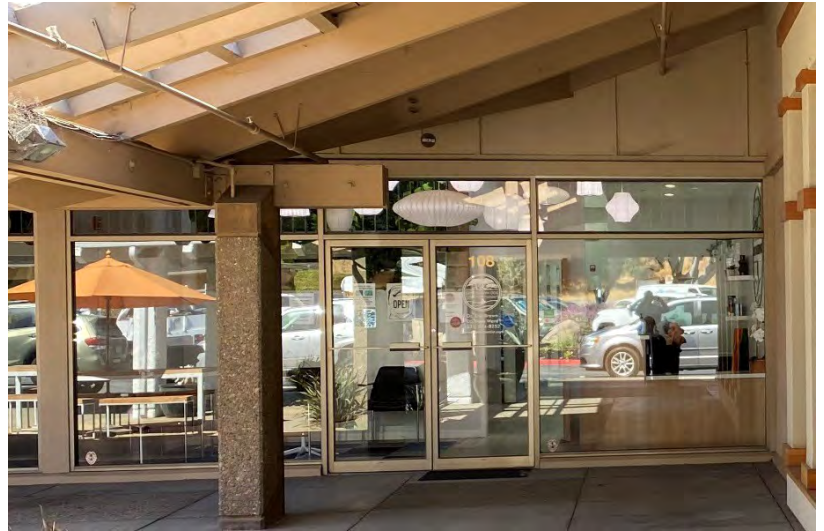
Figure 11. North elevation of Shop

The rear-most section of this building was designed as a retail shop with a glass storefront, terminating in wood panels at the eaves. It now houses a dentist’s office and a café. This area is shown as glass storefront windows, framed in bronze metal, with clay block at the two edges and stucco above the glass on the original plans.

The glass storefront windows have been replaced in an altered configuration, framed in silver aluminum. The stucco and clay block have been removed (Figure 11). This storefront has lost integrity of design, materials and workmanship.

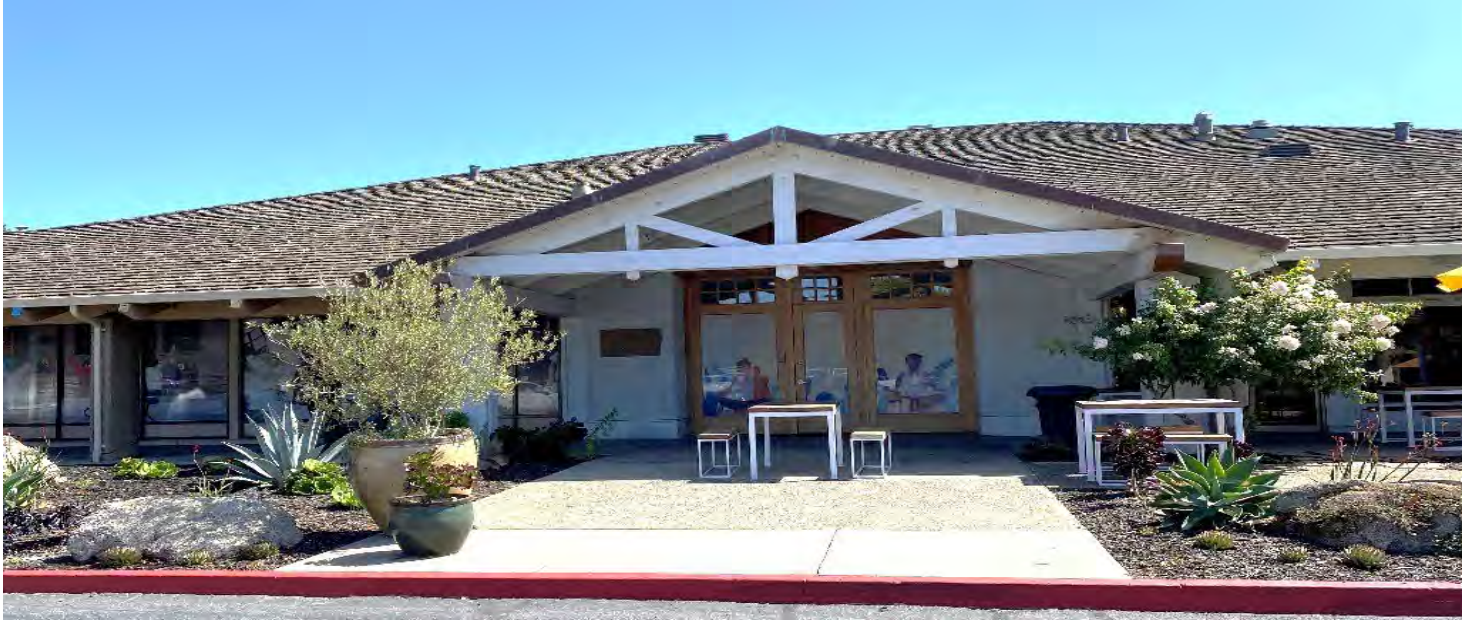
*Figure 14. Cinema Building front in October 2020*

The cinema closed in 1993 and the high central mass of the former cinema was split into two new tenant spaces: a skincare salon in the front and a self-storage facility in the back. A decorative truss has been added at the front of the gable (Figure 14). The former entrance to the cinema was entirely rebuilt: the recessed entrance was brought forward, the metal framed lobby doors were removed and new varnished birch framed doors were installed (Figure 16). The brown integrally colored concrete walls have been painted white and the decorative accents at the peak of the roof (stained redwood framing off-white inset panels) have been replaced with varnished vertical douglas fir. These alterations are a loss of integrity of design, workmanship, and materials.

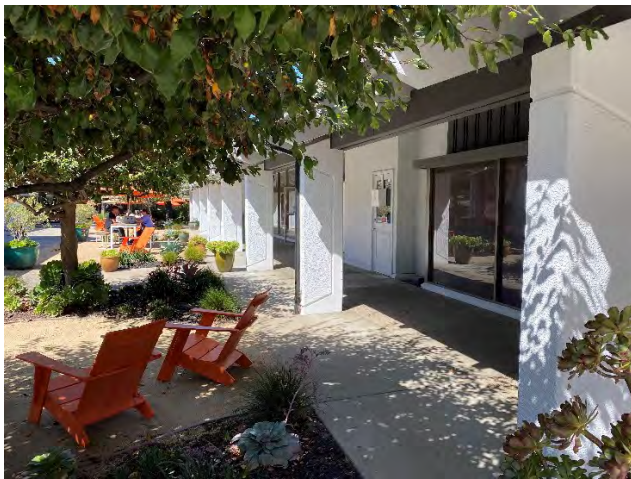
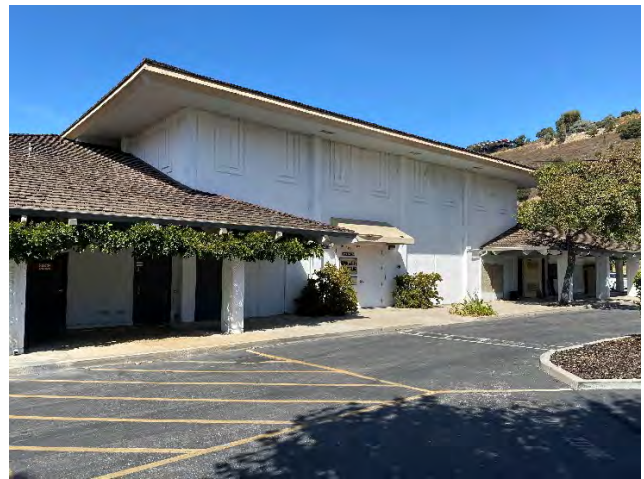
*Figure 17. South and east elevations of Cinema Building in October 2020*

The other, secondary, facades of this building have also been altered (Figure 17). The entire building has lost integrity.
