**Salinas River
Stream Maintenance Program
2022 Work Season**

Annual Report

**United States Army Corps of Engineers
Army Nationwide Permit (NWP) 27 - Aquatic Habitat Restoration,
File Number SPN-1996-223090**

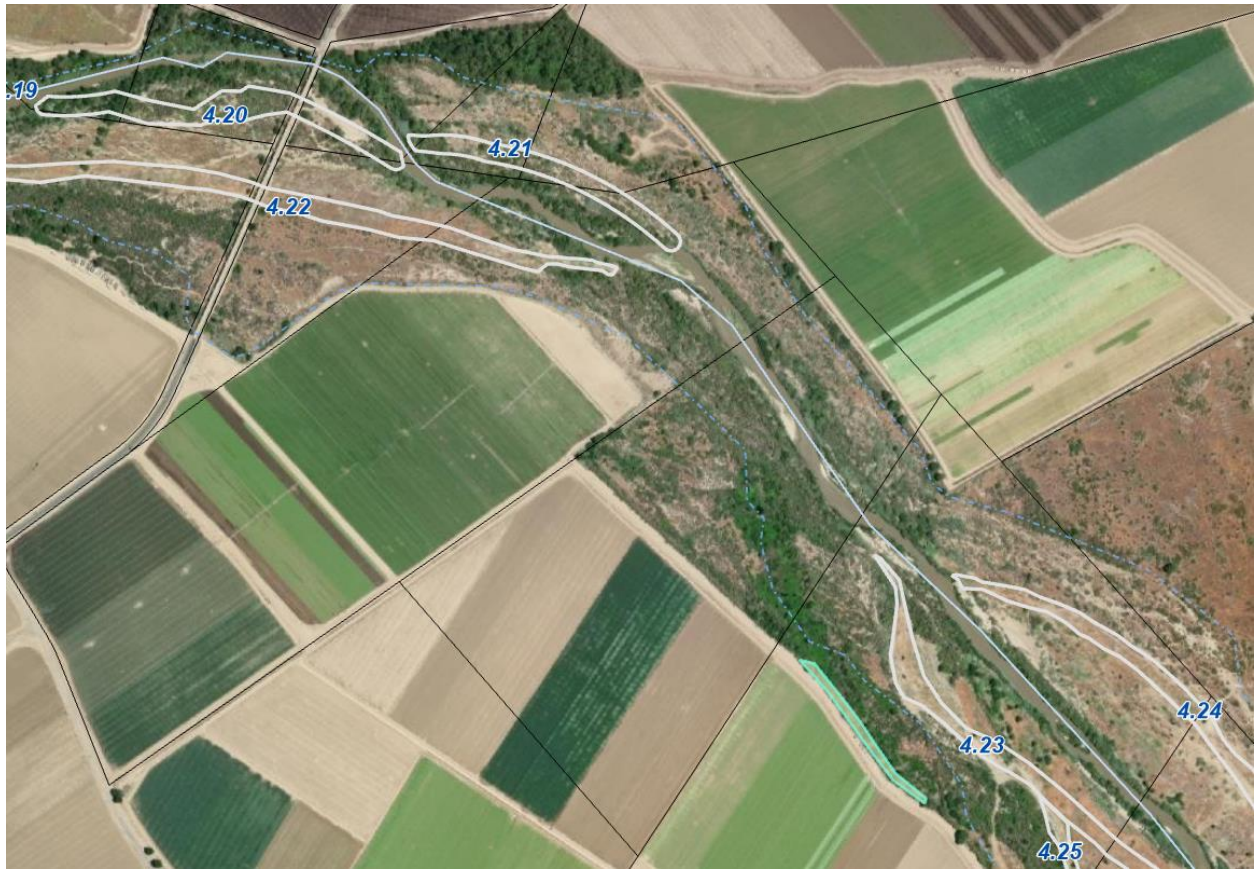
Figure 2 A suitable planting location (light blue) for tree planting has been identified by RCDMC staff and the landowner along the farm levee (see map for reference). Forty Fremont cottonwood cuttings will be collected nearby and planted linearly along the farm.

No trees that would require mitigation were removed during the 2022 work season, and no additional trees are required to be planted in 2022 as mitigation for 2021 impacts. One tree planting project was proposed for mitigating anticipated tree removal however, no sensitive tree removal occurred therefore not warranting required mitigation. The third planting project was intended to repair tree damage caused by River fire debris flows. However, the responsible party later determined that the proposed planting area was not fit for long-term tree survivorship because of the soil’s low organic material content and likely future inundation events. The responsible party in collaboration with RCDMC have identified a treat planting location and will be submitting it in this coming year’s work plan. See map below for reference (see section 3.2).

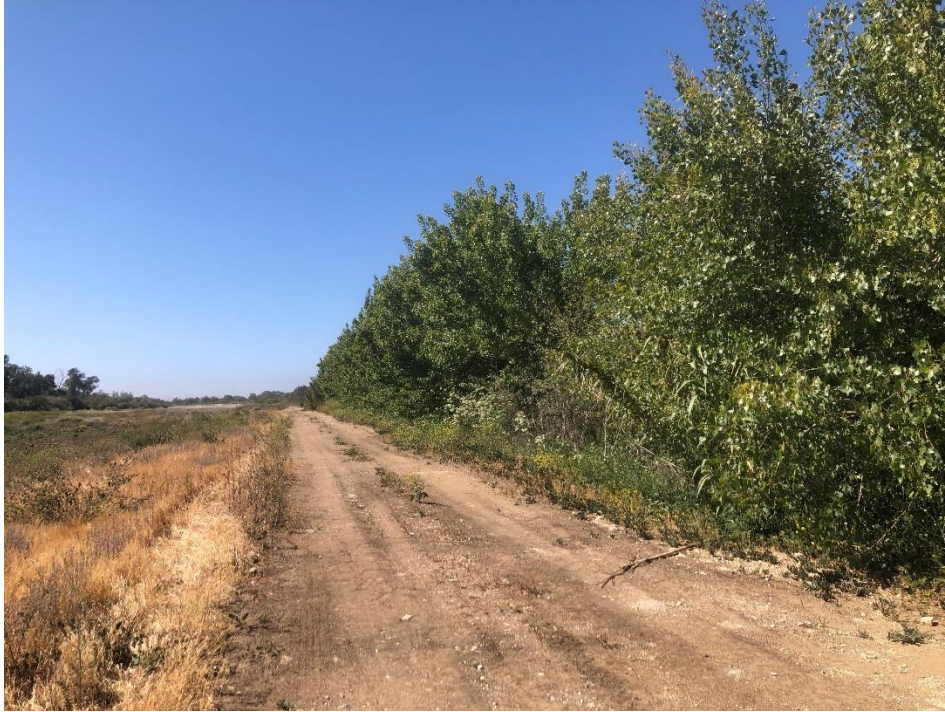
Figure 1. Tree plantings near 5.10 performing well.

There are two tree planting sites with ongoing monitoring. The achievement of the required performance criteria is targeted through ongoing data collection and monitoring, and the sites are visited multiple times per year. The planting sites of 4.22 and 5.10 were established in 2017 and 2016, respectively and in accordance with the data shown in Table 20. The trees that were planted near 4.22 in 2017 did not survive initially. Then trees were replanted to replace those; however, all those trees were damaged in the winter of 2021 because of River Fire debris flows and heaving runoff in late January 2021. The MCWRA, the RCDMC and the Program participant will be evaluating for a new site and begin replanting at a new site in Work Season 2022. The trees planted near 5.10 has trees planted and they are performing well. The trees planted have survived and the Responsible Party continues to manage weeds around the trees. No remedial actions are needed at this time to achieve final performance criteria. The determination of meeting final performance criteria is not available at this time and therefore the MCWRA will continue monitoring and ensuring maintenance. Updated photographs for 5.10 demonstrate the overall health, vigor, statue, and density achieved for the site replantings.

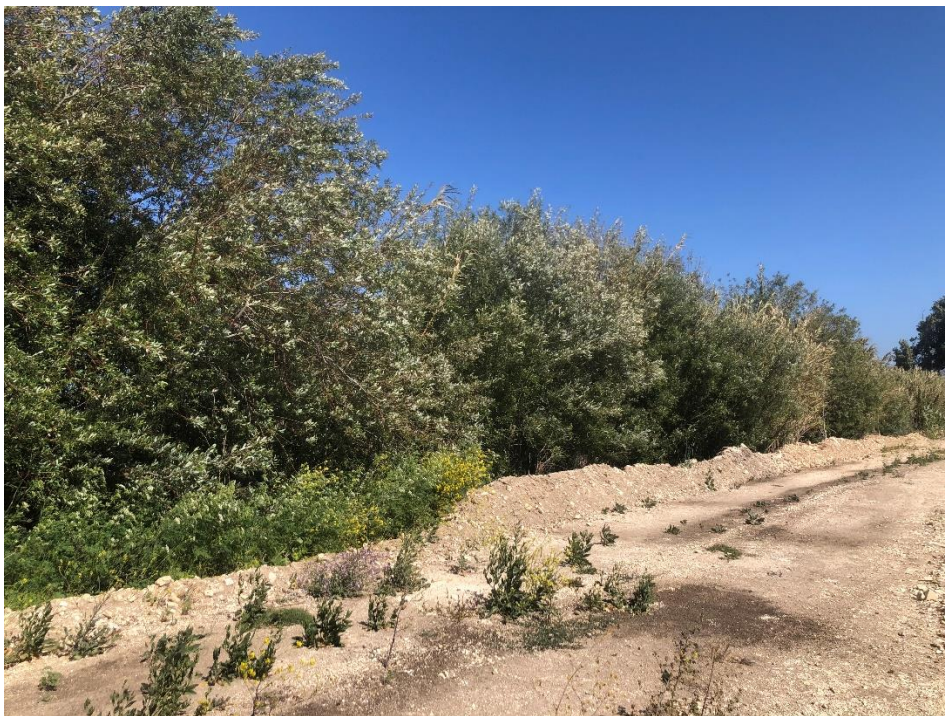
Figure 2. Tree plantings near 5.10 performing well.
