Vegetation Mapping

Salinas River Vegetation Mapping

Salinas River Stream Maintenance
Program EIR

Prepared for Monterey County Water Resources Agency
Project Name Salinas River Stream Maintenance Program EIR
Project Number 30206011
Project Manager Lisa Mash
Task Lead Katie Ross-Smith
Date August 8, 2012

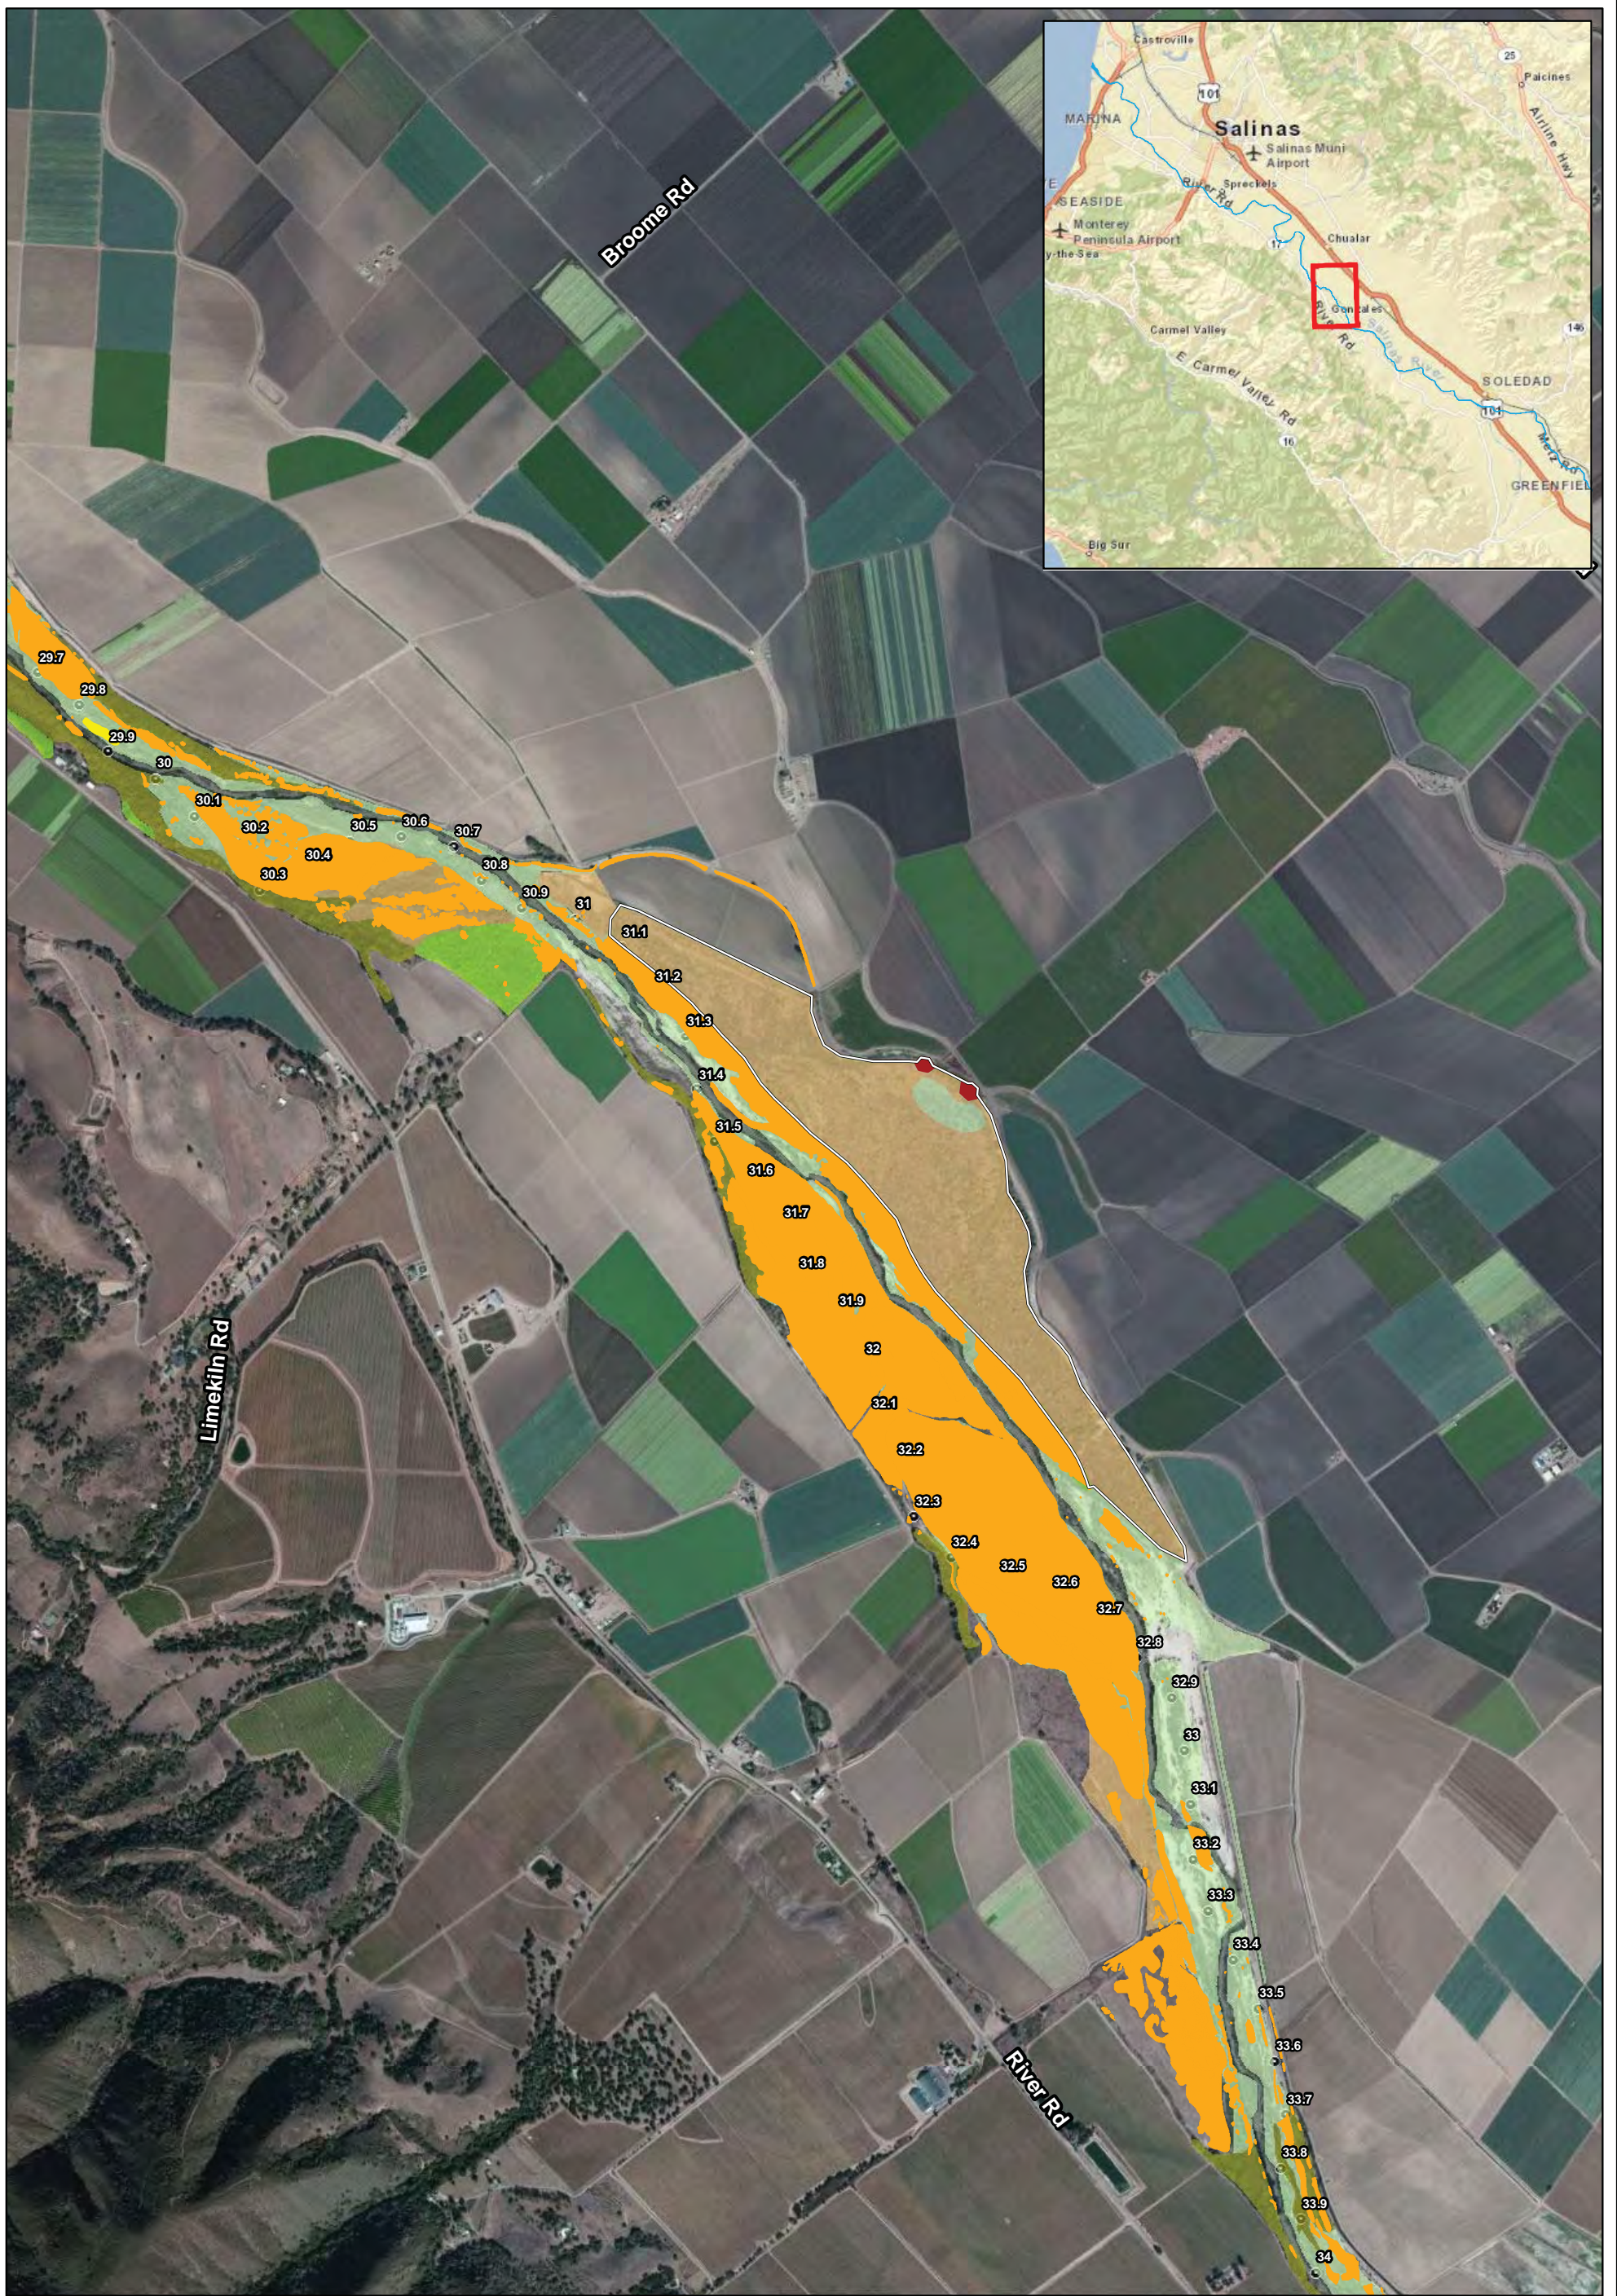
Figure 1
Distribution of Native and Non-native
Vegetation Along Gonzales Slough

Approximately 137 acres of native vegetation were mapped in the vicinity of Gonzales Slough (Table 3-2 and Figure 1). The area surrounding the slough was almost entirely comprised of Coyote Brush Scrub Community (132 acres in total; 97% of the surveyed area). One patch of the Mixed Willow Community was also observed near the ponded water, supported by outfall from facilities located in the agricultural fields to the northeast.

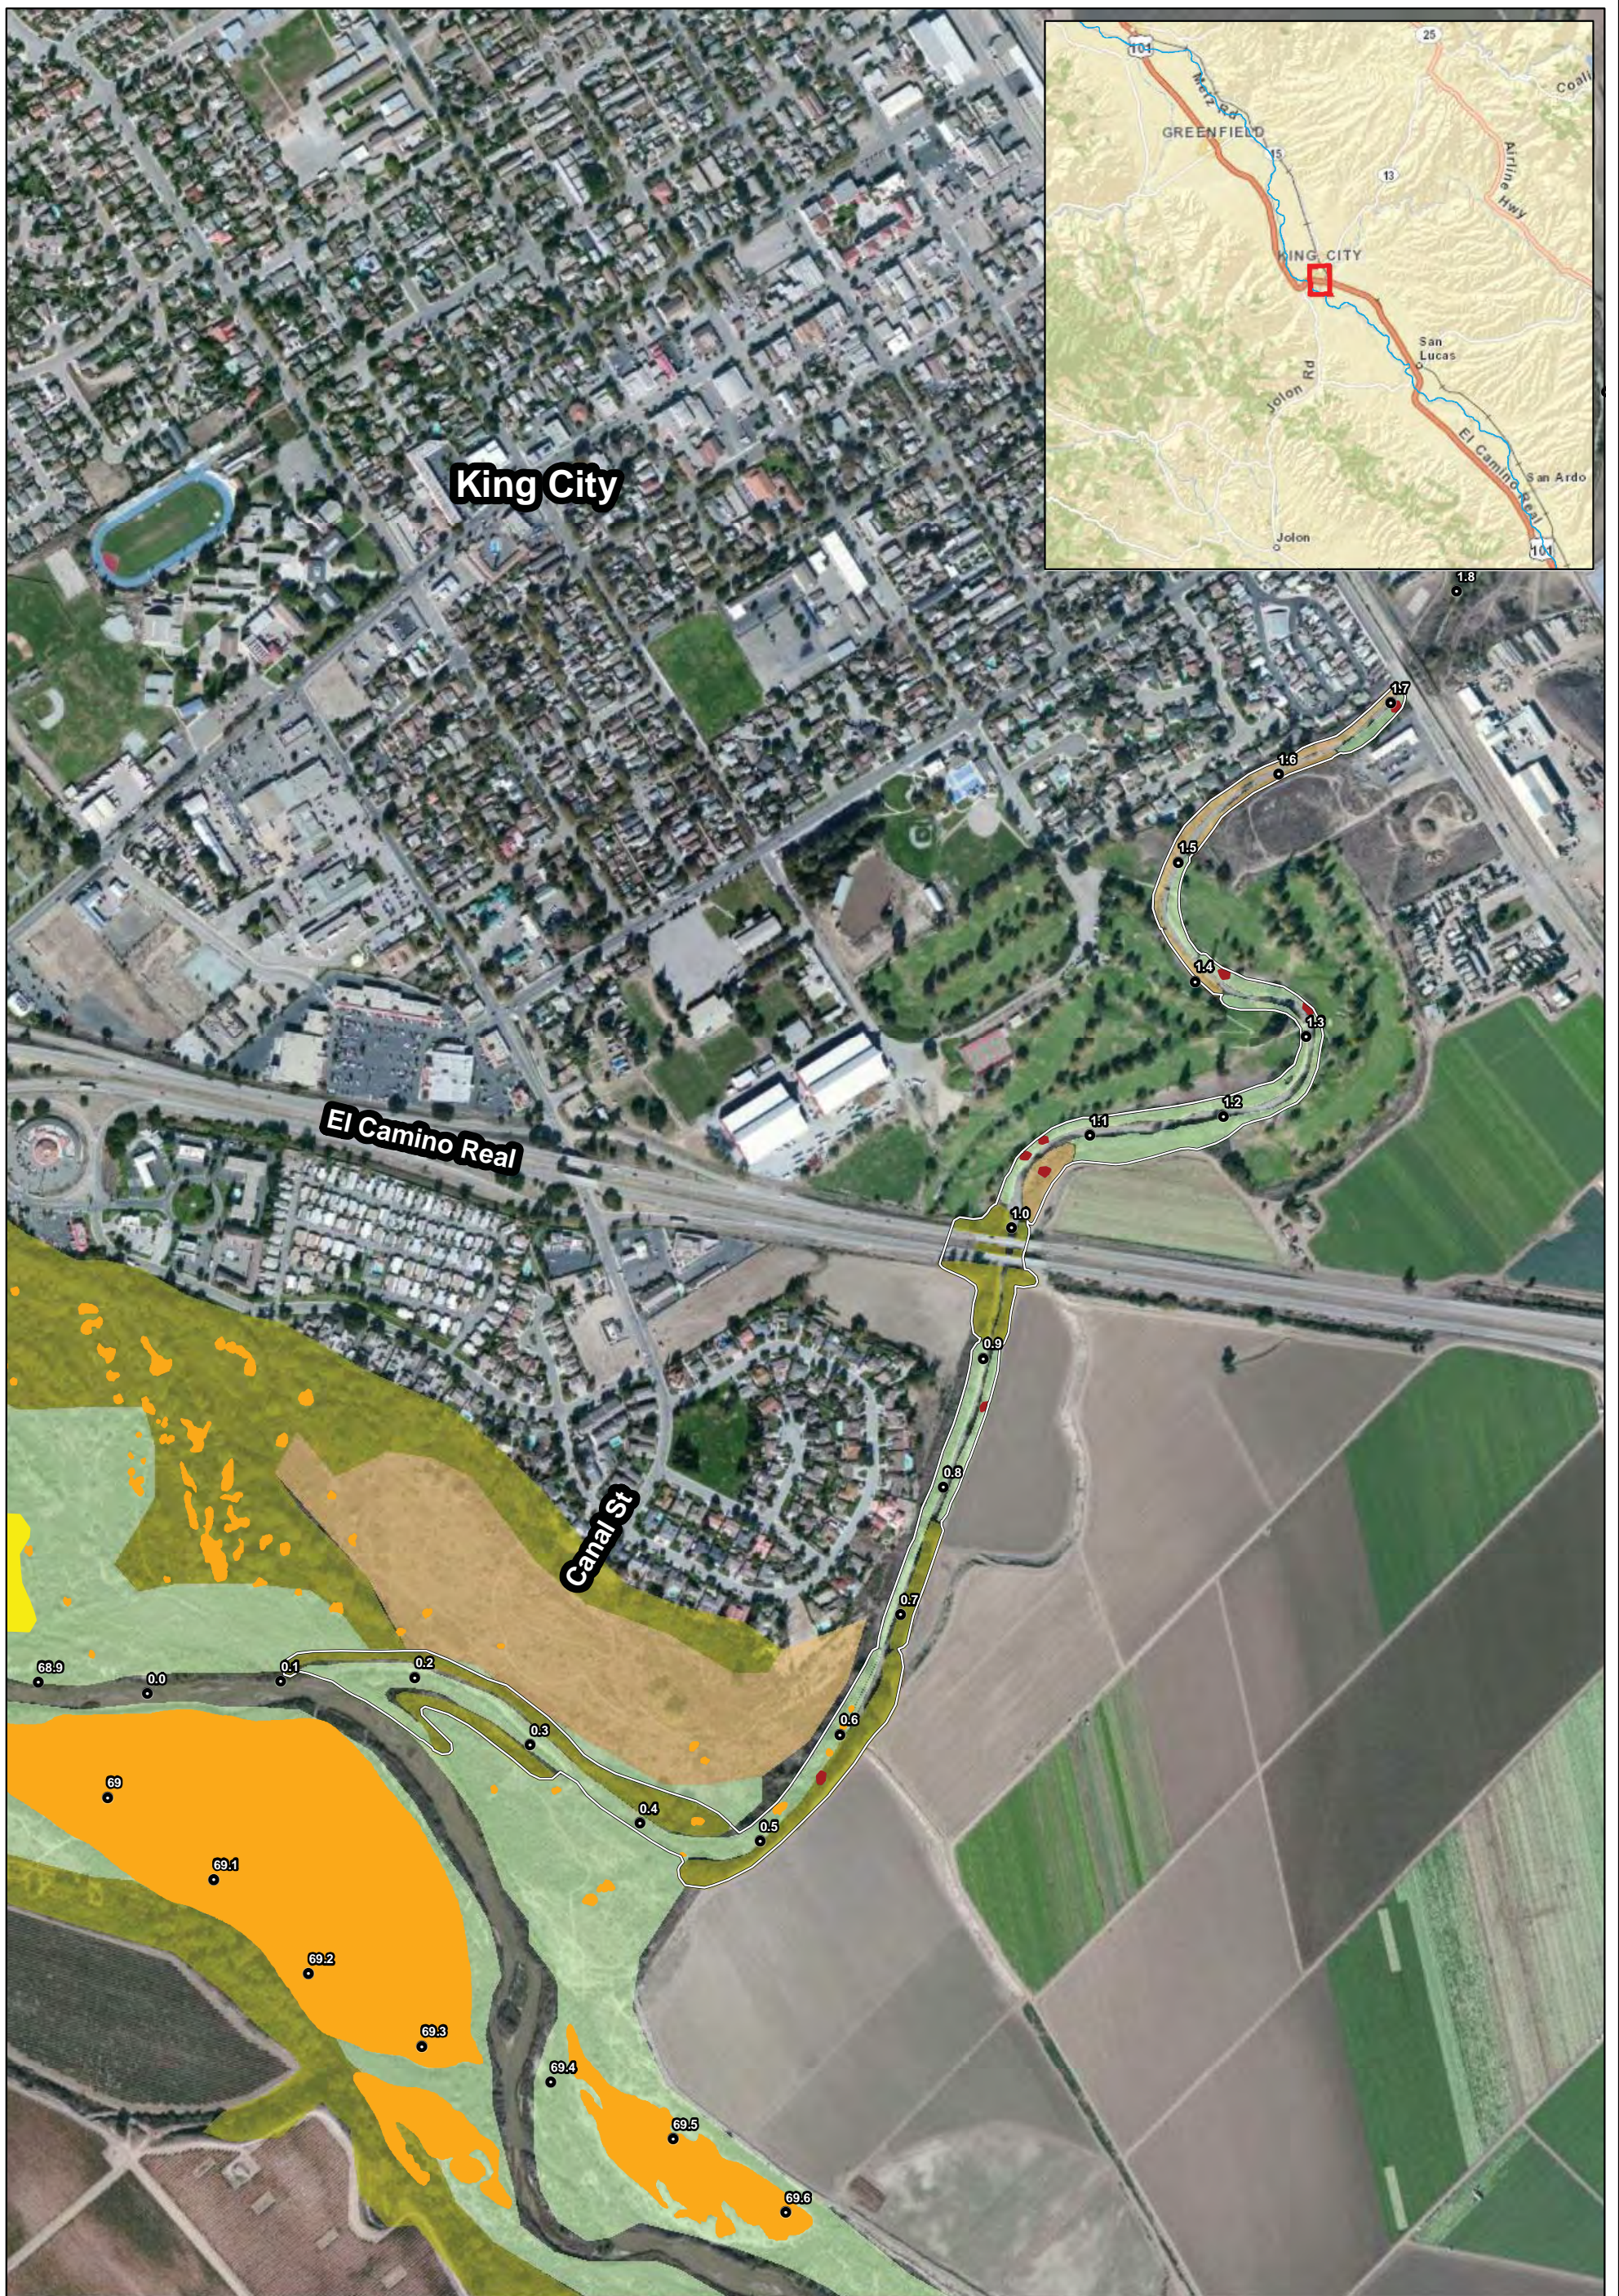
Approximately 23 acres of native riparian vegetation was mapped along the 1.5-mile San Lorenzo Creek (Table 3-2 and Figure 3). The riparian corridor along the upstream 0.7 mile of the creek within the proposed work area was comprised of alternating, relatively sparse Mixed Willow and Coyote Brush Scrub communities. Sparse mixed deciduous trees (with cottonwood dominant, and willow and coyote brush understory) were mapped near RM 0.9-1, near Highway 101. The riparian corridor along the lower 0.9 mile of the creek was comprised of fairly dense Mixed Willow and Mixed Deciduous Tree (including cottonwoods and oaks) communities.

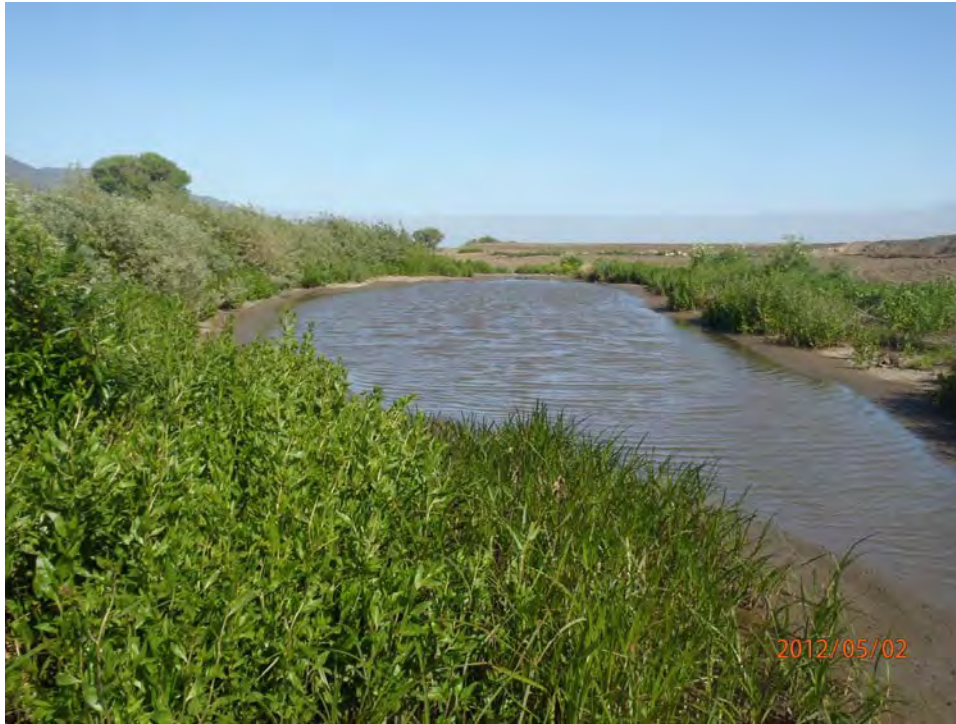
Photo 1. Looking North at Ponded Area of Gonzales Slough

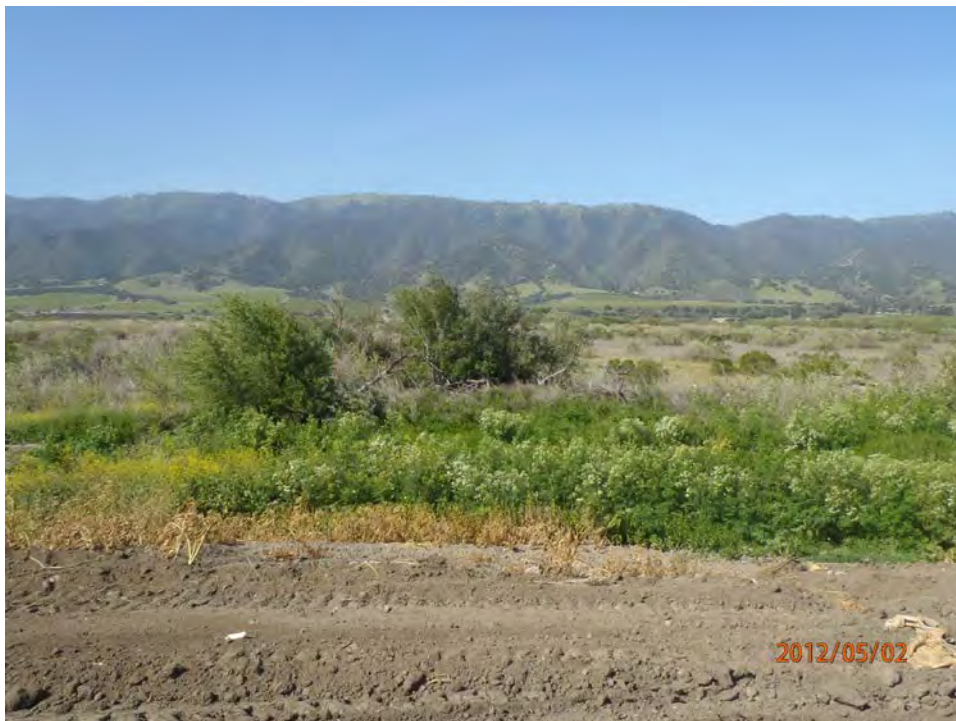
Photo 2. General Habitat Looking West from Gonzales Slough Toward the Salinas River Corridor

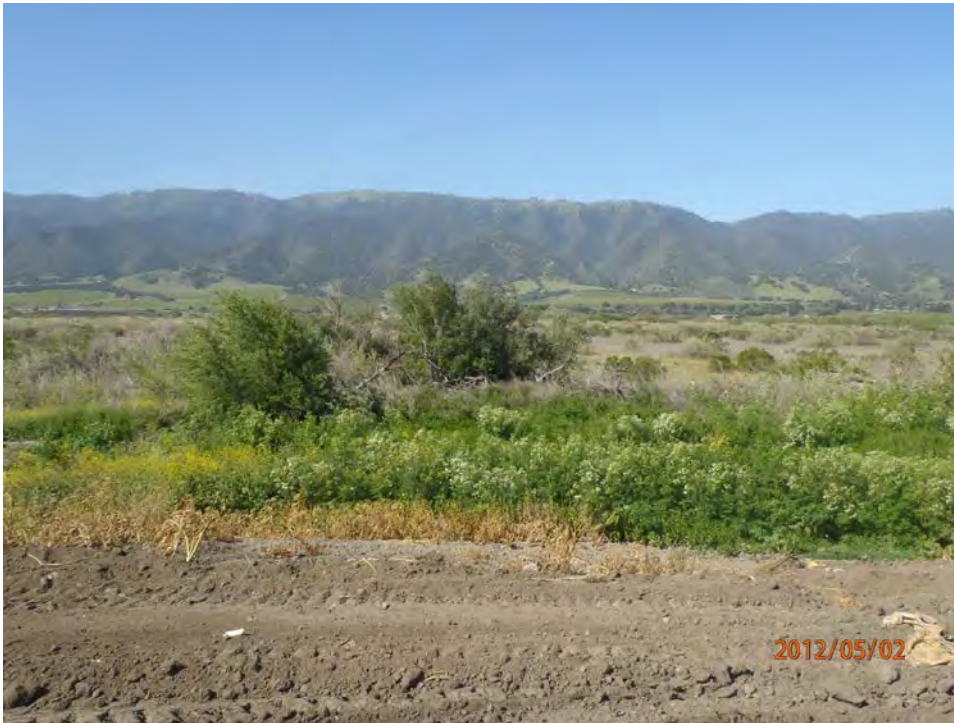
Photo 3. Proposed Maintenance Area Within Bryant Canyon Tributary, Looking Southwest

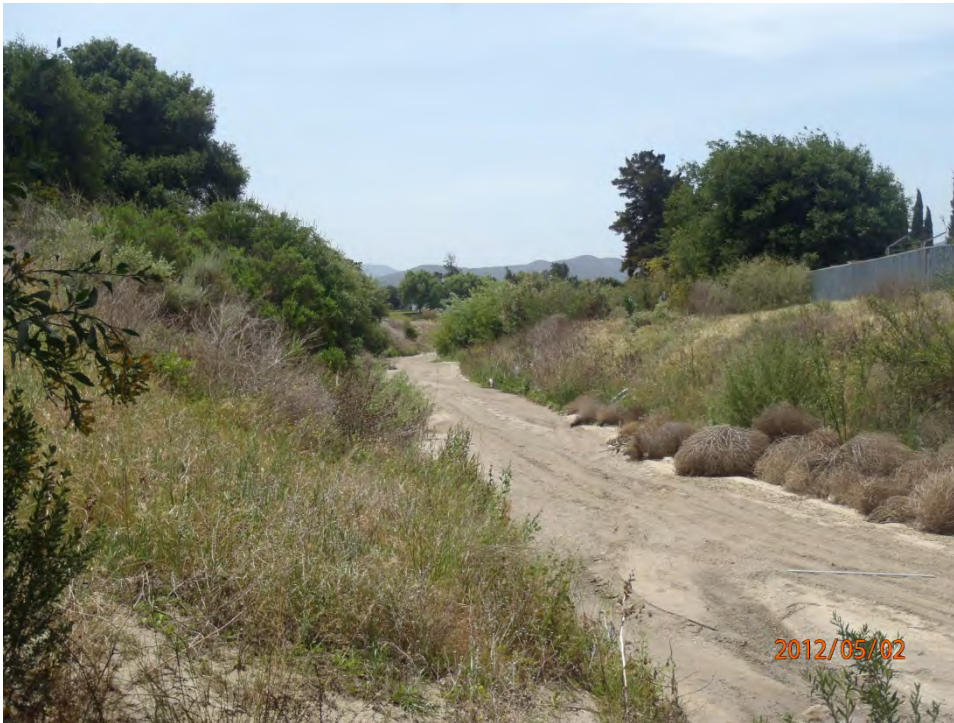
Photo 5. Looking Upstream into San Lorenzo Creek from the Confluence with the Salinas River

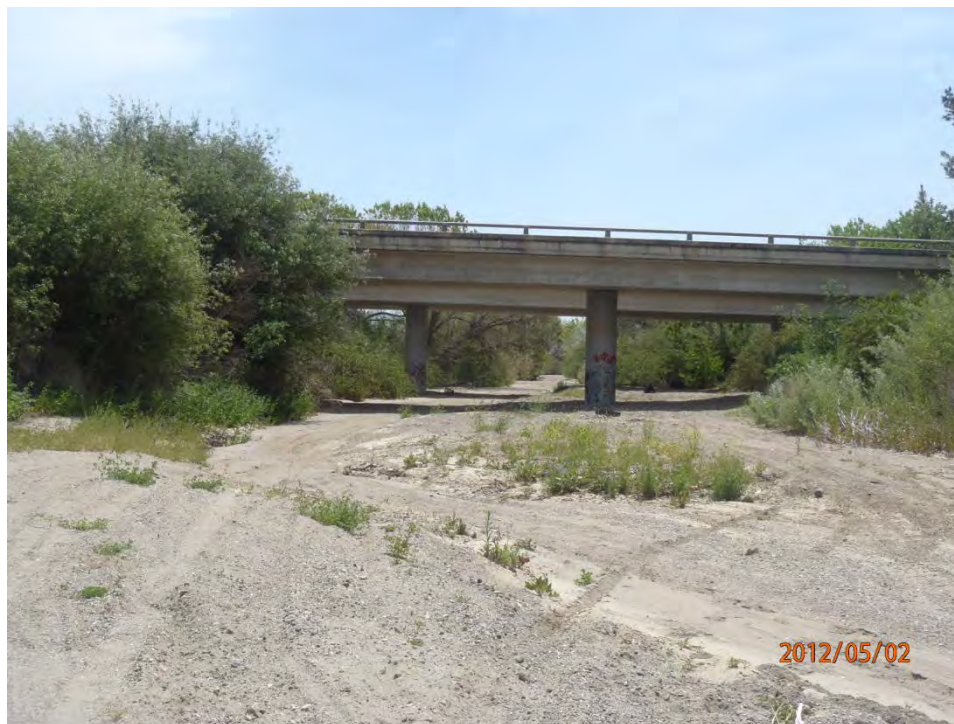
Photo 6. U.S. Highway 101 Overpass within San Lorenzo Creek

Since it is possible that bats may use trees at Bryant Canyon Channel and both trees and bridge structures within San Lorenzo Creek, a pre-construction survey by a qualified biologist is recommended to determine the status of bats at both of those maintenance locations.

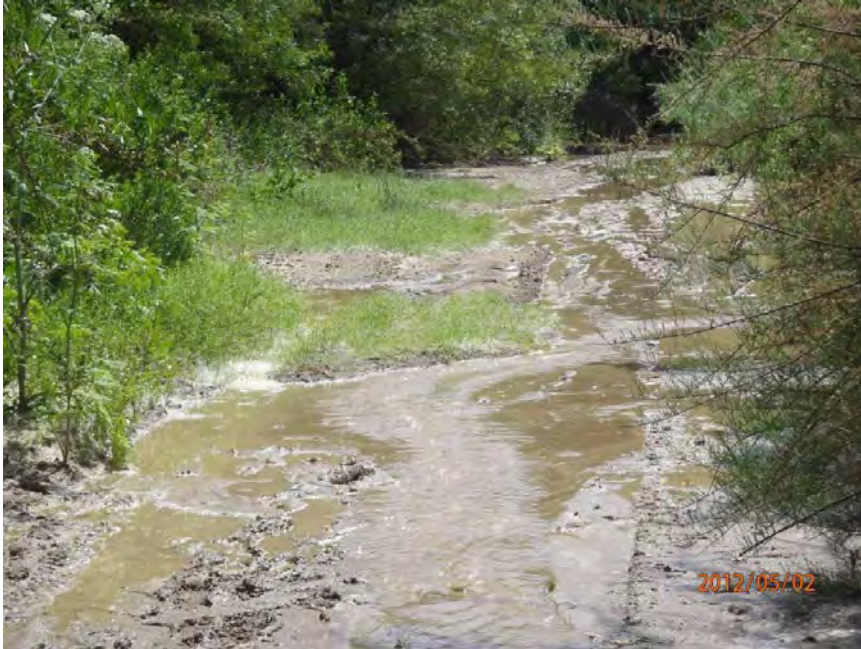
Photo 7. Flow in San Lorenzo Creek from Adjacent Agricultural Operation

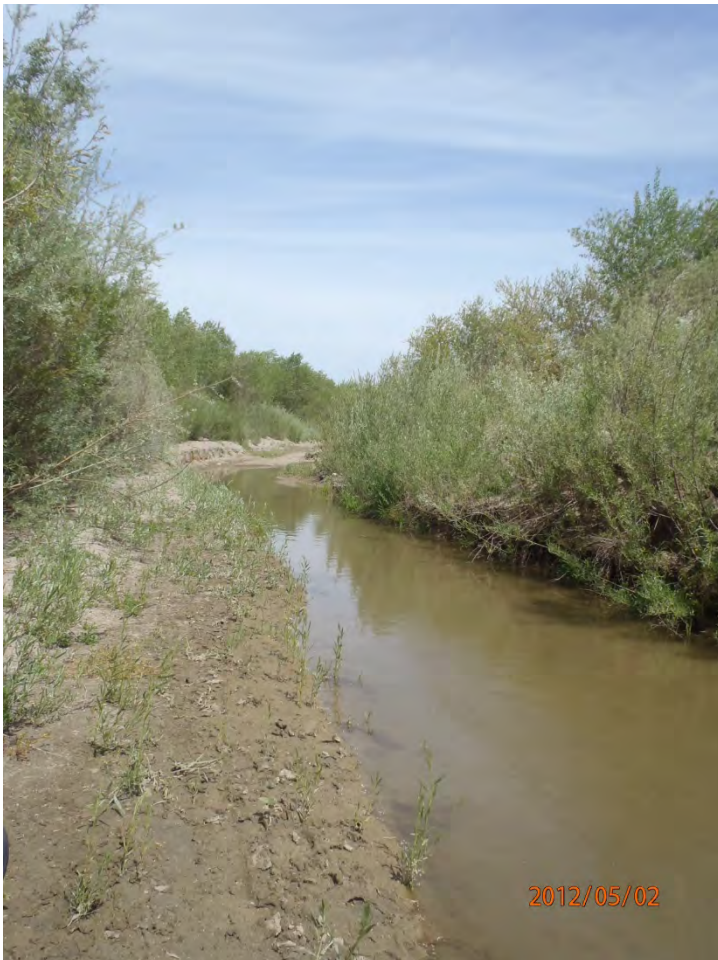
Photo 8. Looking Upstream into San Lorenzo Creek from the Confluence with the Salinas River
