*Upper Salinas - Las Tablas Resource Conservation District*

*Upper Salinas River*  
***Watershed Action Plan***

*Final Report to the State Water Resources Control Board*

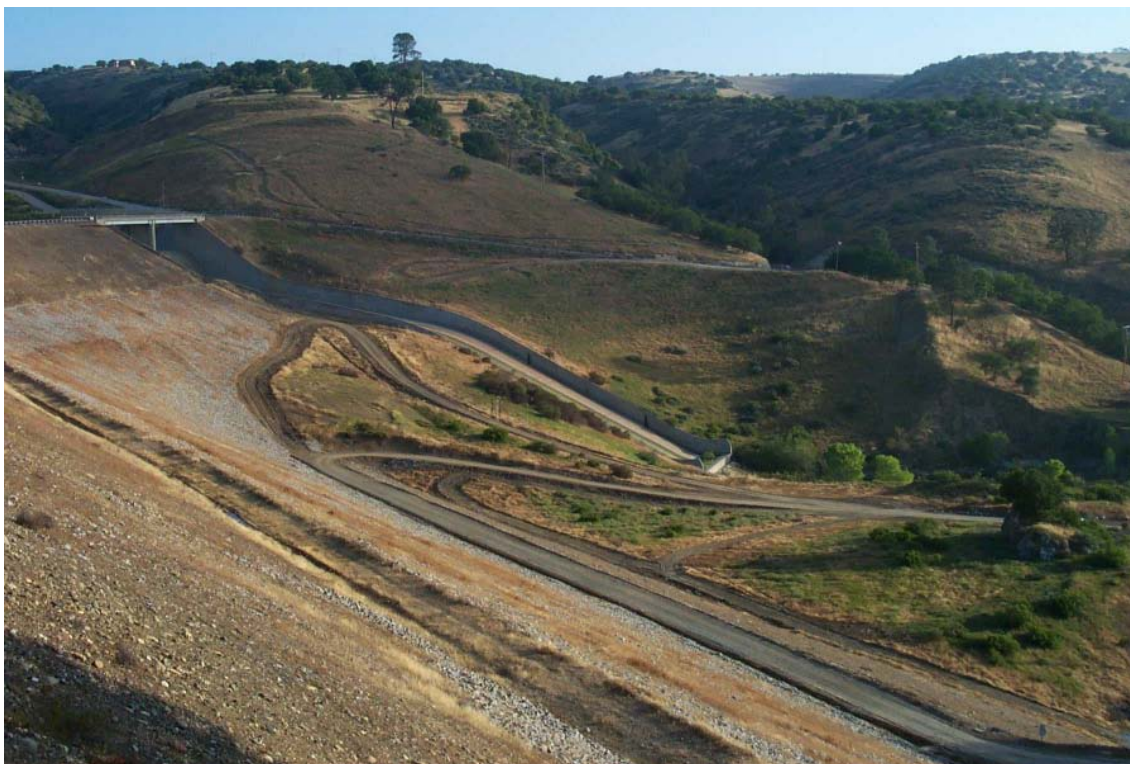
Photo 1.3

Nacimiento Dam is proposed to be enlarged. It is hoped that the proposed dam expansion project on the Nacimiento and Salinas Rivers will include offsite and onsite mitigation to address erosion and to improve the habitat conditions within the remaining steelhead streams in the Upper Salinas River Watershed.

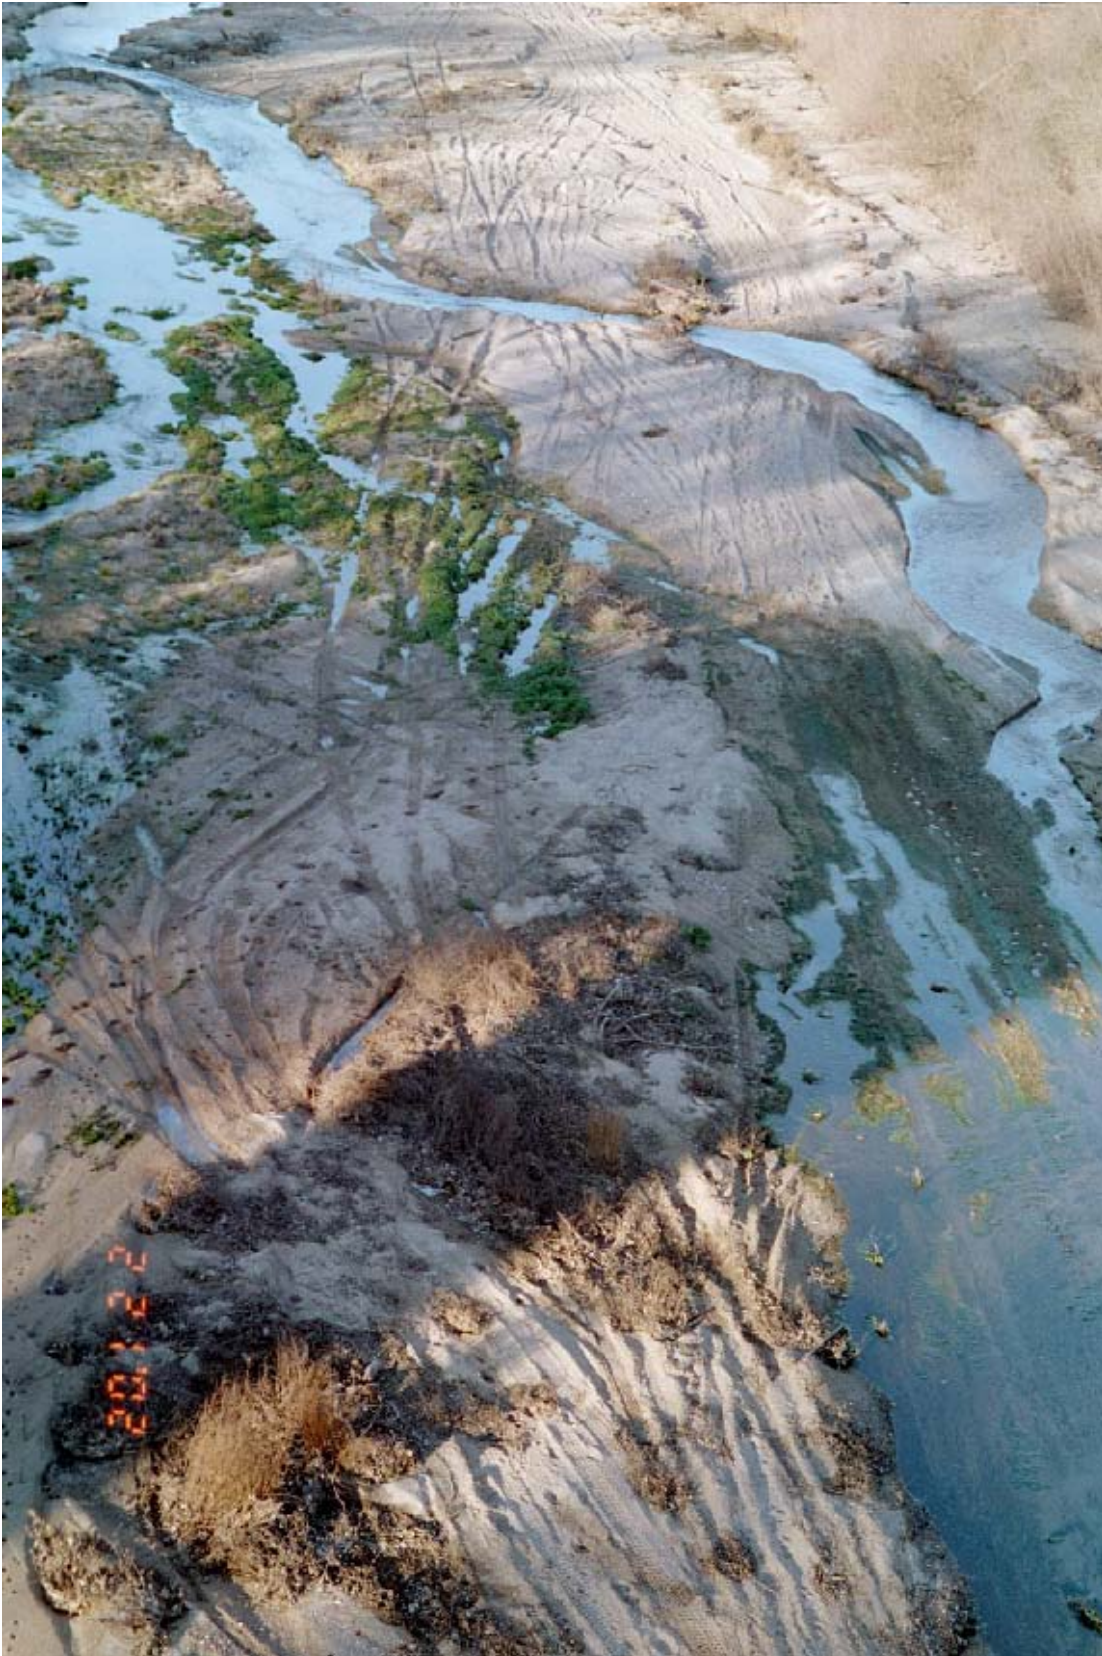
Photo 1.7  
Off-Road vehicle damage in Salinas River channel, winter 2002, in Templeton.

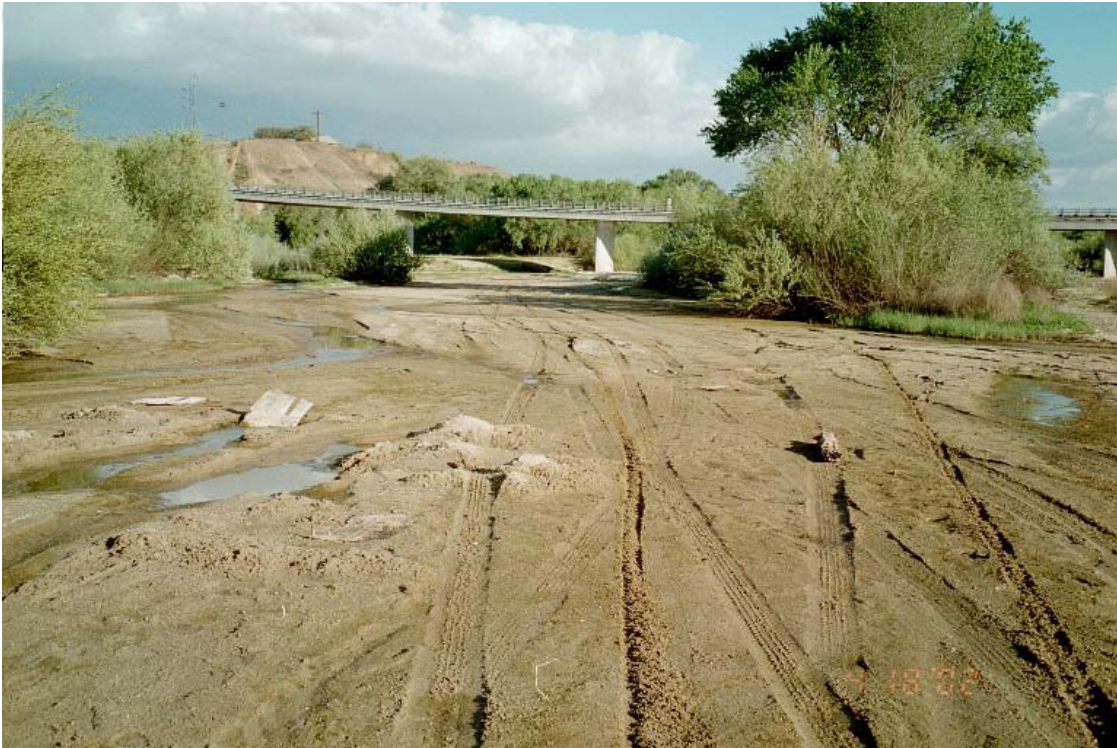
Photo 1.8

Illegal Off-Road usage of Salinas River near San Miguel causes displacement of river bed, pollution of river, and destruction of riparian vegetation along 20 miles of the River.

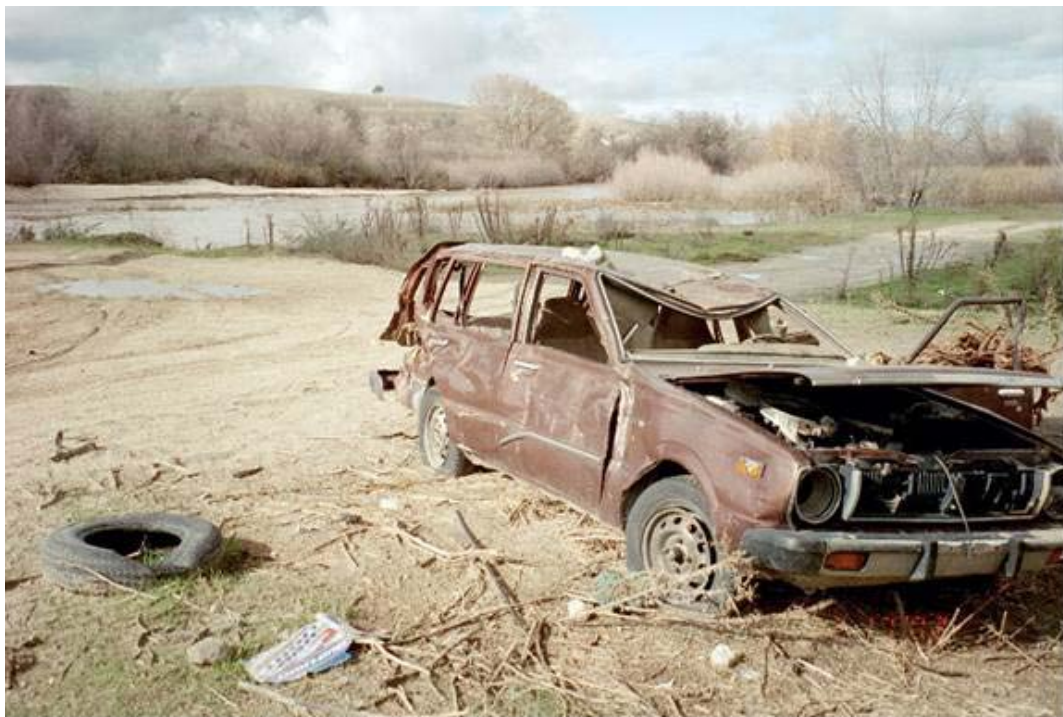
Photo 1.10

Abandoned vehicles and illegal dumping in the Salinas River continues to be a problem. Photo taken within the river channel near San Miguel (US-LT RCD, 2003).

The CRMP also established a "river watch" program. This program developed out of concerns about "off-road vehicles, dumping, vandalism, and other illegal and harmful activities occurring along the Salinas River."<sup>9</sup> (See Photo 1.10) A Trespass Task Group was organized to work with members of the law enforcement agencies. Unfortunately, the river watch program lacked funding and law enforcement support and there continues to be trespass problems along the Salinas River. In 2003, concerned citizens resurrected the river watch program with the cooperation and assistance of the Atascadero City Police Department. Because the vehicular use has severely impacted the Juan Bautista de Anza National Historic Trail along the river, the National Parks Service has also taken notice about the problem and has indicated that they may help in the effort to rid the channel of illegal vehicles.

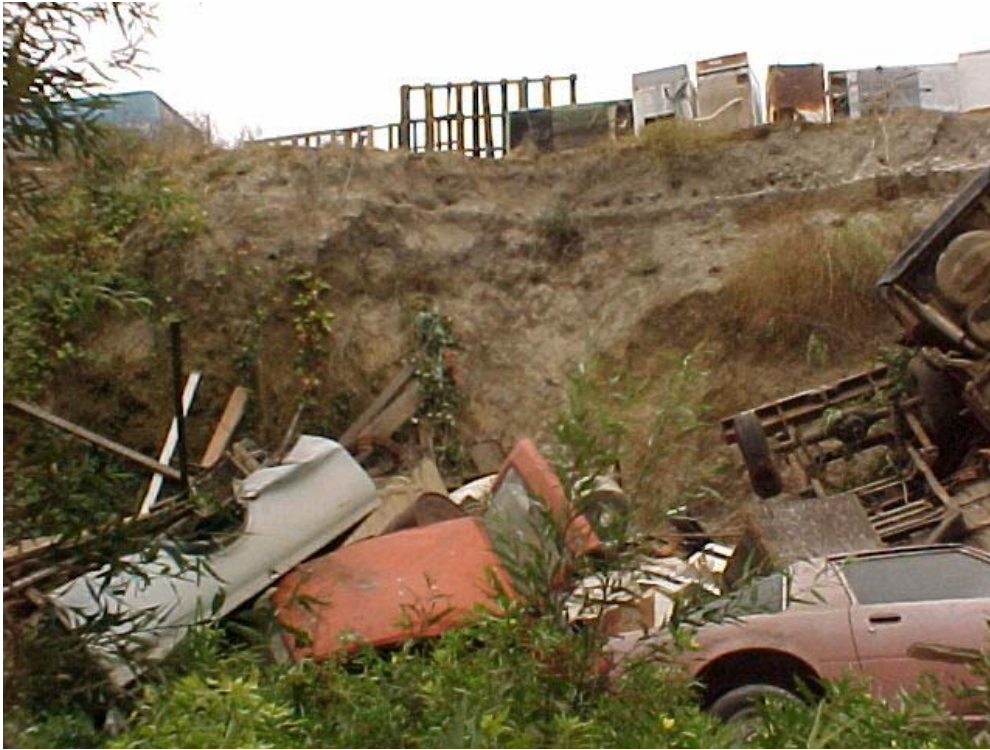
Photo 1.11

Trash and vehicles in Atascadero Creek increase erosion and pollution.

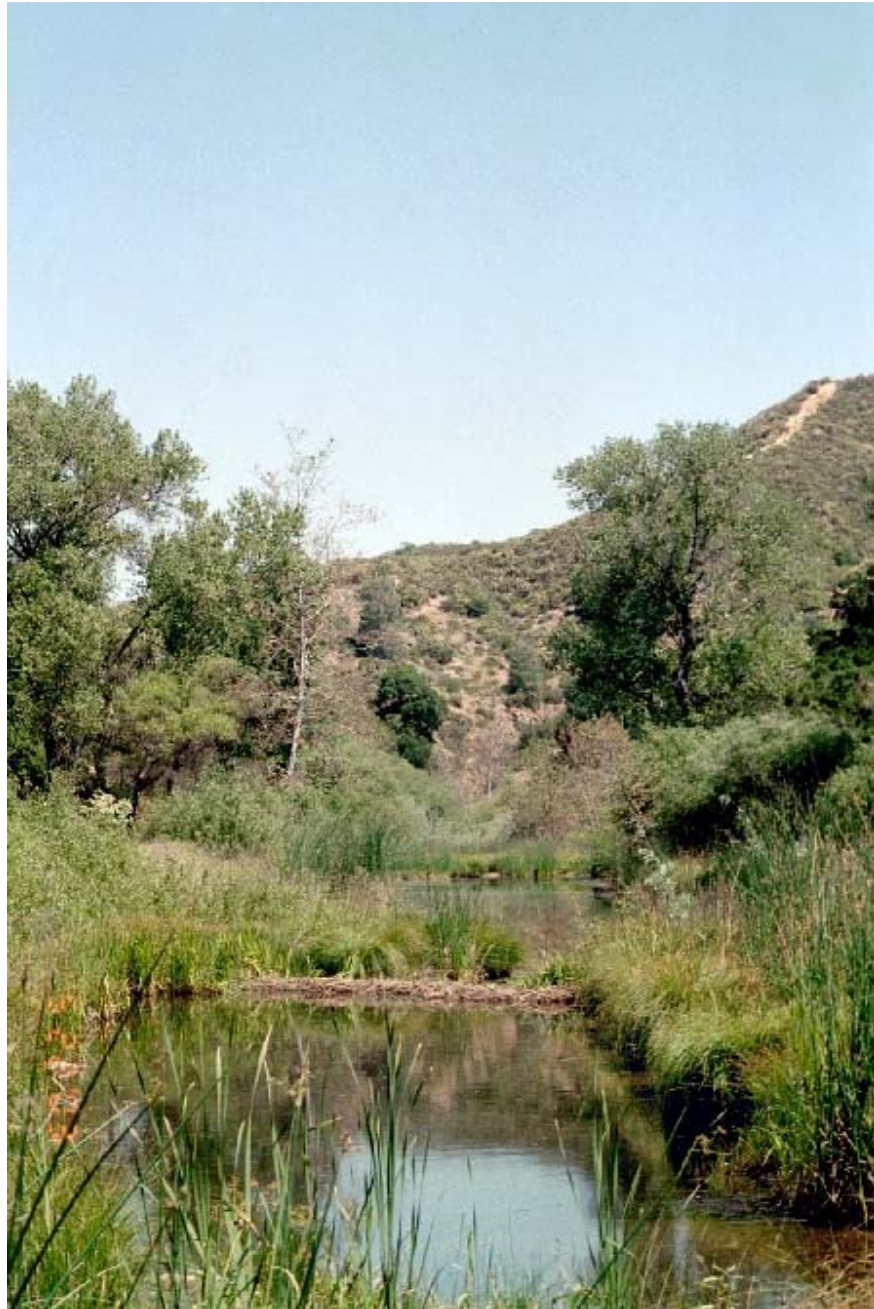
Photo 2.1

Small beaver dam on Salinas River southeast of Santa Margarita. The canyons of the southern reaches of the Salinas are chaparral and oaks. The wildlife is very diverse.

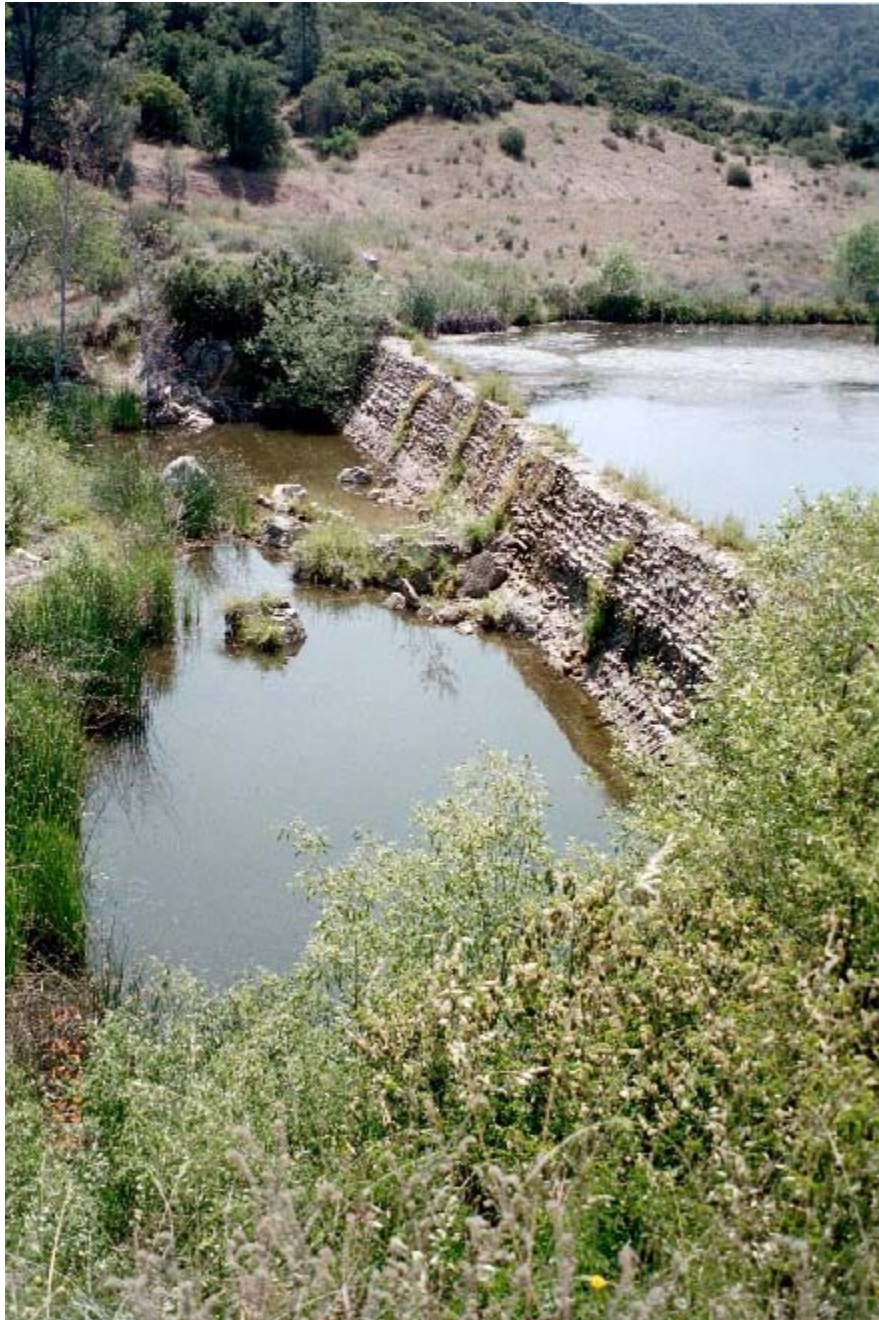
Photo 2.3

Older dam built on the Salinas River near Santa Margarita was an early barrier to steelhead and began to change stream conditions.

The 4,160 square mile Salinas River Watershed, half of which is within the Upper Salinas planning area, is critical to the health of the waters of Monterey Bay. The Salinas is one of the most productive agricultural valleys in the world. The combination of rich soils, ground water supplies, and accommodating climate has resulted in unexcelled agricultural production producing billions of dollars of produce, including lettuce, artichokes, wine grapes and cattle. The excellent soils are the result of thousands of years of flooding of the Salinas River and depositing of sediments from the watershed. Historically, floods periodically reached over three miles wide, continually rejuvenating the land.<sup>1</sup> Today, the natural processes of rejuvenation have been altered by the construction of dams and levees. (See Photo 2.3)

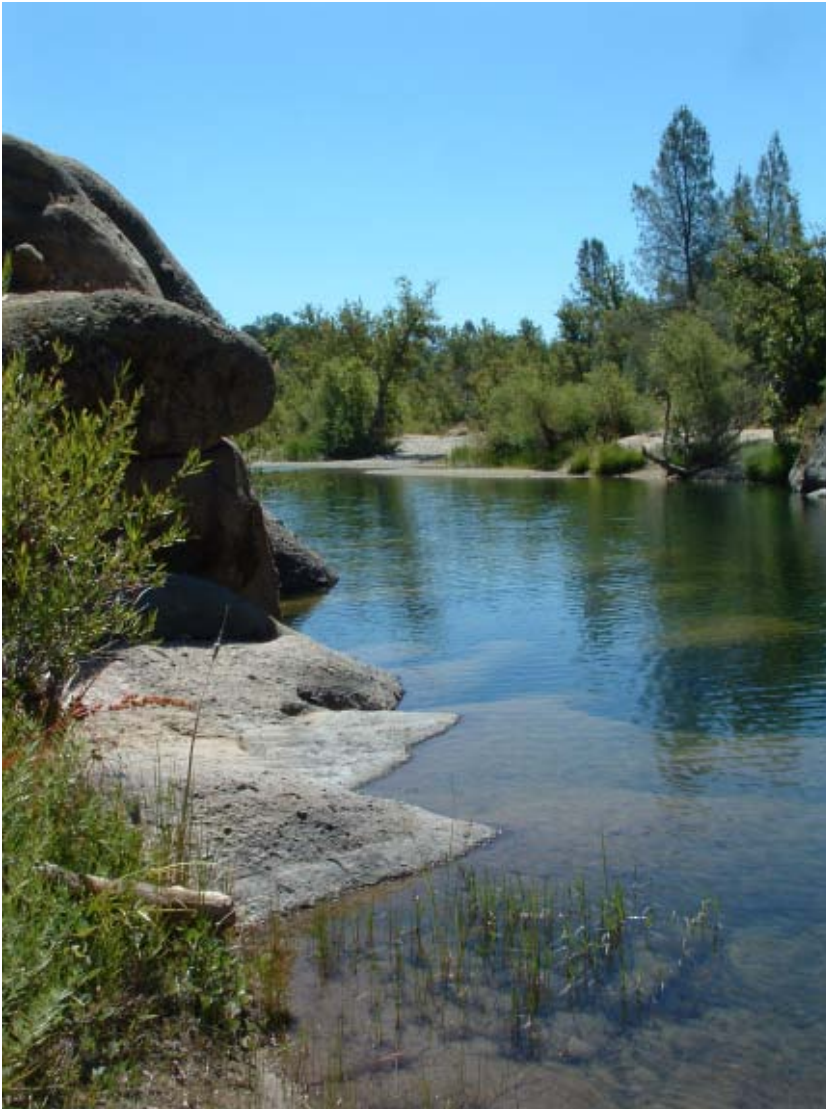
Photo 2.5  
Nacimientto River near  
the Palisades

The upper reaches of the Nacimientto River provided habitat for steelhead and salmon before the construction of the Nacimientto Lake Dam in 1956. This 2004 photo is taken in Fort Hunter Liggett approximately ten miles upstream of the lake, near the boundary between San Luis Obispo and Monterey County.

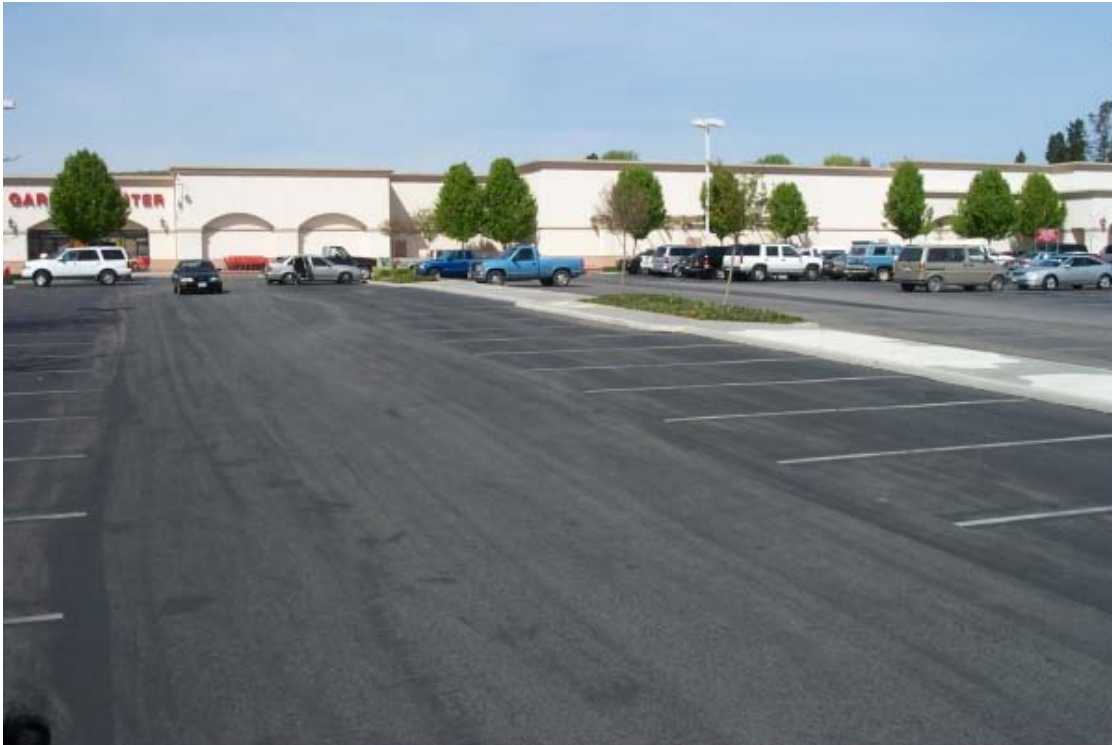
Photo 2.7

Urban growth has changed the character of the Upper Salinas region. Agricultural land has been converted to housing, commercial, and industrial uses. Impervious surfaces quickly shed rainfall, sending concentrated flows to the streams and rivers.

In urban areas, roads, buildings, and parking lots prevent rainfall from percolating into the soil. (See Photo 2.7) Land coverage in some of the commercial areas approaches 100 percent. Vegetation removed from the land has also increased runoff. Stream channels in urban areas have exhibited high levels of pollutants and increased suspended sediment. (see Chapters 4 and 5)

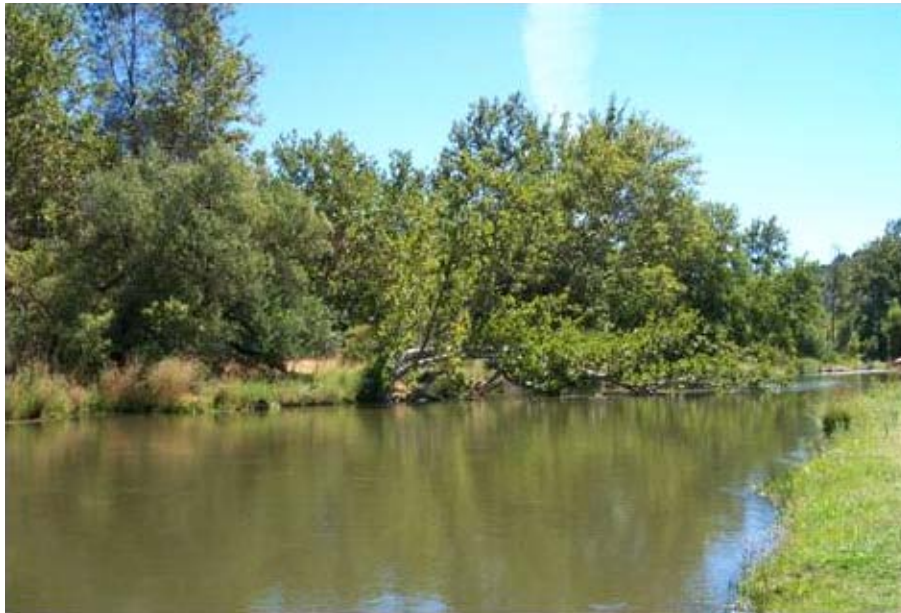
Riparian vegetation along the Nacimiento River

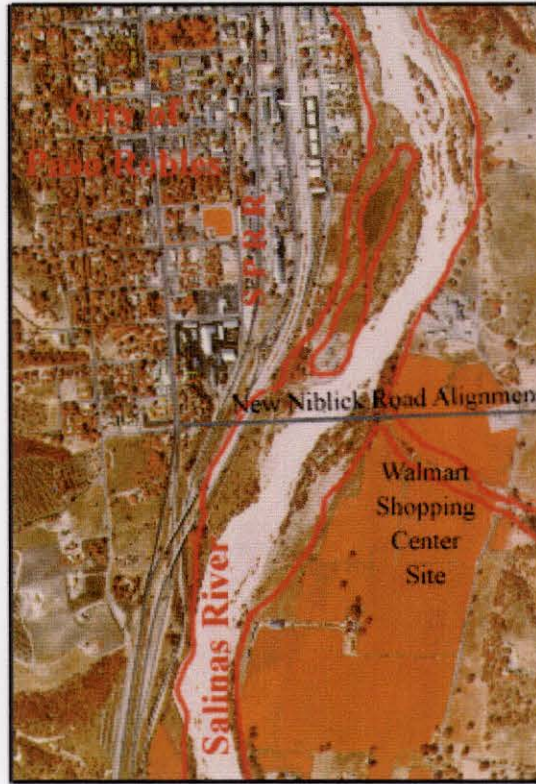
1978 Infrared Aerial Photo

Average Riparian Vegetation Cover: 23%

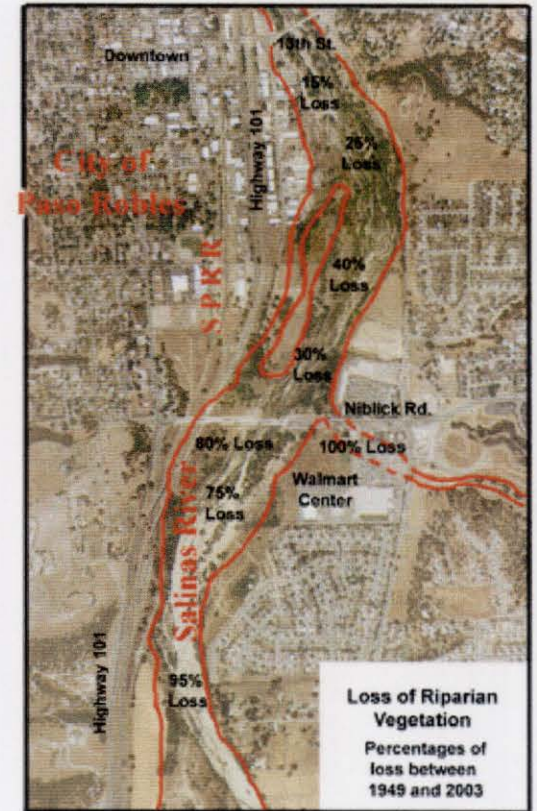
2003 Aerial Photo

Salinas River South of 13th Street Bridge

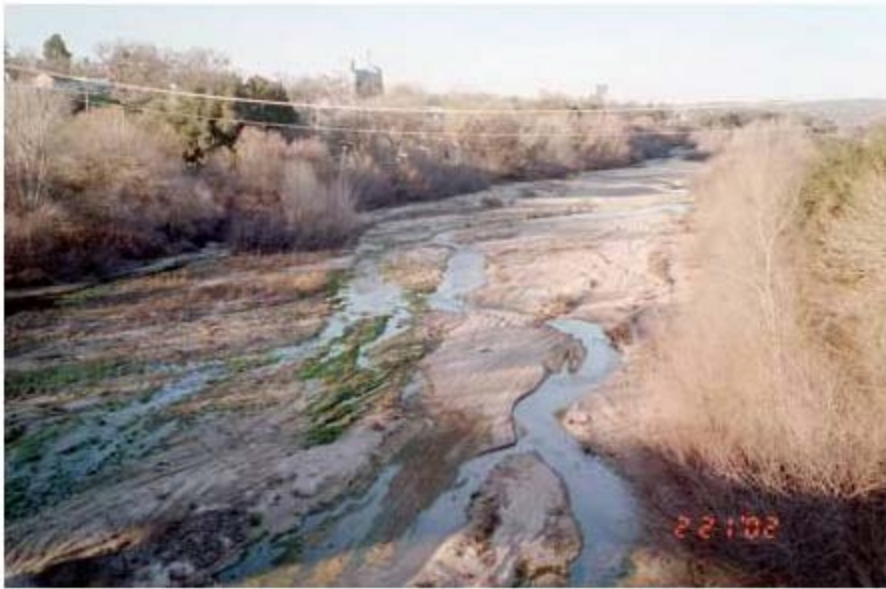
OHV's in the Upper Salinas River Watershed

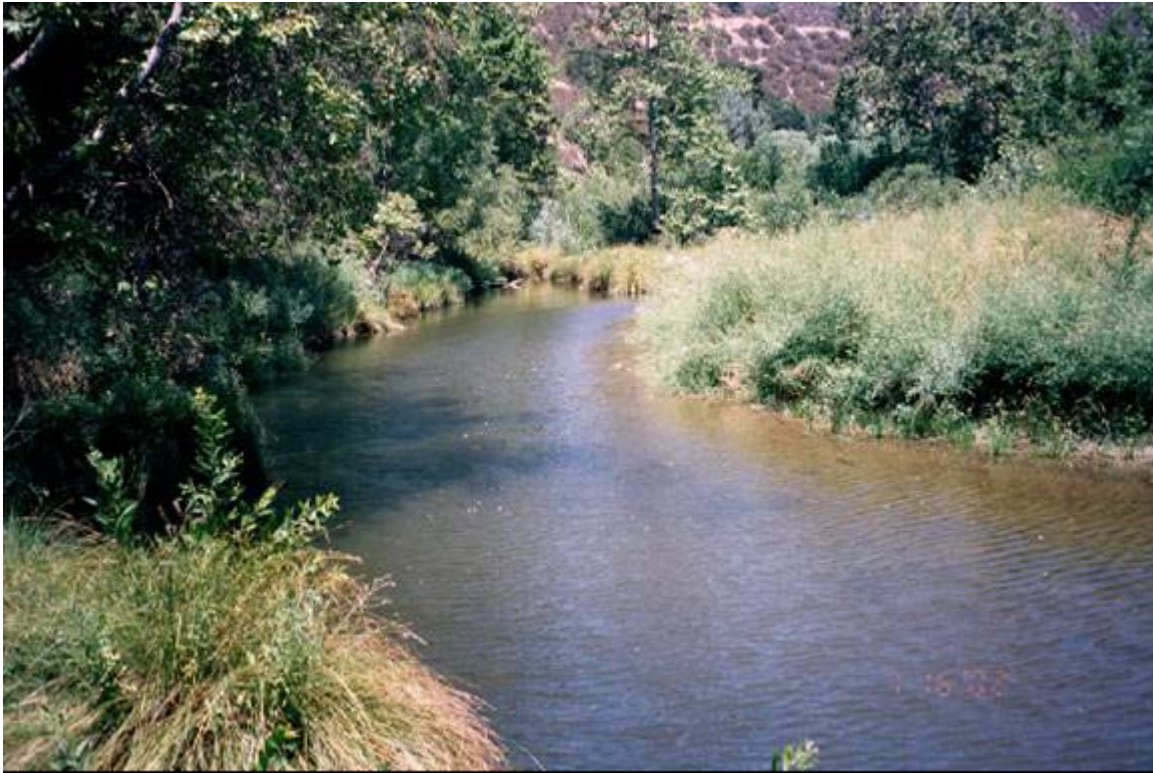
Photo 4.1  
Salinas River southeast of Santa Margarita near old Highway 58 bridge in July 2002  
Channel is stable and riparian vegetation provides 100 percent bank coverage.

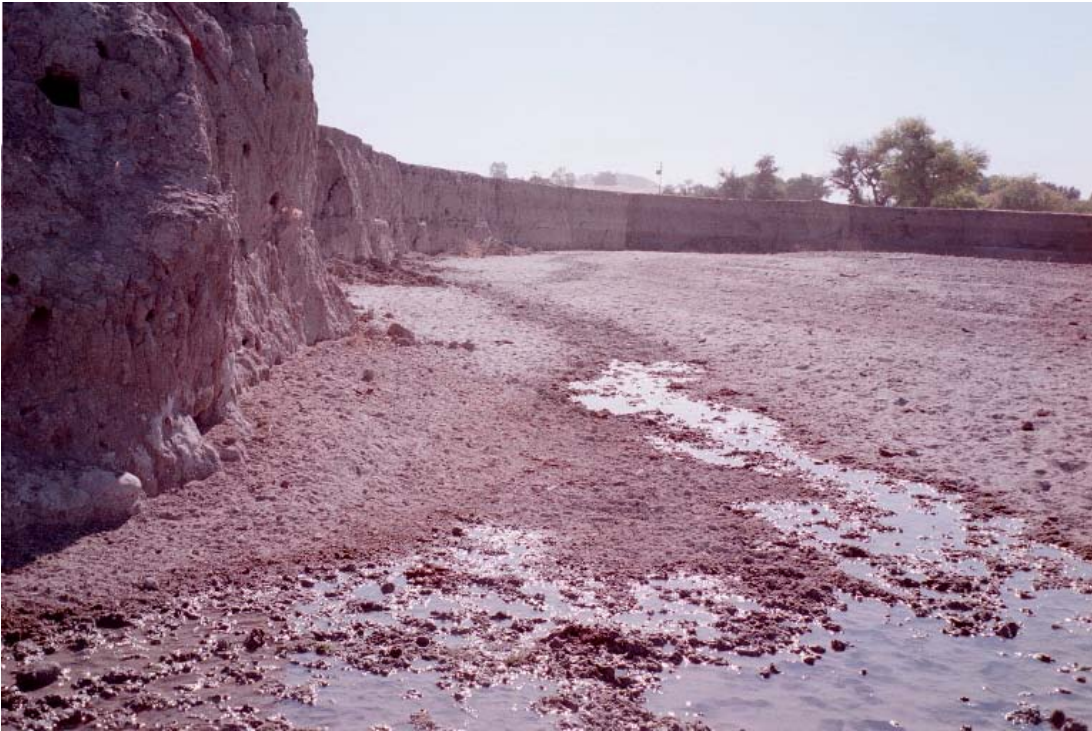
Photo 4.2  
Cholame Creek erosion in a braided channel. Location is downstream of confluence with Little Cholame Creek. Riparian vegetation has disappeared.

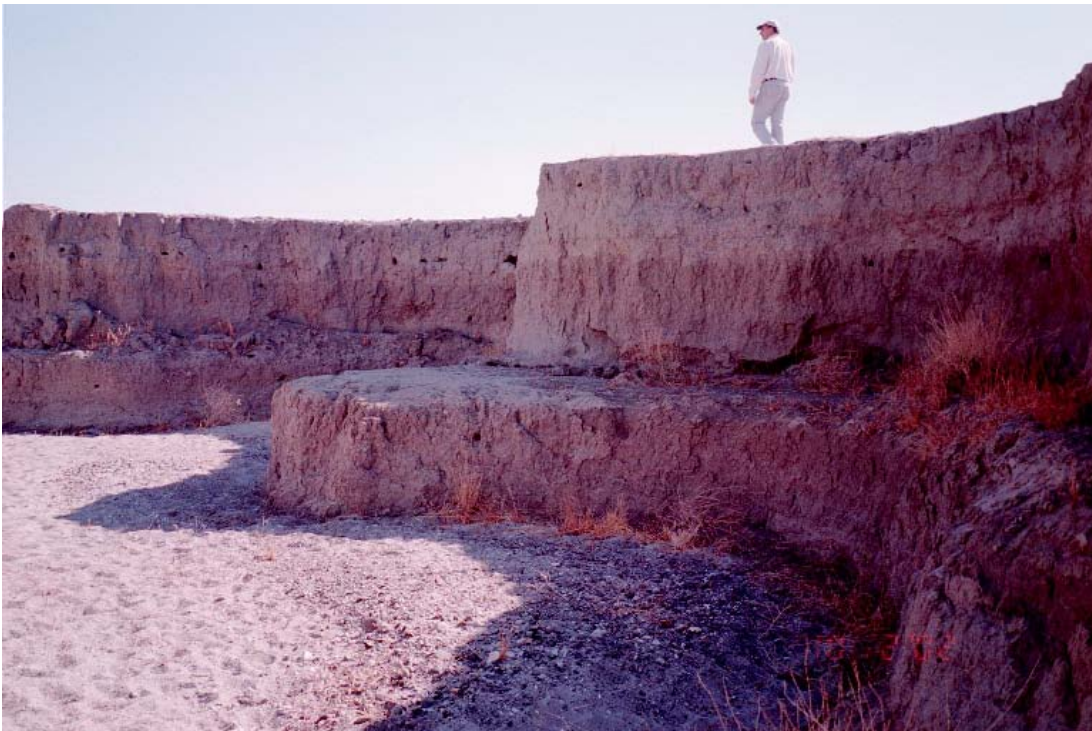
Photo 4.3  
Cholame Creek bank erosion. This creek is one of the sources of sediment in the Salinas River.

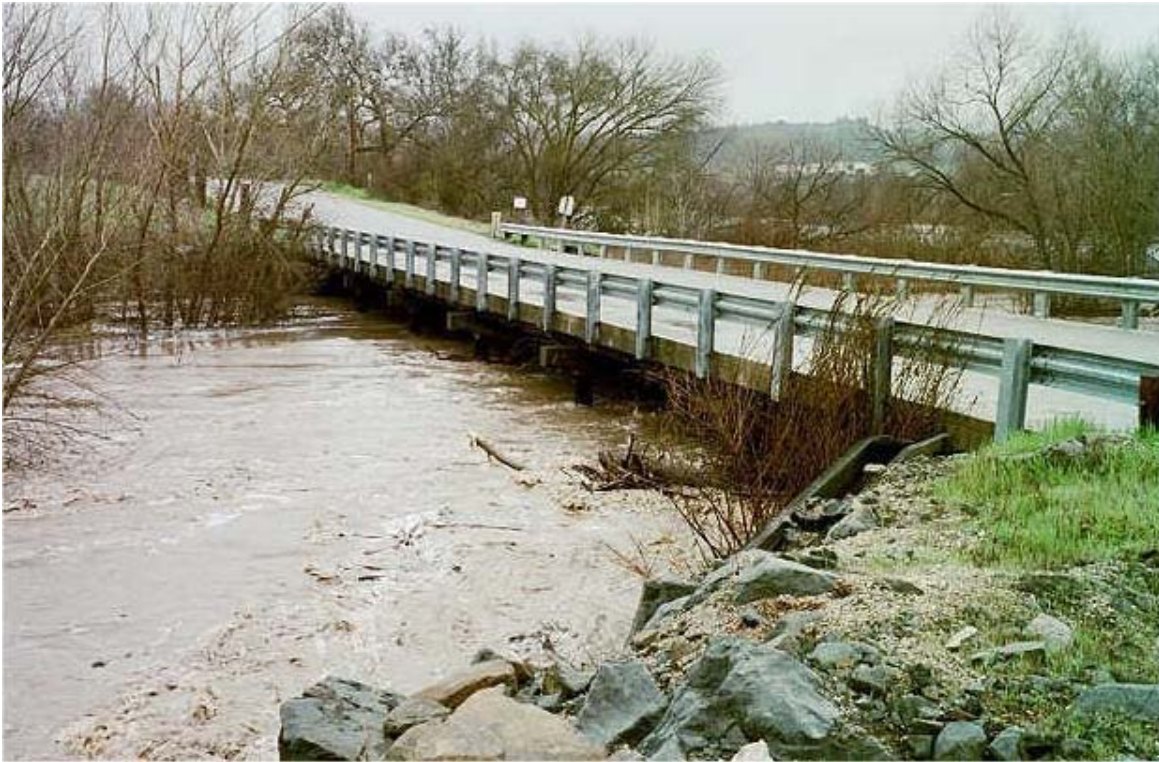
Photo 4.3a

Huerhuero Creek at North River Road carried large concentrations of sediments during 2001 rainstorms.

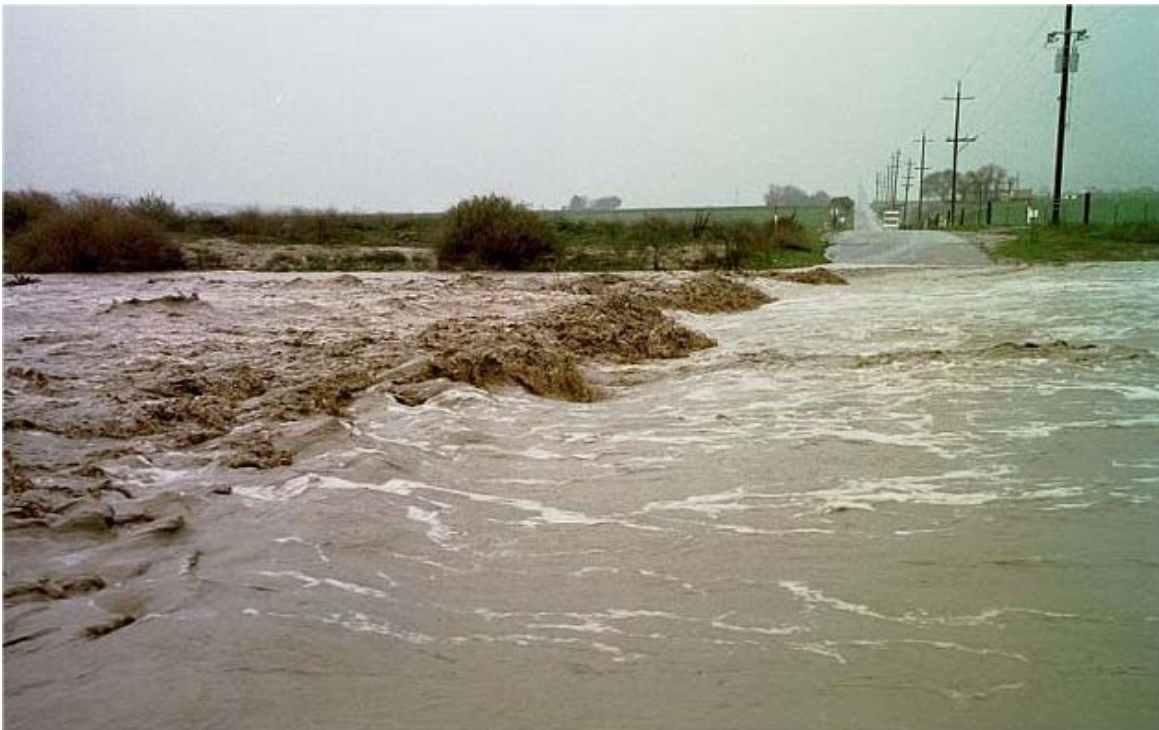
Photo 4.3b

Water samples were taken from streams and rivers during and after rainstorms to Determine the percentages of suspended sediment. (See Section G, Sediment Transport)

The sediments in the Estrella River were monitored during the storms that occurred on March 5 and 6, 2001. (See Photo 4.3b) The site is upstream of the crossing at North River Road. It is located approximately one mile upstream of the confluence with the Salinas River. During a 23 ½ hour period, samples were obtained and flows in cubic feet per second were determined. For the period from 11:30 a.m. on March 5 to 4 p.m. that same day, the river flow averaged 3,444 cfs. A suspended sediment sample taken at 11:30 indicated 79 cubic centimeters of sediment per 1,000 milliliters (1 liter). At 4:00 p.m. that afternoon, another sample was obtained from the river containing 81 cubic centimeters of sediment per 1,000 milliliters. The transparency of the samples was less than 0.2 centimeters. A 1,000 milliliter sample taken at 11:00 a.m. on March 6<sup>th</sup> contained 36 cubic centimeters of sediment. The flow had lessened to 1,781 cfs.

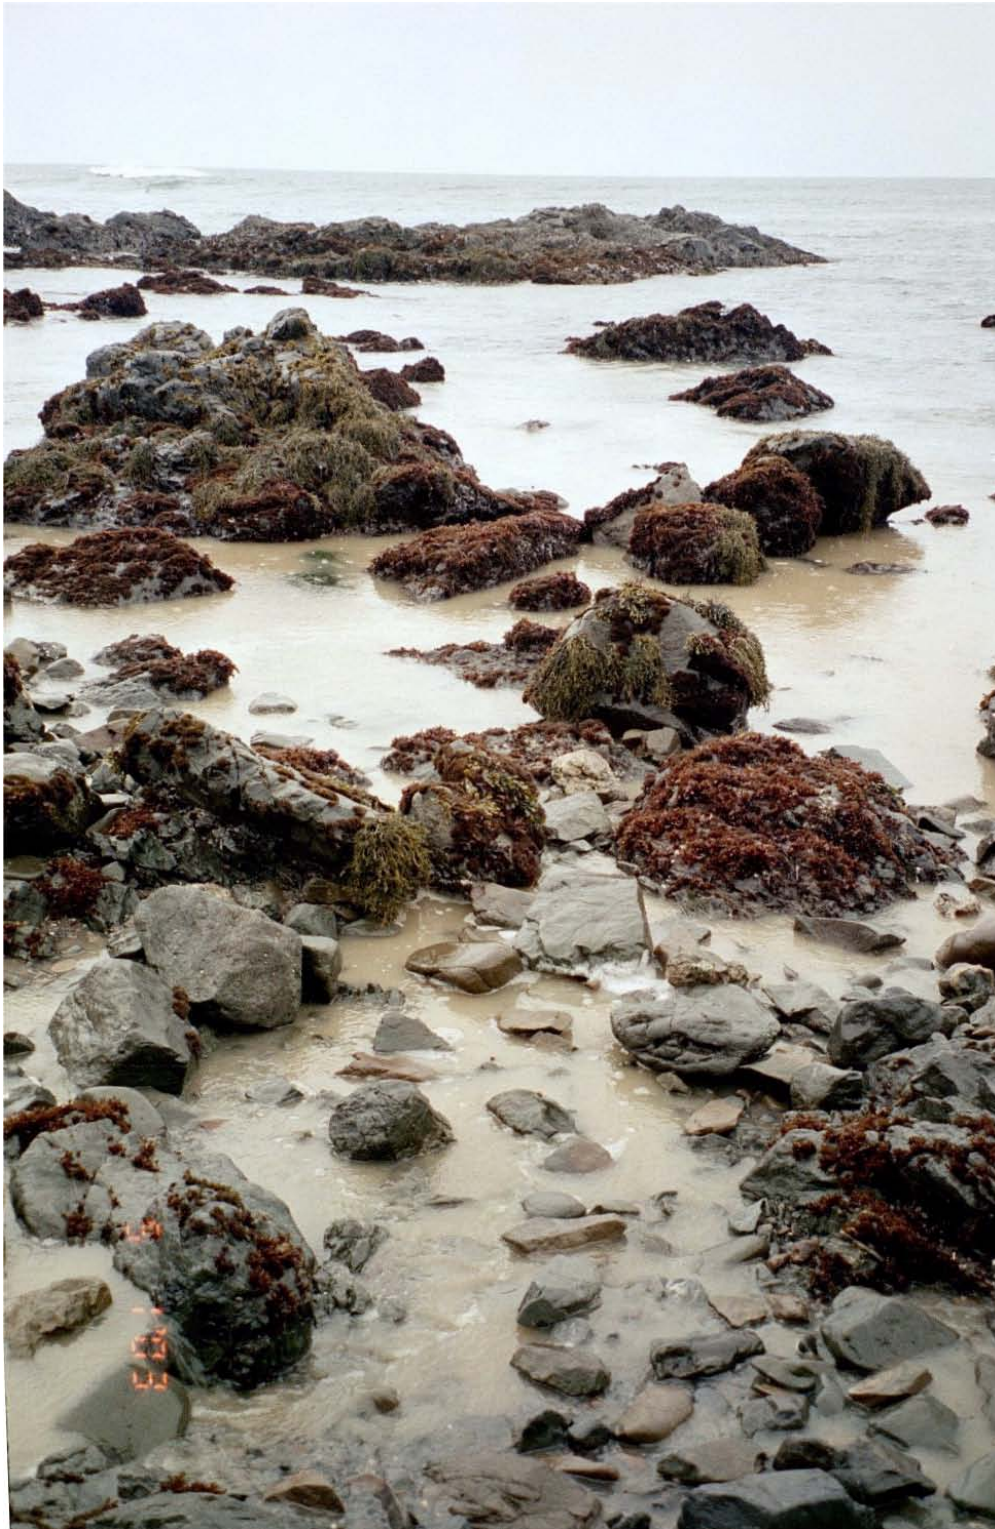
Photo 4.3c  
Sediment entering the ocean can impact water quality and marine habitat

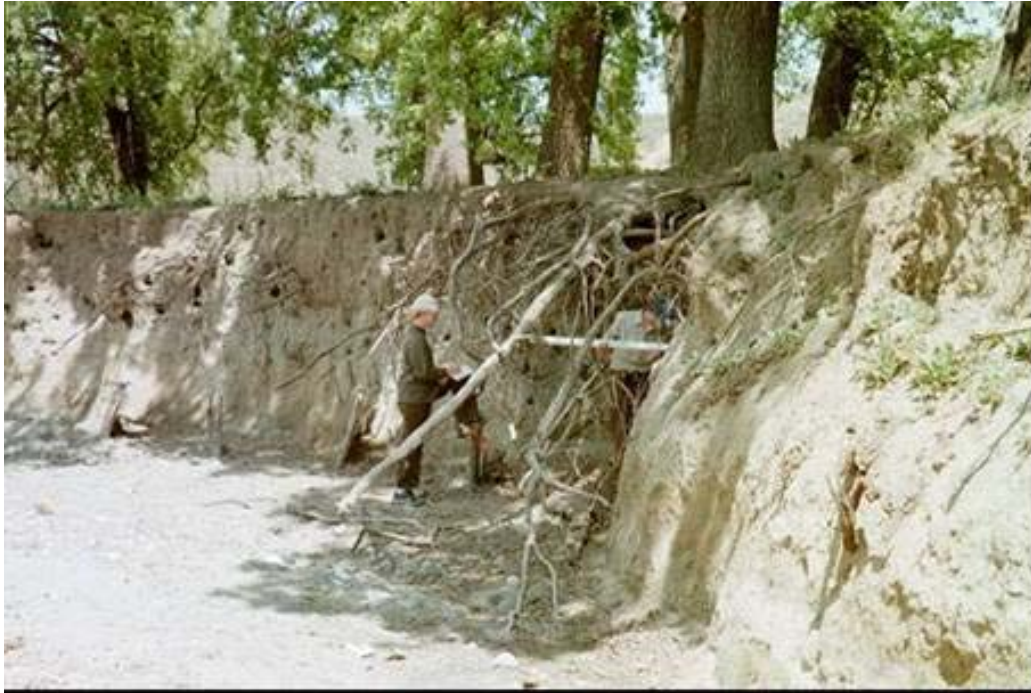
Photo 4.4

CCC staff assists RCD in surveying bank erosion upstream in Study Reach B, Little Cholame Creek.

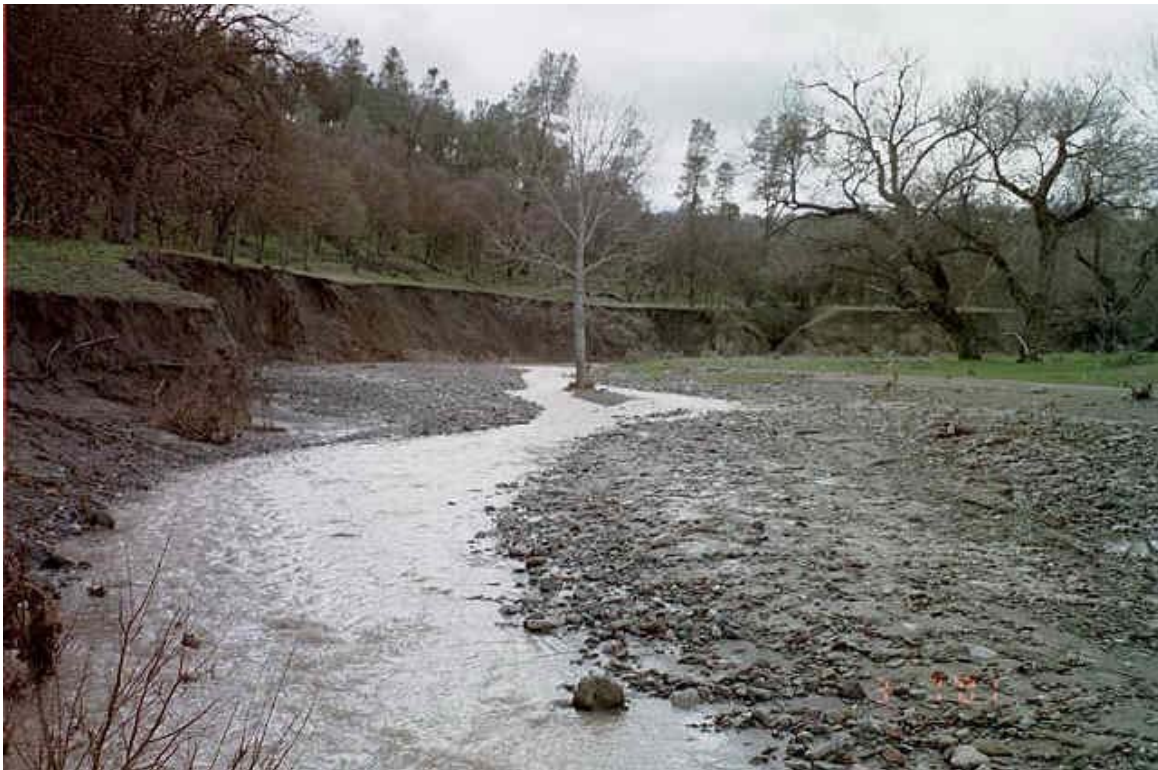
Photo 4.5

Little Cholame Creek, Study Area A(1) upstream of bridge during a rainstorm in March 2001.

Reach A(1) is a C-5 and D-5 channel, characterized by rapidly eroding vertical banks. The channel has degraded 4.25 feet. An older abandoned channel is evident. It is over 100 feet to the left of the current channel. This older channel meanders through the pasture adjacent to the current channel. A projection of channel progression has been plotted and shown in Figures 4.2 and 4.3. Portions of the channel are braided and highly unstable. Very little riparian vegetation is evident two-hundred feet upstream of the County bridge. (Note that Stream Water Quality Monitoring Site #16 on Little Cholame Creek at the County Bridge on Parkfield Road had no surface flow during the winters of 2003 or 2004. According to the landowner, there were several short duration flows immediately after heavier rainstorms. Those flows only lasted for a very short period of time.)

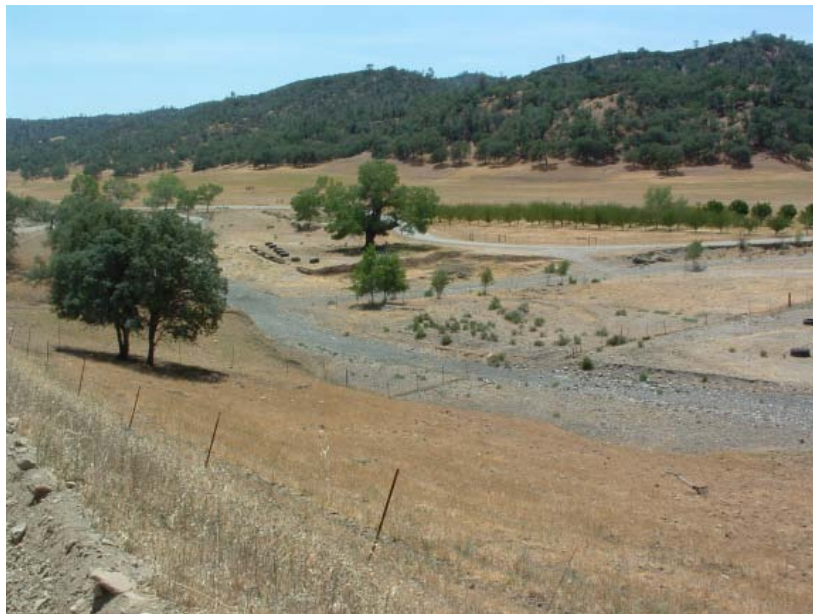
Photo 4.6  
Reach A(2), Pine Canyon and Little Cholame Creek confluence.  
No cattle exclusion. Less than 1 percent riparian vegetation.

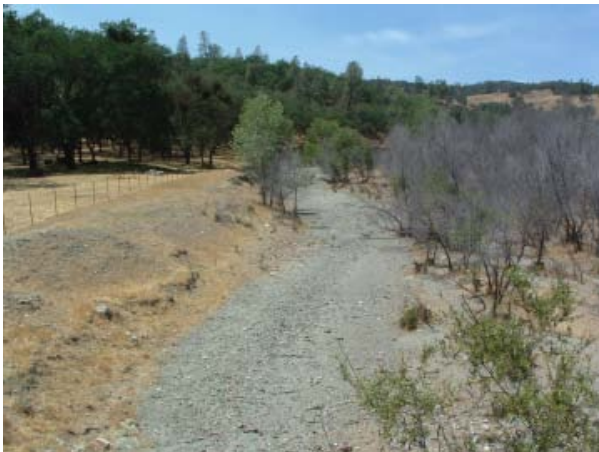
Photo 4.7

Reach A(1) immediately upstream of Reach B  
Unrestricted cattle use in this reach.

Study reach B is located approximately three-quarters mile upstream of Study Reach C and is separated from Study Reach A(2) by a bridge and fence. The watershed impacting Study Reach B is approximately 17 square miles or 11,000 acres. This reach is located immediately downstream of a County Road Bridge. This reach is a braided D-5 channel type. The land use along Reach B is grazing. While there is evidence of bank erosion, woody riparian vegetation has begun to stabilize the channel. There is significantly more riparian vegetation in Study Reach Area B than there is in Areas A or C. (See comparison of Photos 4.7 and 4.8)

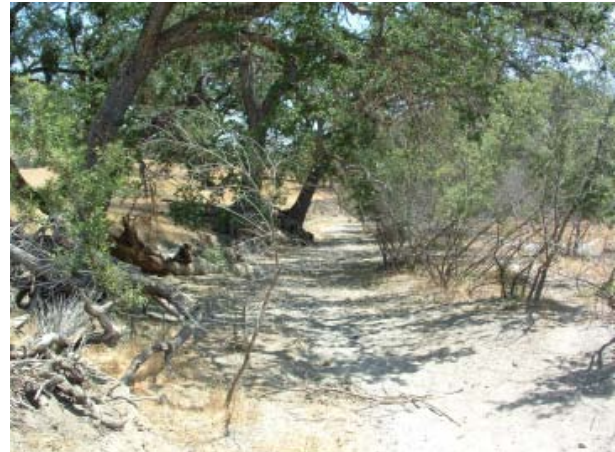
Photo 4.8

Reach B, immediately downstream of Reach A(1)  
Cattle managed in this reach.

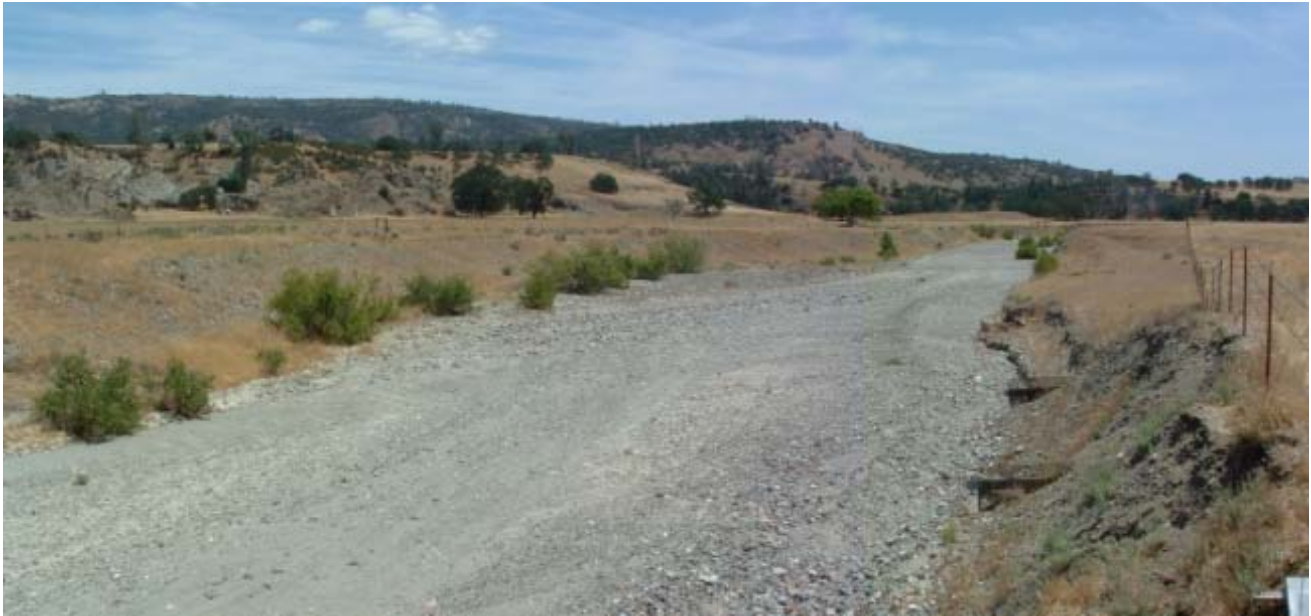
Photo 4.9

Little Cholame Creek Reach C. Riparian vegetation is 5 percent after 4 years of cattle exclusion.

The upper 800 feet of the reach was not modified. It remains an F-5 stream type, with steep and unstable banks. The bed degradation and vertical banks are attributed to the loss of riparian vegetation.<sup>4</sup>
