*Upper Salinas - Las Tablas Resource Conservation District*

*Upper Salinas River*  
***Watershed Action Plan***

*Final Report to the State Water Resources Control Board*

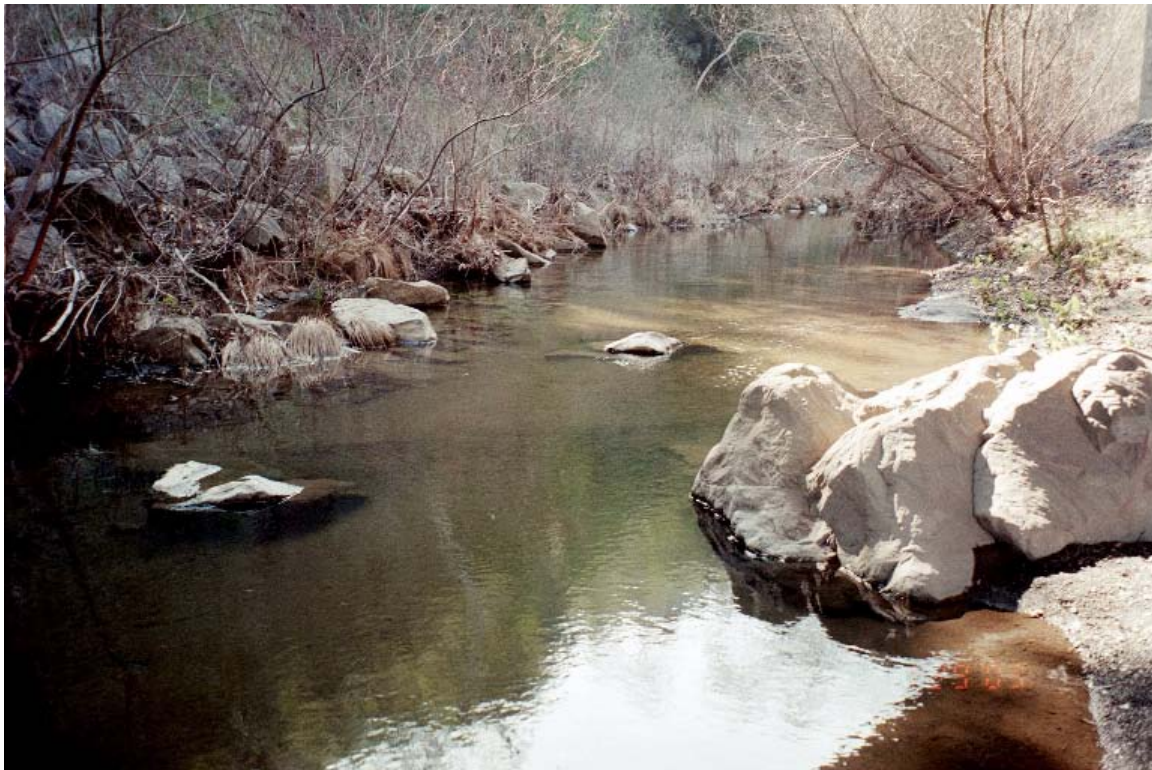
Photo 4.11  
Atascadero Creek at 3 Bridges, spring 2003

The survey area is located west and east of the third westernmost bridge. Reach D(1) of Atascadero Creek is a stable C-3 and C-4 meandering Channel Type. (See Photo 4.11) Reach D(2) immediately upstream of Reach D(1) is a B-3 step-pool Channel Type with a bed of predominantly cobbles and boulders. The area east (downstream) of the bridge is comprised of stable C-3 and C-5 Channel Types. The channel bed is predominantly sand near the bridge. A short riffle under the bridge as well as several short reaches downstream of the bridge is comprised of gravel and cobble beds.

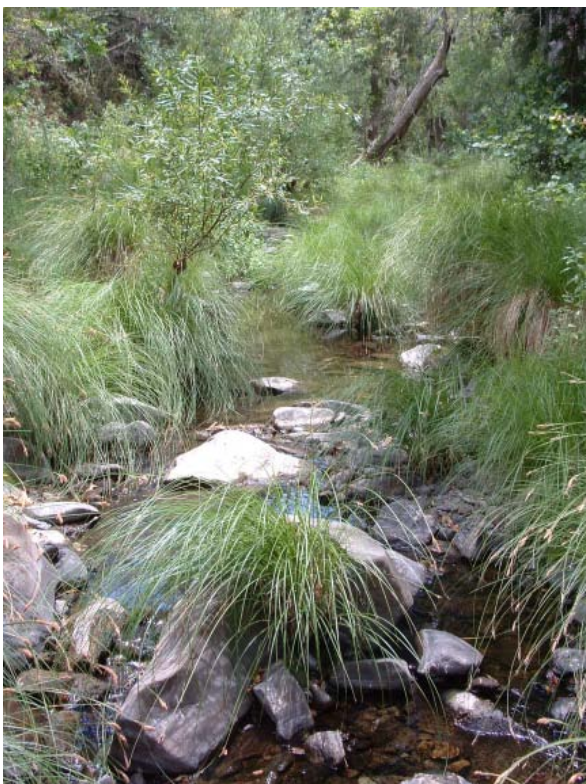
Photo 4.12  
Atascadero Creek near 3 Bridges

Study Reach A(2) is upstream of the pool. The channel transitions from C-5 to B-2. The slope increases to 3 percent and bank vegetation cover is over 90 percent. This reach is characterized by many small boulders with numerous step-pools as shown in the photo to the left. A cross-section was surveyed at 25,300 feet (300 feet upstream of the bridge). This portion of the channel has an entrenchment ratio of 1.85 to 1 and the channel appears to be relatively stable. Water quality has been consistently better at this site than at the two survey reaches within the urban portion of Atascadero Creek. (See Chapter 5)

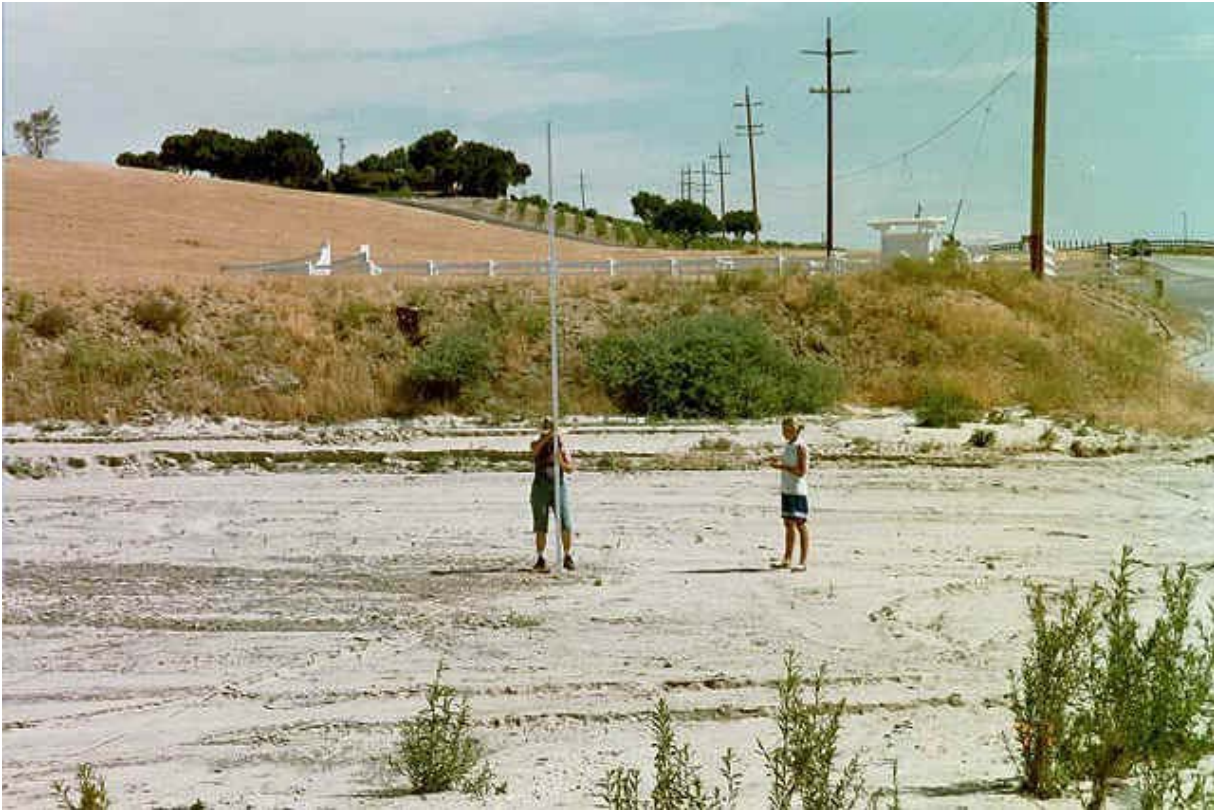
Photo 4.14

Estrella River, upstream of North River Road is often dry during the summer and fall. During the winter and spring, it can carry heavy loads of suspended sediment.

The US-LT RCD conducted a morphological survey of the Estrella River in the vicinity of the crossing of North River Road. The road crossing is an “Arizona” style crossing. The roadway is the same elevation as the channel bottom and it is inundated in even small flows. Upstream of the crossing, the Estrella River channel is experiencing numerous areas of serious bank erosion. Much of this erosion is because of the loss of channel riparian vegetation. Downstream of the road, there is a pronounced scour hole. Suspended sediment in the Estrella is very high. During large rainstorms, sediment levels of 90 cubic centimeters per 1000 milliliters have been recorded. The Estrella may be a major cause of excessive sediment in the Salinas River. (See Figure 4.14)

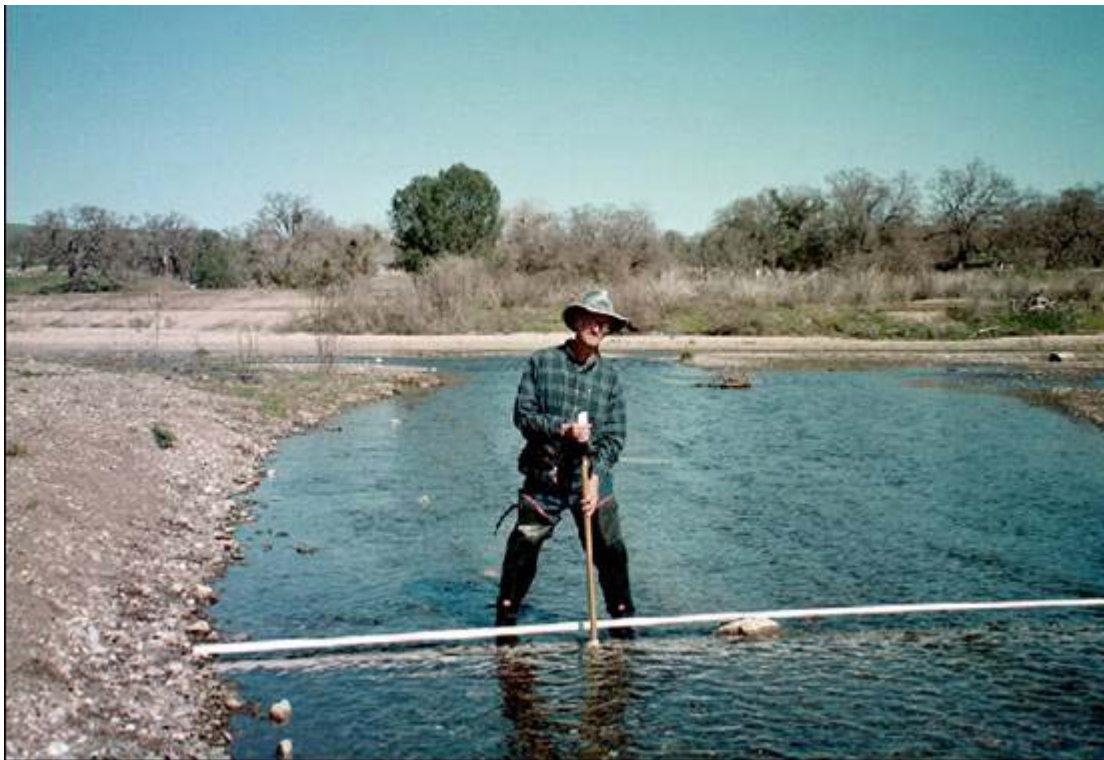
Photo 4.15

Stream Flow, Salinas River near confluence with Atascadero Creek

Two reaches of Atascadero Creek were evaluated within the urban portion of the watershed in the City of Atascadero. One is about one mile upstream of the confluence, in the vicinity of the West Mall bridge crossing and the other is located at the confluence with the Salinas River. (See Photo 4.15)

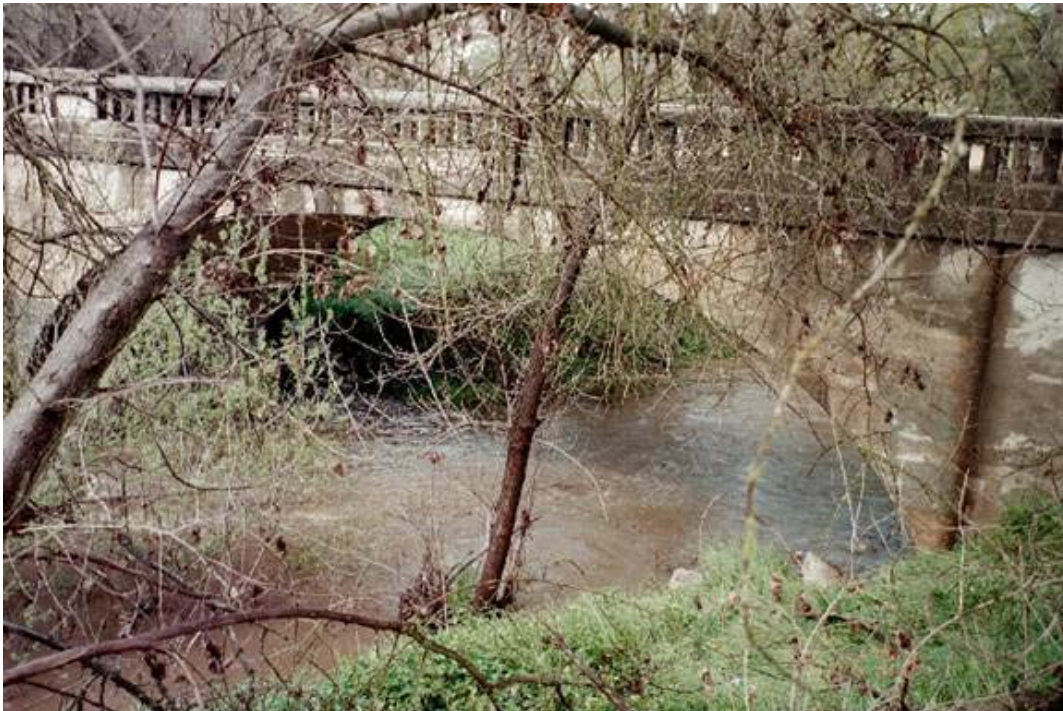
Photo 4.16  
Atascadero Creek, West Mall Bridge, winter 2003

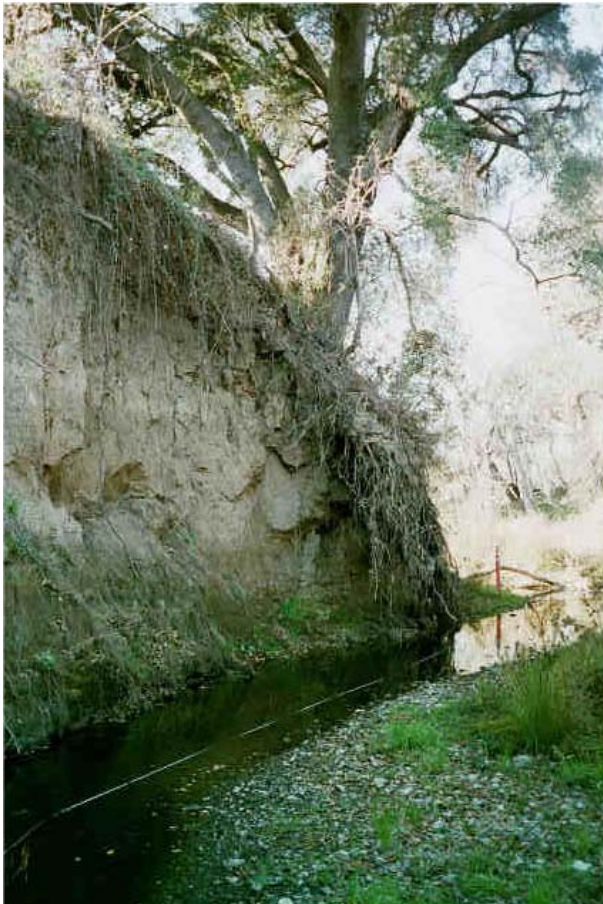
Photo 4.17  
Left bank, January 2001, Cross-Section 5,300'

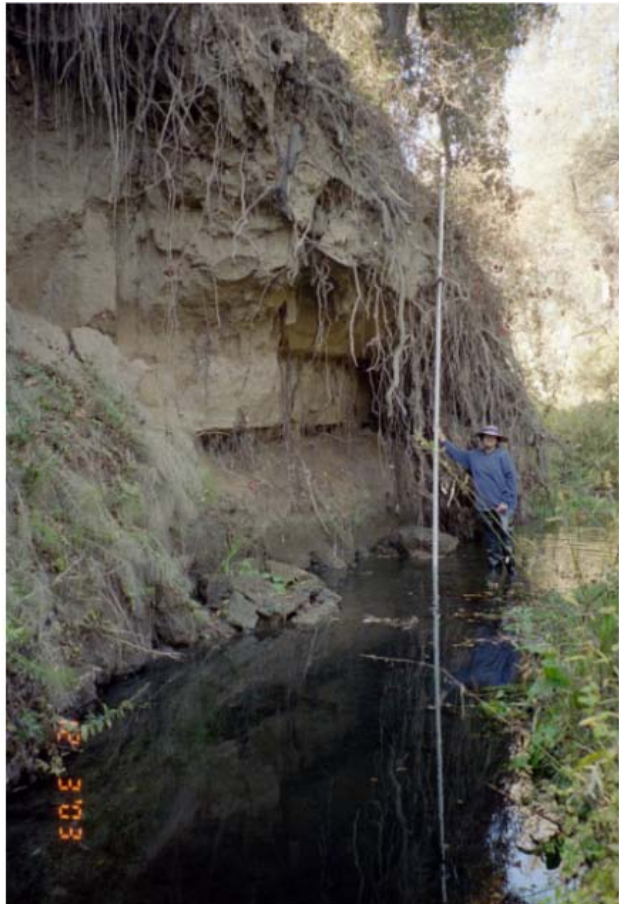
Photo 4.18  
December 2003 survey shows 4 feet of bank erosion

During the four years of study, the left bank has eroded horizontally four feet. (See Figures 4.15 and 4.16 and Photos 4.17 and 4.18)) Erosion has occurred even during drought conditions and fairly low channel flows during storms. During 2001-2003, an existing pool downstream of the oak tree has partially filled with sediment. Downstream of the oak tree, in 2001, the school district constructed a boulder and concrete rip-rap bank repair to protect existing buildings. That section of bank had eroded toward the school district offices.

According to Simon's "Channel Evolution Model," Atascadero Creek is beginning its widening cycle as it tries to create a new state of equilibrium.<sup>7</sup> The channel will continue to broaden as Atascadero Creek tries to regain a new floodable terrace at a lower elevation. In this reach, it is estimated that approximately 15 cubic yards per lineal foot of channel have eroded and washed downstream.

The school district recently drilled a well and constructed a small water storage tank on the terrace near the riprap structure. If the bank near the oak tree is not stabilized soon, the weight of the oak tree will cause the bank to fail and the tree will topple into the stream channel. The tree will take with it much of the top terrace. Several small portable storage sheds located near the tree will possibly be carried into the stream when the bank fails.

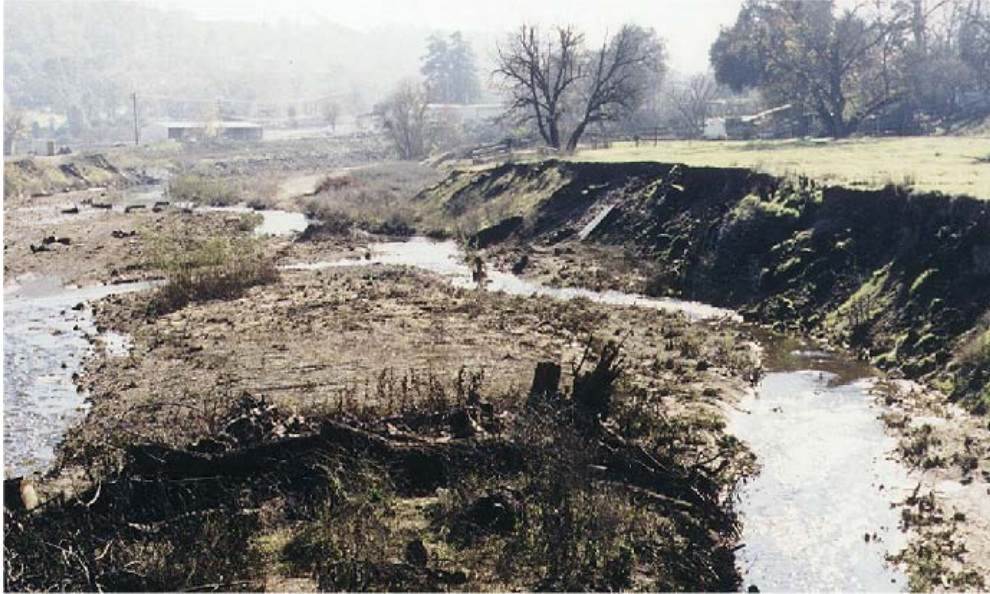
Photo 4.19

Atascadero Creek at the confluence with Salinas River prior to restoration project November 1999  
Note that banks have no riparian vegetation, they are rapidly eroding and the channel is braided.

In an effort to stabilize this reach, the Atascadero Mutual Water Company, which owns the creek channel north of the Sycamore Street Bridge, has conducted several creek bank restoration projects. In the late 1990's, they constructed two boulder deflectors along the east bank and installed a short rock riprap structure along the right bank at the middle of a long outside meander curve. In 2000, the Water Company regraded the left and right banks to a 2 to 1 slope and planted riparian vegetation. Later, the CCC and AmeriCorps assisted the Water Company in installing two willow wattles along the toe of the bank and planting willows. (Photos 4.19 and 4.20 show the transition after the banks were graded and planted) Oaks and sycamores were planted along the top of the bank. Due to lack of adequate near-surface groundwater and poor rainfall, much of the riparian vegetation died.

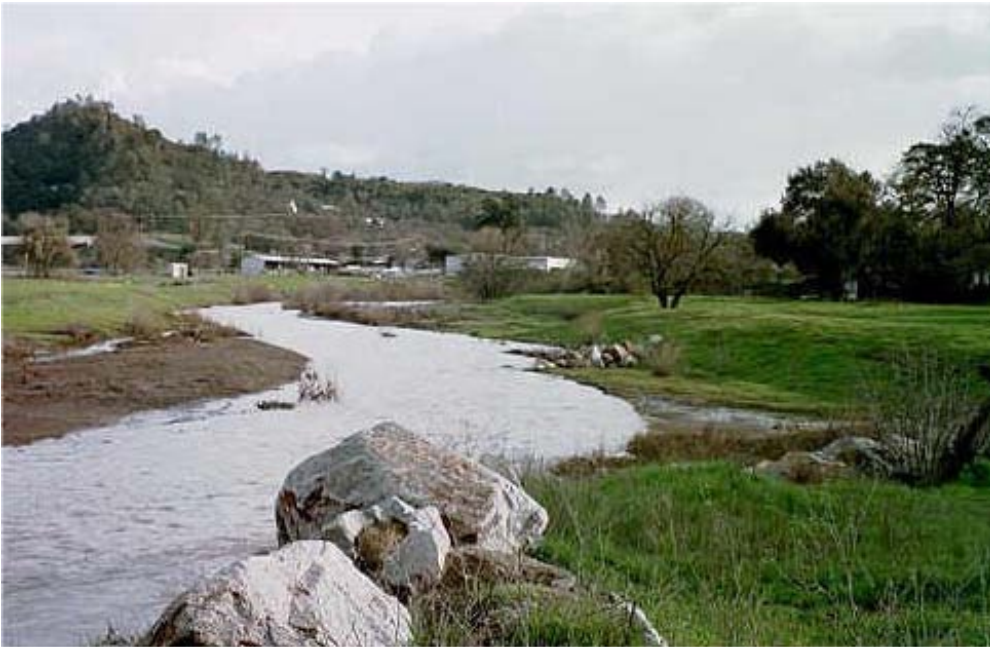
Photo 4.20

Atascadero Creek at the confluence with Salinas River, March 2001.  
After bank regrading and stabilization by Atascadero Mutual Water Co.  
The channel is no longer braided and erosion has been reduced.

At the 800 foot section, both the right and left bank were graded back to approximately a 2 to 1 slope. Sinuosity prior to the channel restoration in 2000 was low, with at ratio of 1.10 to 1 and entrenchment was moderate at 1.73. Prior to restoration, this reach of Atascadero Creek was a D-5 channel type. It was highly unstable with eroding steep banks. After the grading of the banks, the entrenchment ratio was improved to 1.94 to 1 and the stream has started to stabilize into a single channel. Correspondingly, the sinuosity of the channel has improved to 1.21 to 1. Several gravel bars and small pools have formed. The banks now have a grass cover. Riparian plantings have not been highly successful, due in part to a lack of subsurface water.

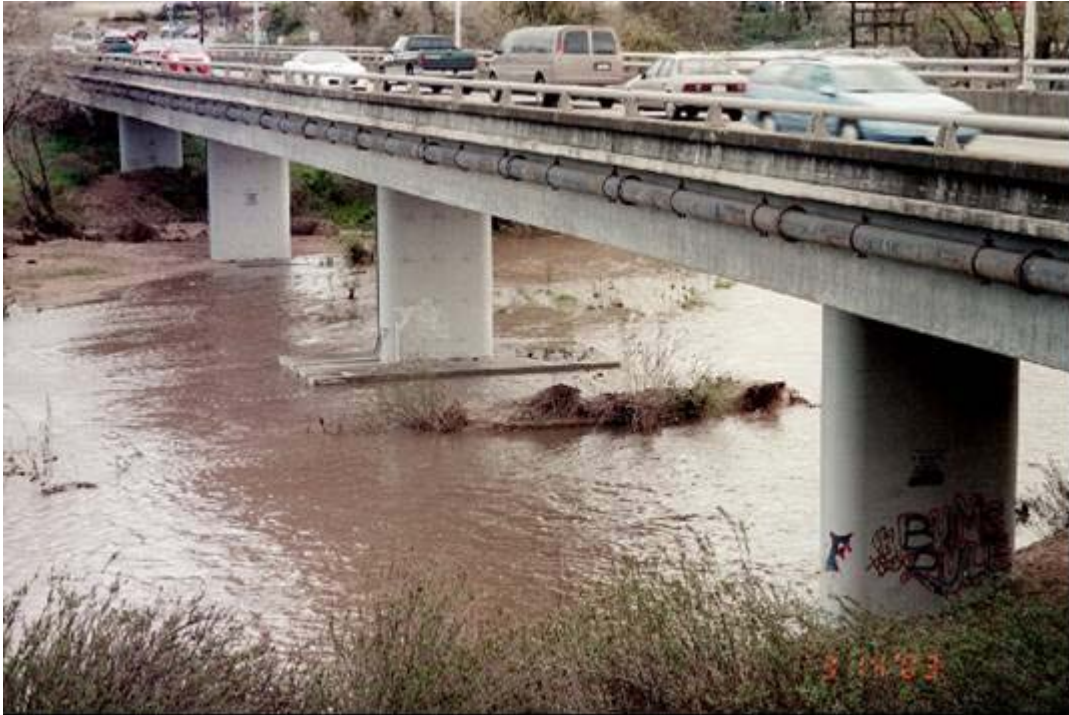
Photo 4.21  
Salinas River, 13<sup>th</sup> Street Bridge, after rainstorm, winter 2003

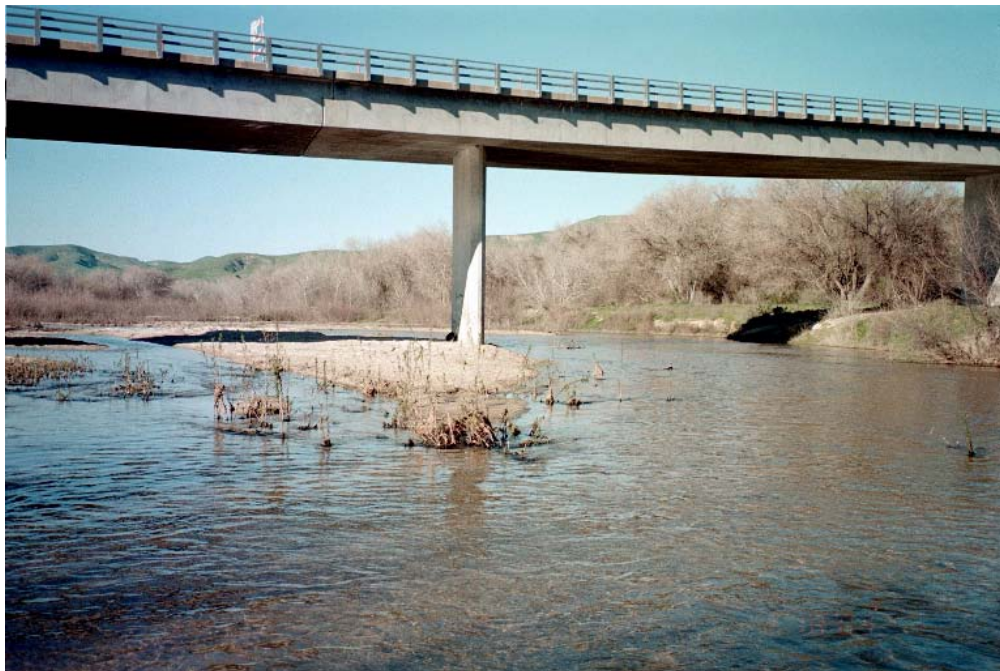
Photo 4.22  
Salinas River, San Miguel Bridge, winter 2003

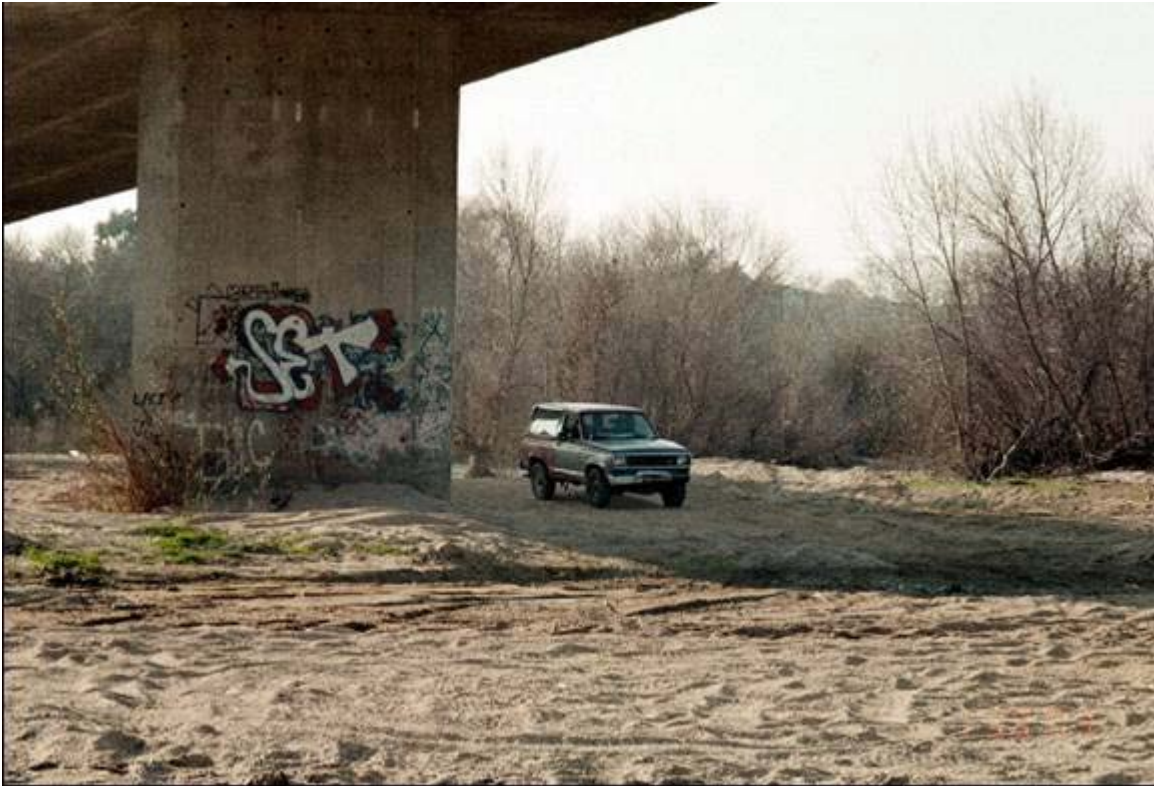
Photo 4.23  
Salinas River in San Miguel  
Illegal OHV's in channel destroy riparian vegetation, degrade habitat, and cause erosion.

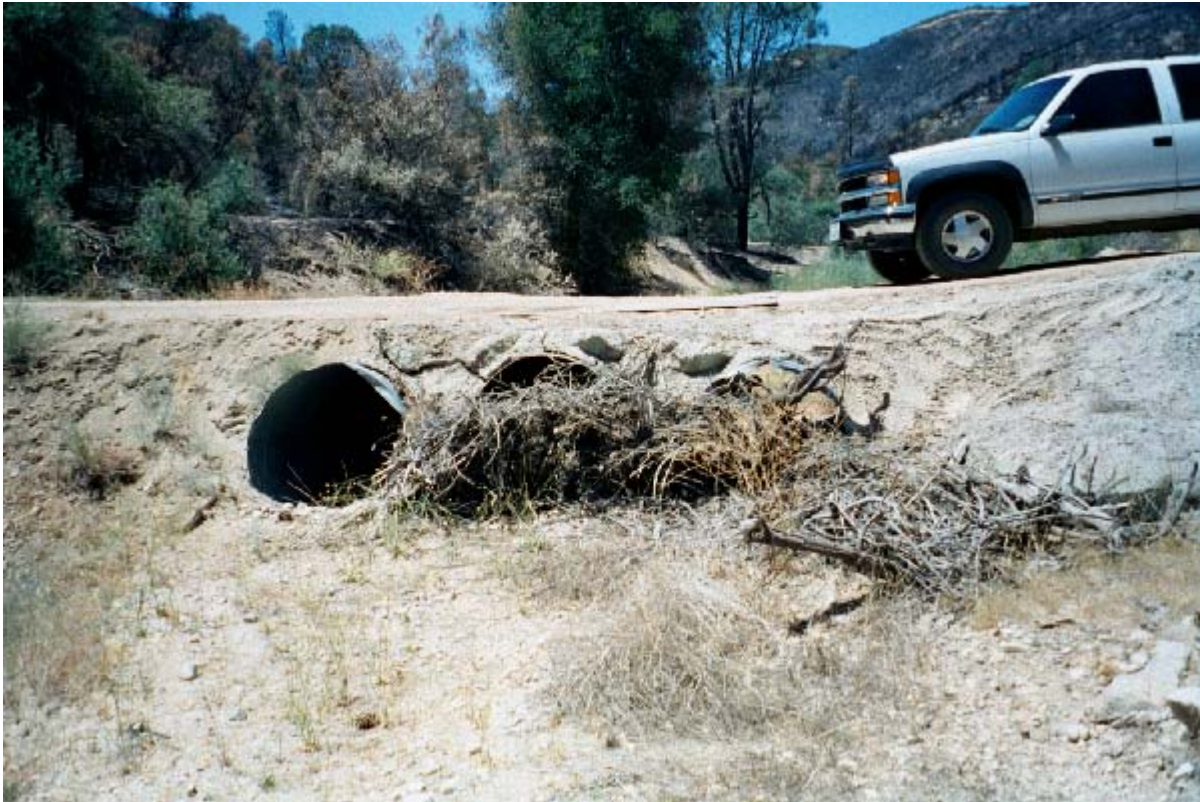
Photo 4.24

6. Silt fences and hay bales seldom provided significant protection against erosion or sediment transport to stream channels.
7. Debris in culvert pipes can cause overtopping of the structure and erosion. (See Photo 4.24)

Blocked culverts in the Huerhuero River may cause flooding and erosion. Recent upland vegetation removal has resulted in increased soil erosion. (Note that some of the soils in this watershed are highly erosive)

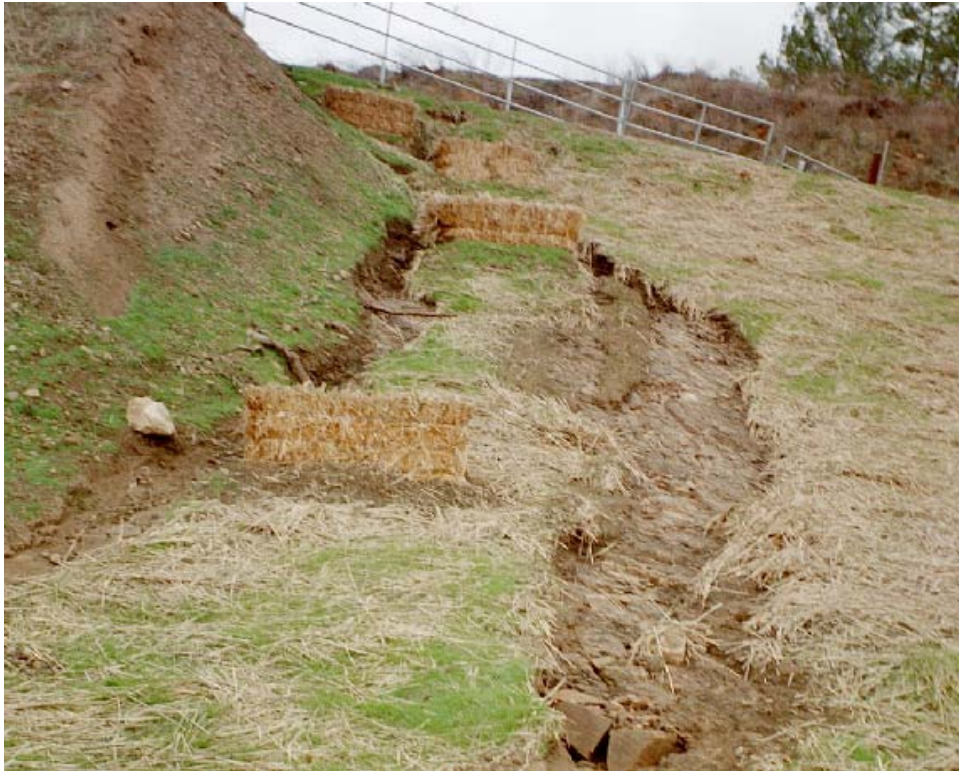
Photo 4.25

Roads often divert existing drainage, concentrating flows in drainage channels causing erosion. Roads are a major cause of upland and stream soil erosion. (See Photos 4.25 and 4.26)

An example of poor erosion control. This erosion was caused by the construction of a road. The US-LT RCD provides guidance to help prevent erosion from roads that results in sediment in streams.

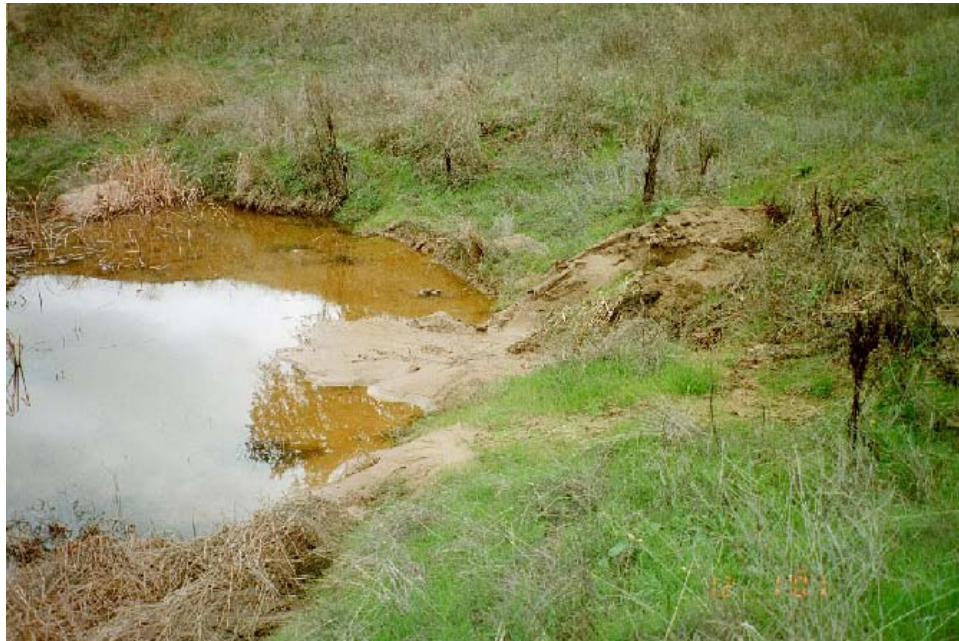
Photo 4.26

This is an example of a creek clogged with sediment from soil erosion caused by road and improper use of hay bales in photo above. Erosion control measures are needed to solve this problem.

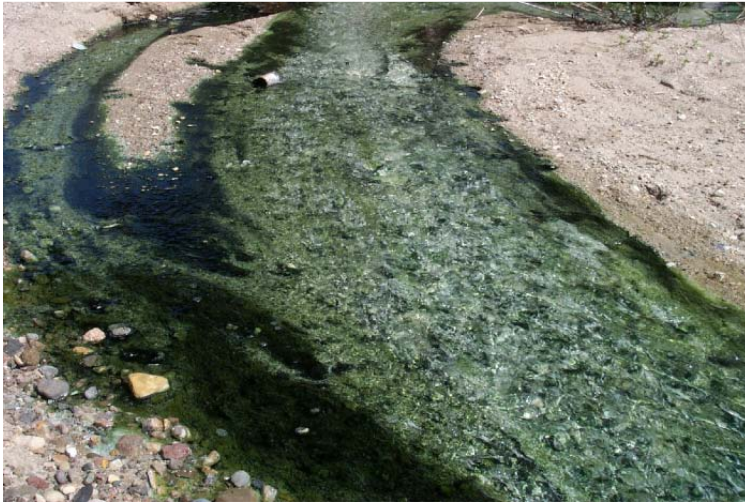
Since the magnitude 6.5 earthquake on December 22, 2003, there have been two independent streams flowing through the Salinas River channel in Paso Robles. The new stream, originating from the sulfur hot springs that sprung up in the City Hall parking lot during the earthquake, enters the channel around 10<sup>th</sup> Street and stretches approximately 200 yards before reaching its confluence with the Salinas River at the 13<sup>th</sup> Street Bridge.

Hot Sulfur Stream in the Salinas River at Paso Robles

According to *Geotimes*, the sulfur spring “has spewed thousands of gallons a day of hot water laced with boron” since the earthquake. Though the county is seeking an alternative solution for disposal of the spring waters, “for now, the stream of warm, high-boron sulfuric water goes directly to the Salinas River . . . both the high temperature and boron content could affect the river’s fish.”<sup>39</sup>

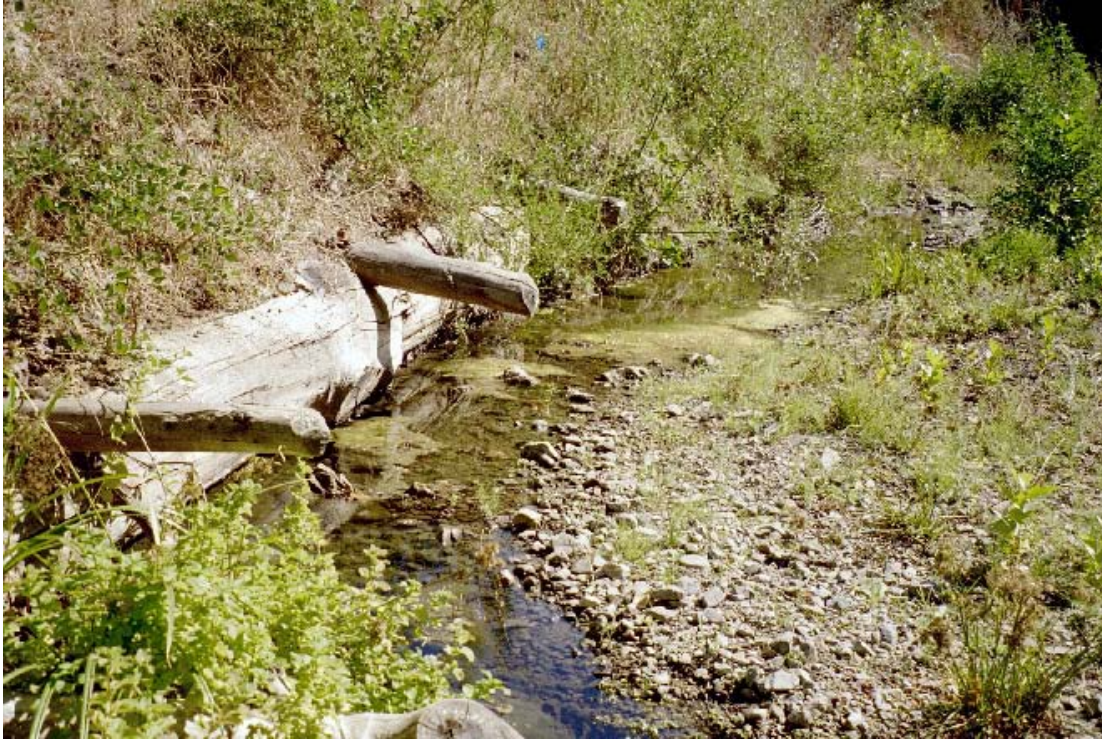
Photo 7.2

Example of stream restoration intended to protect stream banks and maintain healthy fisheries.

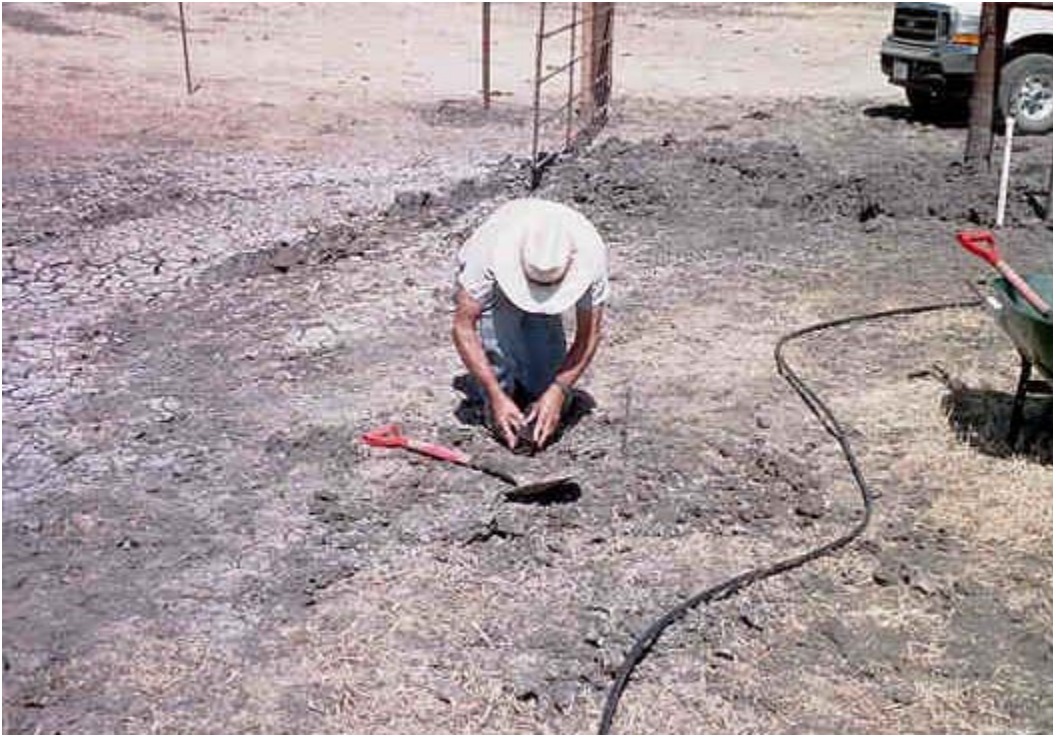
Photo 7.6  
Landowner, Jack Varian, plants oak trees near a new wetland designed by the  
US-LT RCD at his ranch near Parkfield

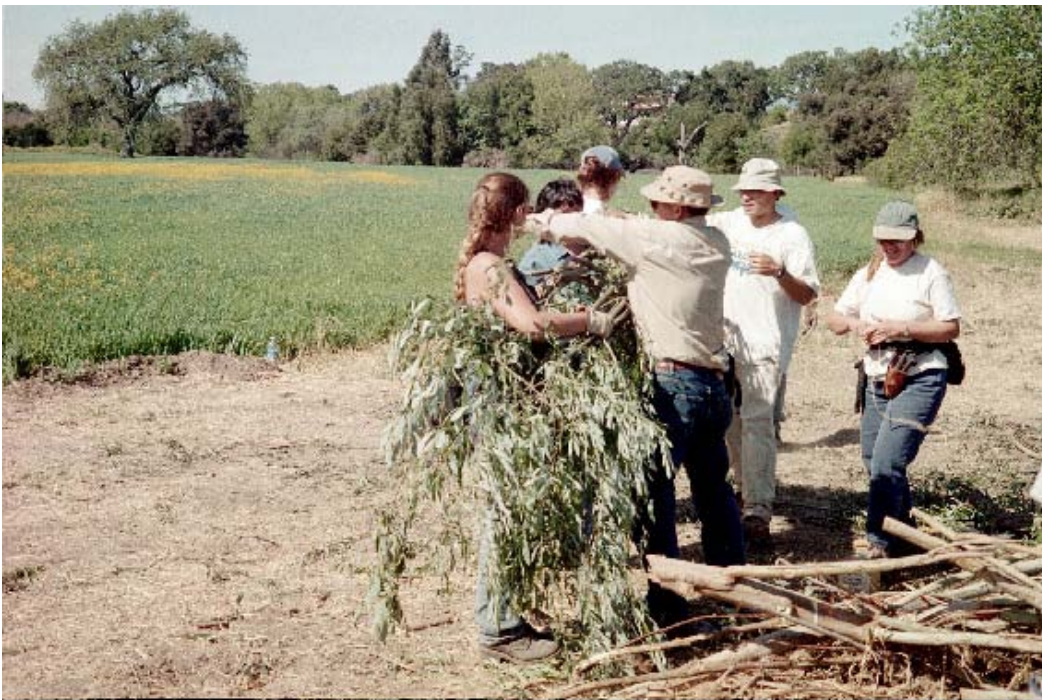
Photo 7.7  
NRCS instructs US-LT RCD and others in the construction of willow wattles and other bioengineering  
techniques of stream channel restoration

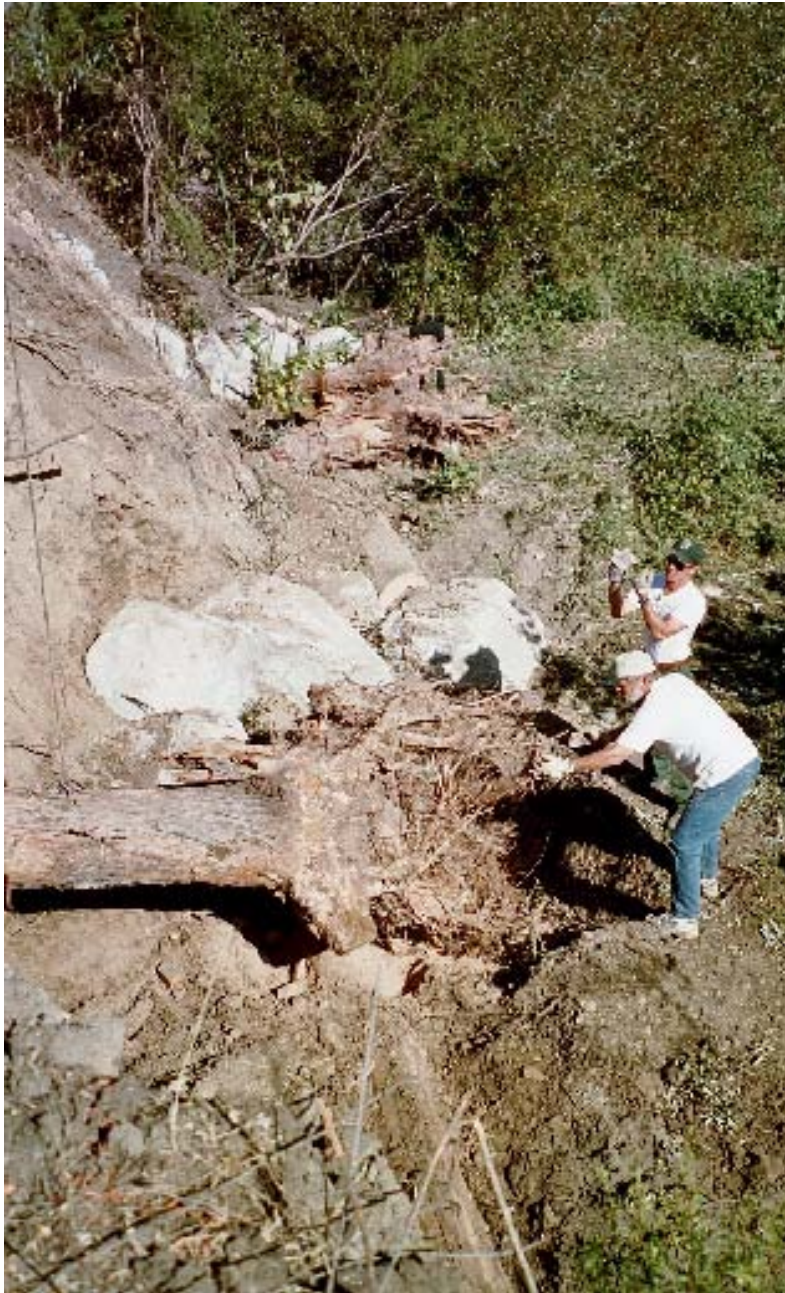
Photo 7.8  
Department of Fish and Game staff assists landowner  
in maneuvering rootwad at US-LT RCD designed channel restoration

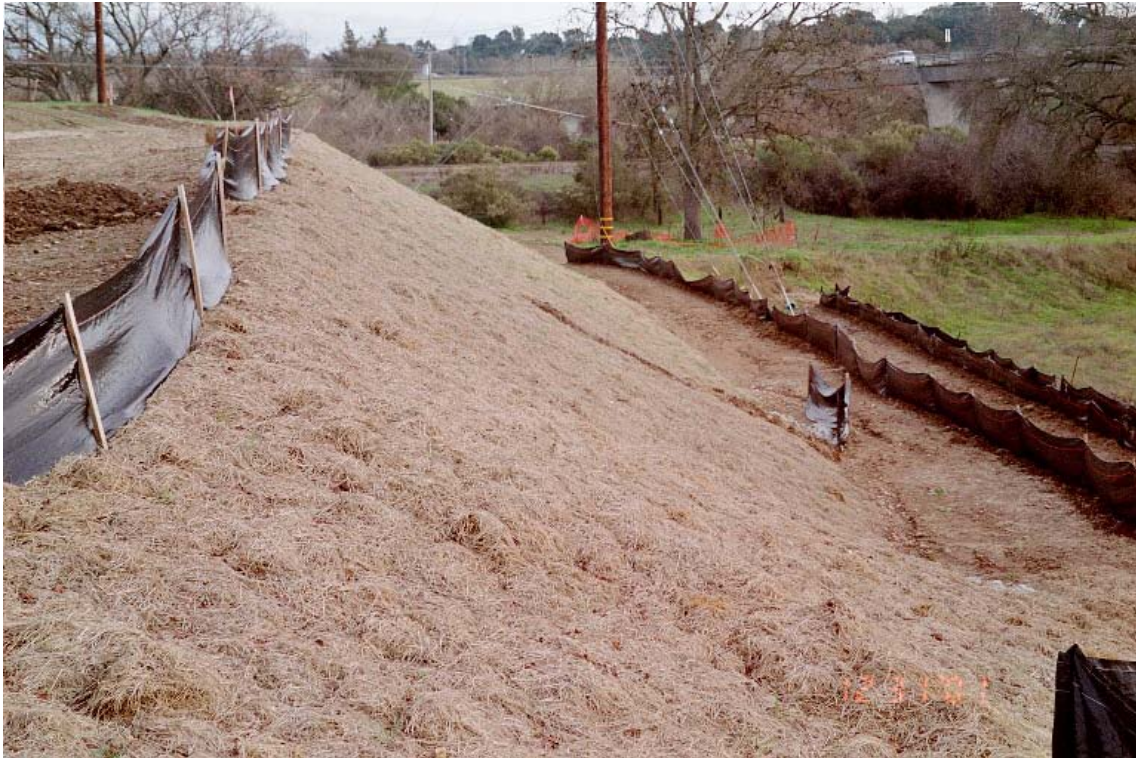
Photo 7.9  
Example of good erosion control implementation measures.

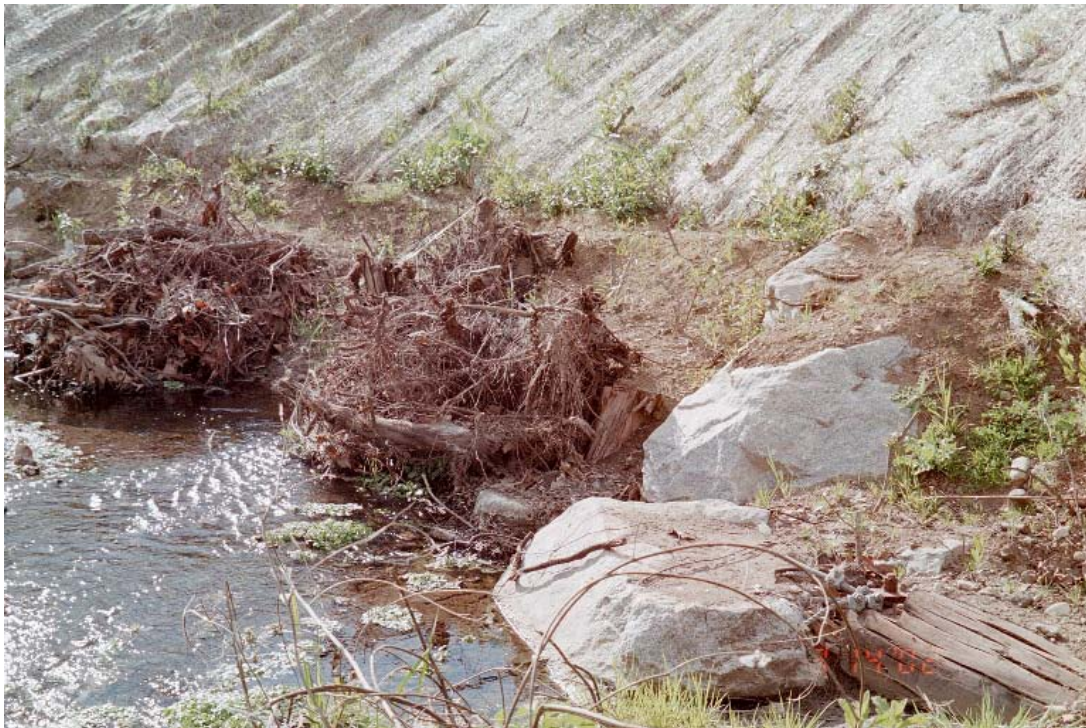
Photo 7.10  
Creek Bank Stabilization and Restoration using rootwads, boulders and logs designed by RCD.

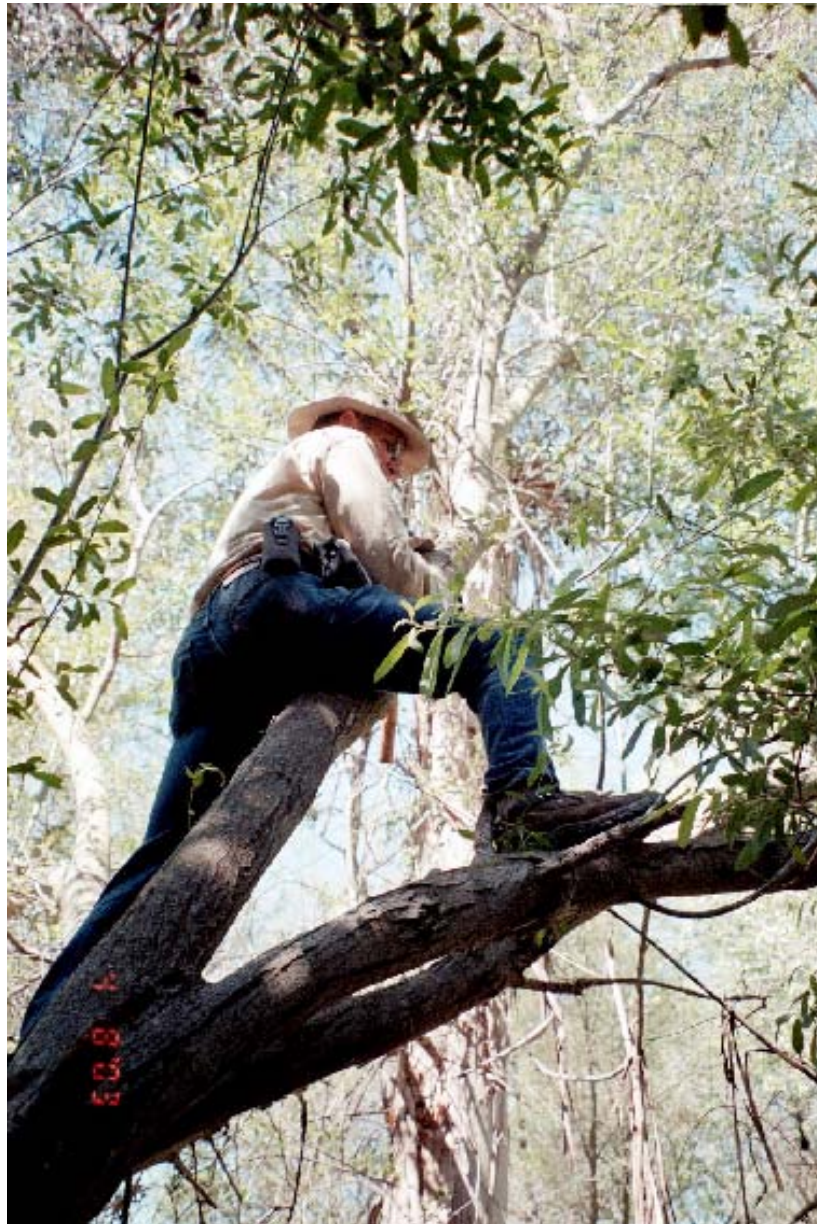
Photo 7.11  
Obtaining willow cuttings for streambank stabilization project

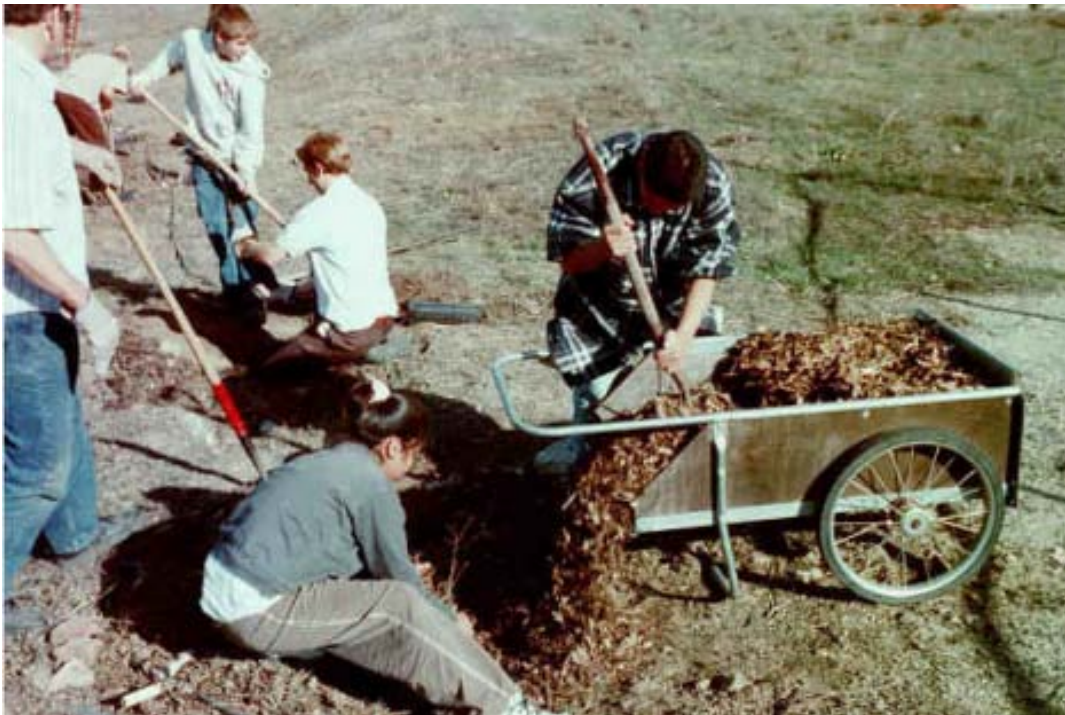
Photo 7.13

CCC and volunteers plant riparian vegetation along Atascadero Creek. This vegetation helps stabilize stream banks, provides shading to cool the water for the fish, and improves water quality.  
(Project partially funded by Atascadero Mutual Water Company)
