**MONTEREY COUNTY WATER RESOURCES AGENCY
BOARD OF DIRECTORS
RESERVOIR OPERATIONS COMMITTEE**

**MONTEREY COUNTY WATER RESOURCES AGENCY
BOARD OF DIRECTORS - RESERVOIR OPERATIONS COMMITTEE**

Nacimiento River Flow Reduction Temperature Monitoring

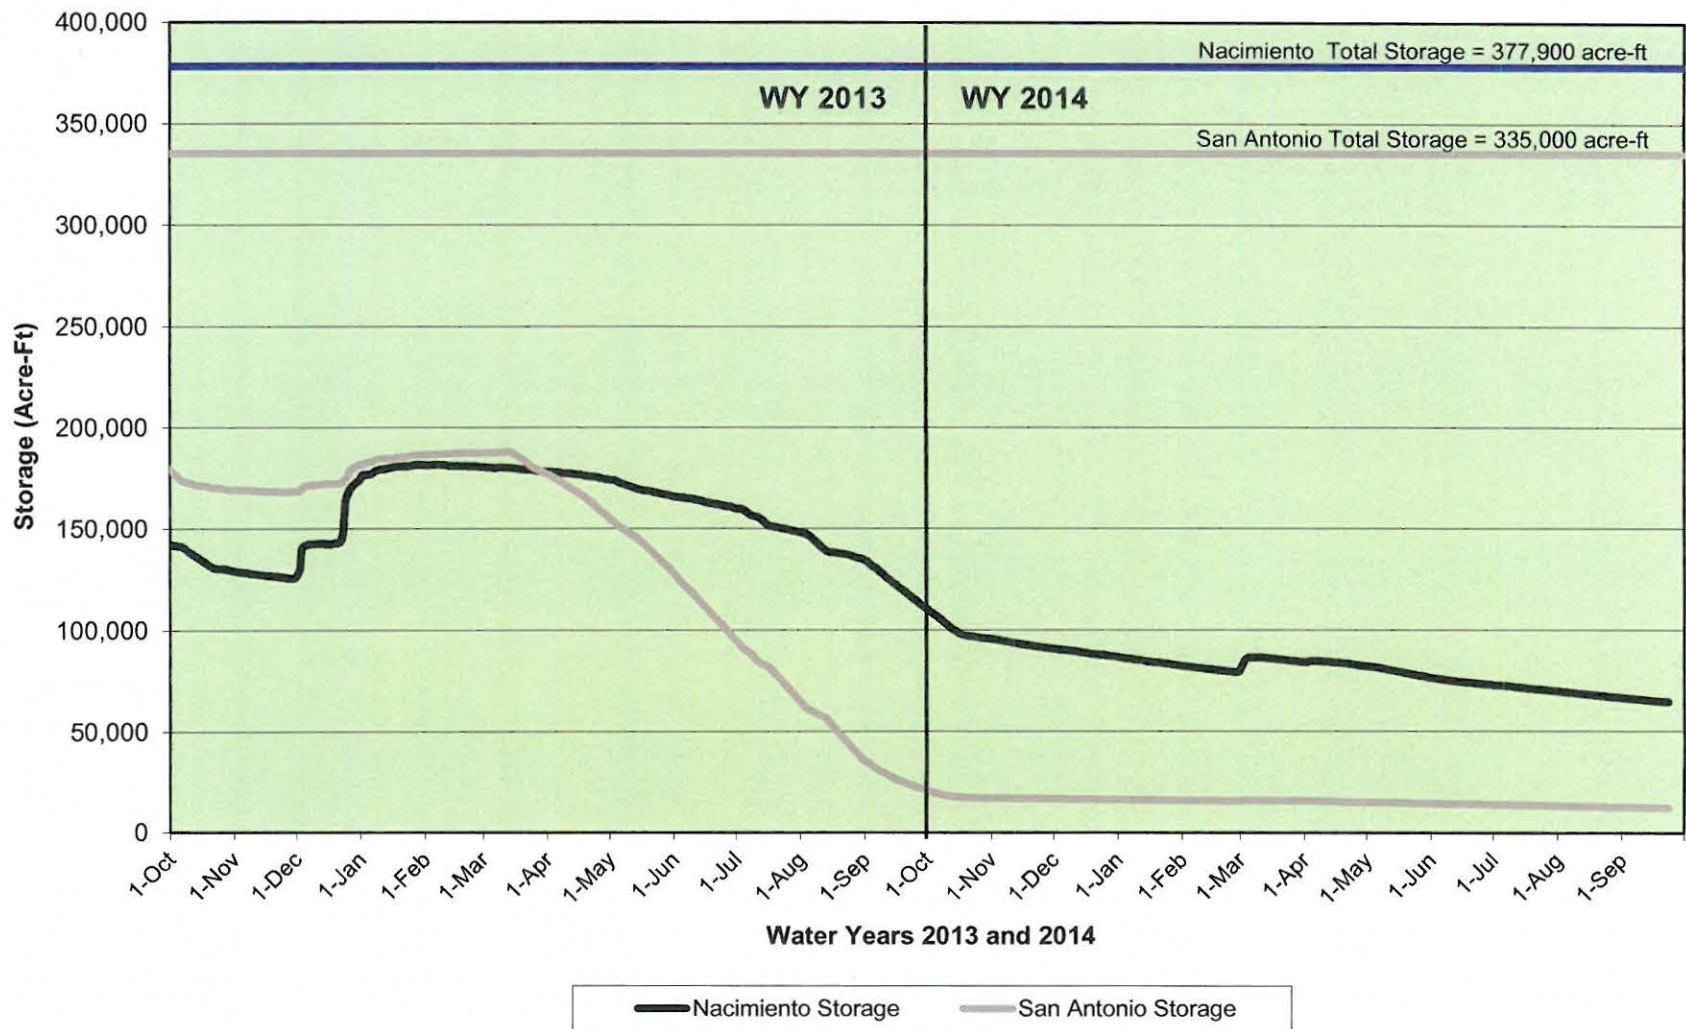
Reservoir Storage

RESERVOIR ELEVATION / STORAGE: The following reservoir conditions were recorded on September 23, 2014. San Antonio Reservoir is at an elevation of approximately 649.65 feet mean sea level (msl), 12,341 acre-feet of storage. Nacimiento Reservoir is at elevation 717.8 feet msl, 64,450 acre-feet of storage. San Antonio Reservoir is at 4% of storage capacity and Nacimiento Reservoir is at 17% of capacity.

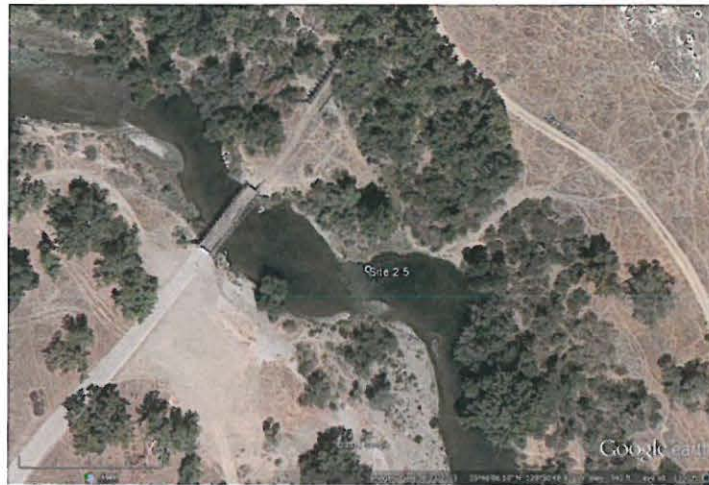
Site Description: The temperature logger is located approximately 4.46 km (2.77 miles) downstream of the Nacimiento Dam outlet. The monitoring location is located approximately 44 m downstream of the abandoned bridge that connects Perimeter Road and River Road over the Nacimiento River (Figures 1 and 2). The instrument is staked to the left bank at the first riffle downstream of the abandoned bridge. The instrument is positioned in the thalweg of a riffle approximately 2 m downstream of the crest.

Figure 1: Site 2.5 aerial image.

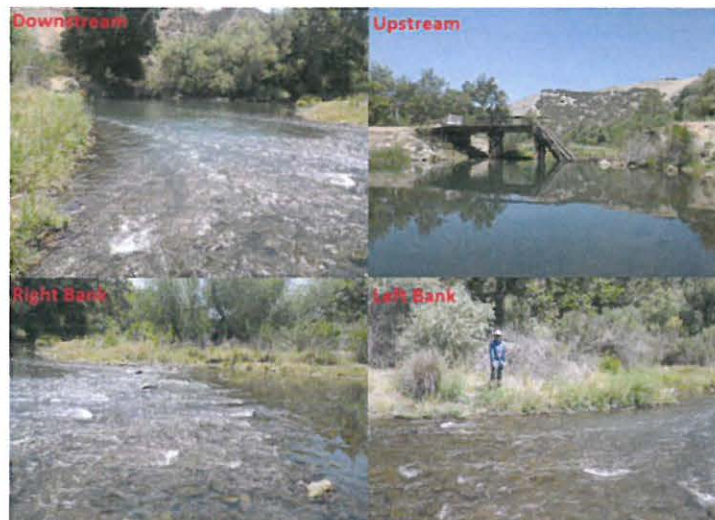
Figure 2: Site 2.5 at 28 cfs.

Habitat Description: The logger is located in a riffle descending from a large pool. The upstream pool is over 80 m in length and has depths that exceed 1.5 m. The logger is in a riffle that spans the entire width of the channel. The thalweg of the channel is located along the left bank (Figure 3). Depth is less than 20 cm for over 50 percent of the channel. At the time of deployment it was sitting on the substrate in

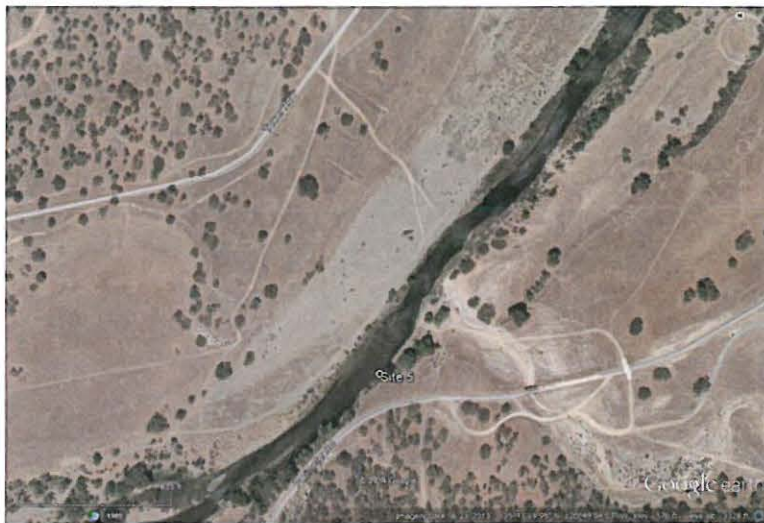
Site Description: The temperature logger is located approximately 8.24 km (5.1 miles) downstream of the Nacimiento Dam outlet. The monitoring location is located in an expansive reach best classified as a glide, as it lacks depth to meet pool status (Figure 6 and 7). The instrument is staked to the right bank 10 m downstream of a power-line crossing. The cable extends towards the water between two scrub willows with branches that extend into the water. A cluster of three sycamore trees (20 cm DBH) are a good indicator of relative location if power-lines are ever removed. The cabling point is upstream of the three tree cluster. The instrument is positioned in the thalweg of the channel within 2 m of the bank.

Figure 6: Site 5 aerial image.

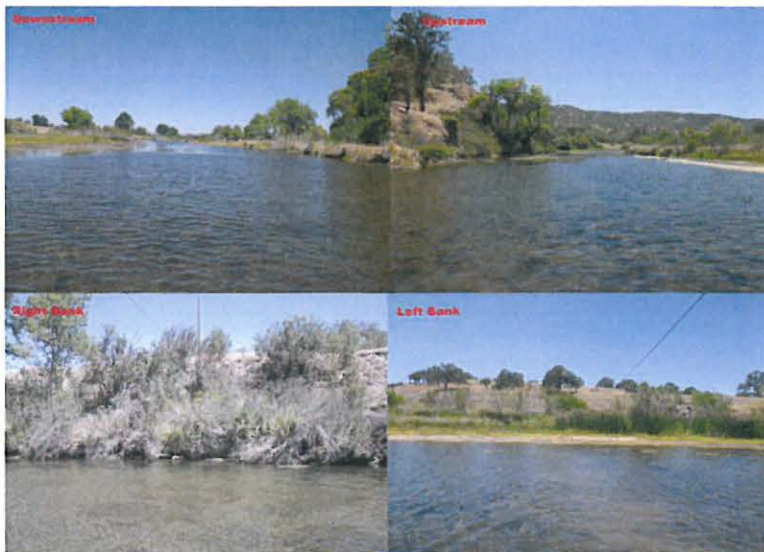
Figure 7: Site 5 at 28 cfs.

Habitat Description: The logger is located in a habitat best classified as a glide. The habitat up and downstream is uniform, wide, with a right bank dominated thalweg. Areas along the left bank are shallow and have limited canopy cover, and the maximum depth along the right bank (thalweg) is approximately 45 cm (Figure 8). The canopy cover above the logger is sparse, and majority of the channel upstream of the site is exposed to direct sunlight. The reach has a high potential for thermal increase. The habitat is not beneficial to *O. mykiss* (figure 9) as it lacks complexities and has a substrate made primarily of sand with a secondary of silt and mud.

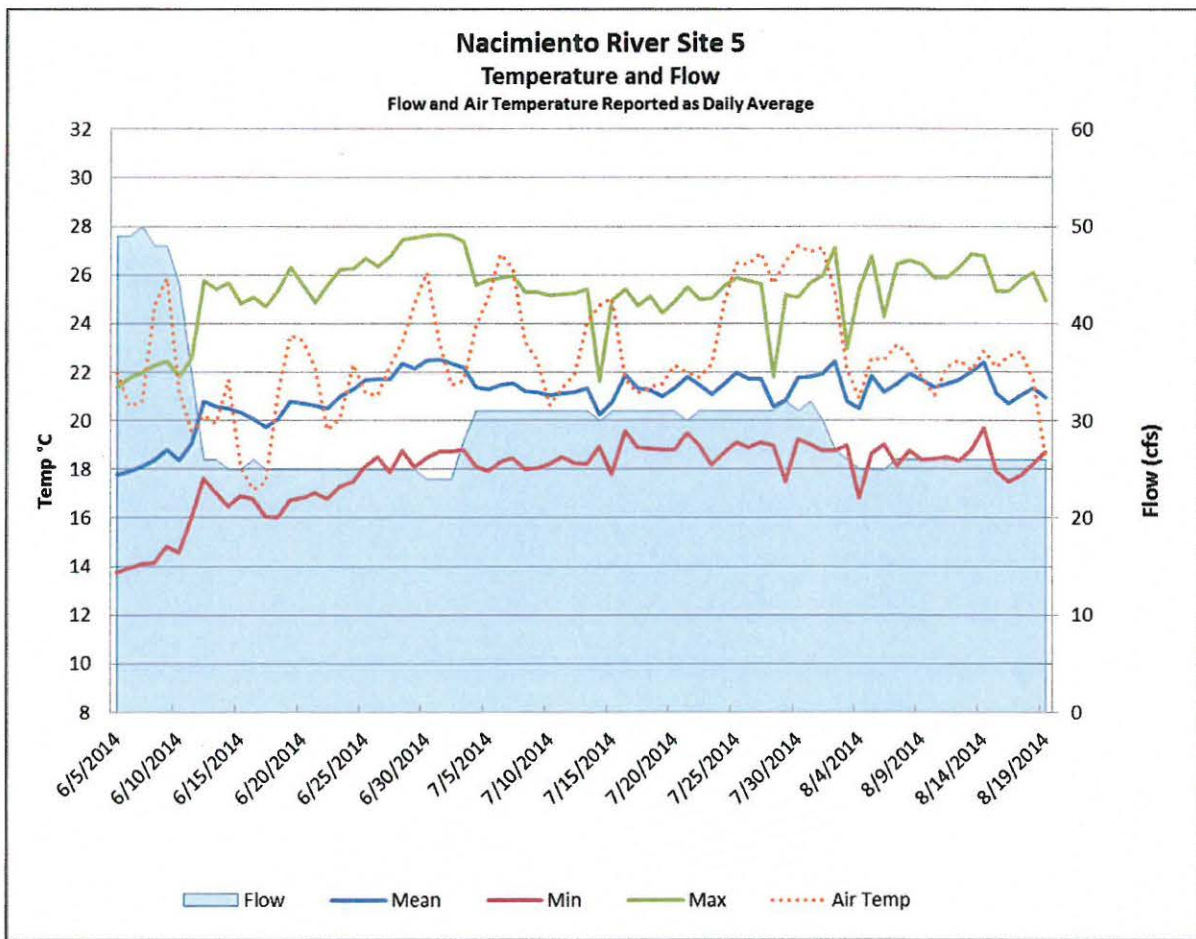
Temperature Data: The water temperature provided below is based on daily mean, minimum, and maximum degrees Celsius, generated from hourly temperature recording from a Hobo U-22 data logger. Flow is provided in daily average cubic feet per second (cfs) generated from quarter hour preliminary data collected at the USGS 11149400 Nacimiento River below Nacimiento dam near Bradley, CA stream flow gage. Temperature is provided in daily average from the MCWRA weather station located near Nacimiento Dam approximately 6.36 km west of Site 5. The averages were generated from hourly data in Celsius.

The Hobo U-22 temperature logger deployed to satisfy the Biological Opinion was downloaded. Data was collected continuously with downloads occurring on June 17 and 24, July 9 and 25, and August 20. The data represented in Figure 10 includes June 5, 2014 to August 20, 2014. The USGS adjusted preliminary (as of August 27, 2014) flow data based upon field measurements, therefore, they will not match data that was provided in the June and July monitoring reports. The correction does not significantly alter the hydrograph.

Figure 10: Daily temperature data collected at site 5.

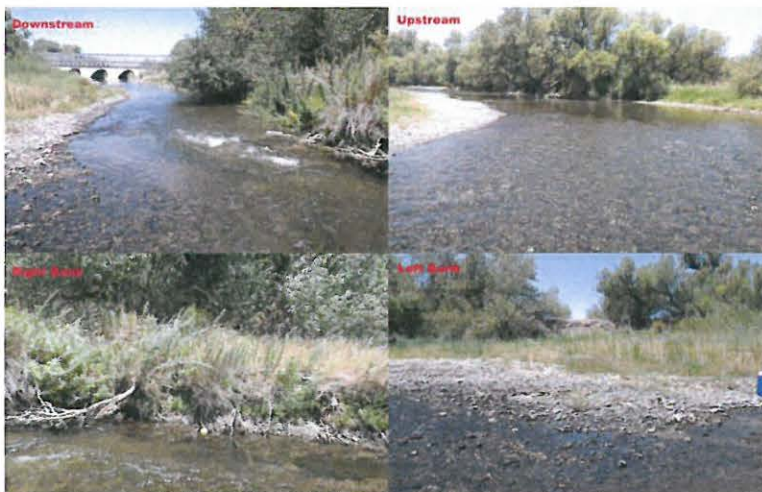
Figure 12: Site 7.5 at 28 cfs.

Habitat Description: The logger is located in a riffle habitat. It is an area of high surface turbulence downstream of the shallow riffle crest. The riffle is located on a slight meander with a right bank dominated thalweg. The maximum depth is approximately 40 cm (Figure 13). The habitat upstream consists of a shallow riffle flowing from a pool habitat. The pool has limited velocity, but has more overhanging vegetation than other reaches. Downstream, the riffle flows into a run that passes through three large culverts under the Bee Rock Road Bridge. At the logger site, overhanging vegetation is sparse, but submerged roots and artificial structures in the form of concrete scraps create potential beneficial habitat for *O. mykiss* (figure 14).

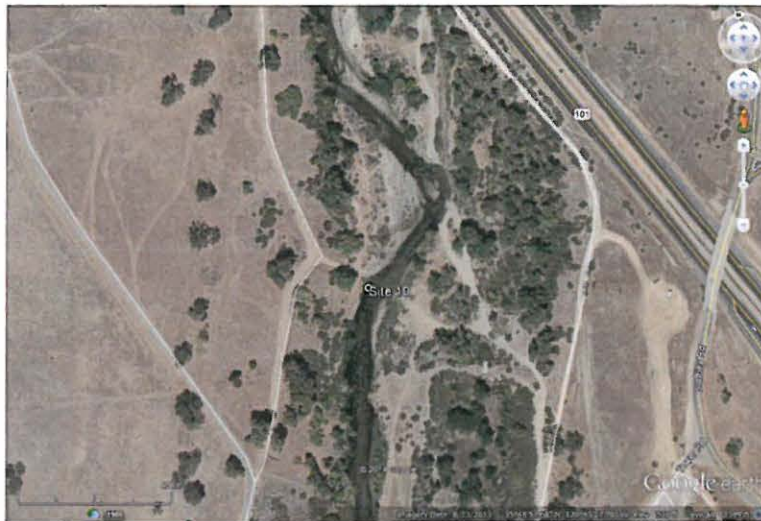
Site Description: The temperature logger is located approximately 18.0 km (11.18 miles) downstream of the Nacimiento Dam outlet. The monitoring station is located in a habitat best classified as a glide/run transition habitat. The logger is deployed on the left bank 5 m upstream of a river fording point crossing. A dirt road leads to the water edge and continues across the river at the site, approximately 300 m downstream of the abandoned Tower Road Bridge Crossing (figure 16 and 17). The logger is cabled to a vegetated berm. The cabling point is in line with a large oak tree on the left bank.

Figure 16: Site 10 aerial image.

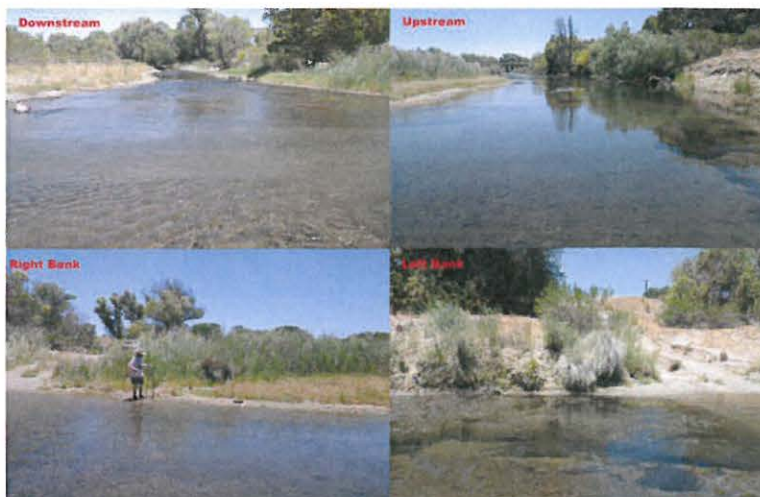
Figure 17: Site 10 at 28 cfs.

Habitat Description: The logger is located in a glide/run transition as it flows from a uniform low velocity habitat upstream. The logger is positioned in the left bank dominated thalweg, amongst rooted aquatic vegetation. The maximum depth of the channel is approximately 50 cm (Figure 18). The habitat upstream consists of open glides, and habitats that could potentially be classified as pool. The low gradient and lack of channel complexities makes habitat typing difficult. The area upstream has limited canopy cover and has slow velocity. The area downstream gets more complex with runs and riffles and the presence of habitat complexities. At the logger site, overhanging vegetation is absent and lacks habitat complexities (figure 19).

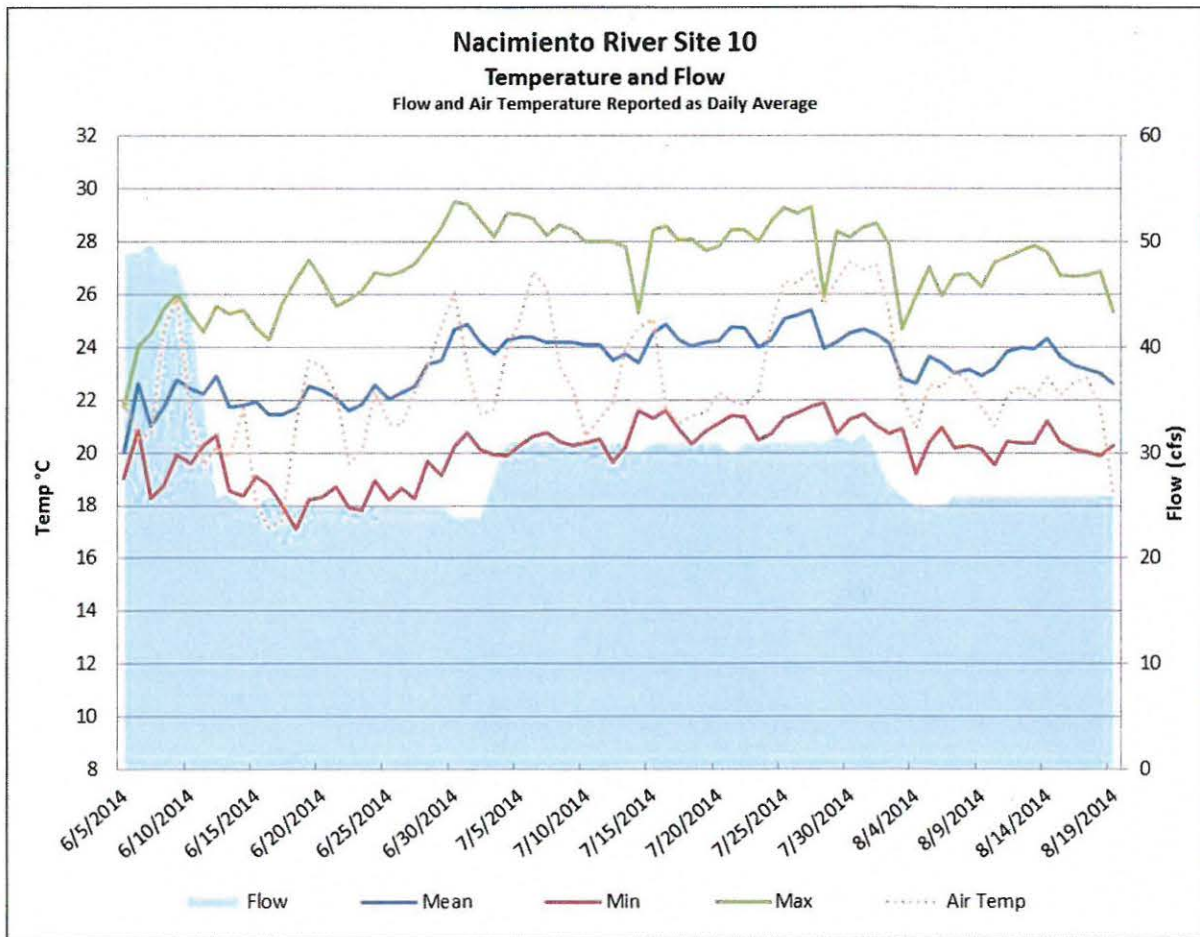
Temperature Data: The water temperature provided below is based on daily mean, minimum, and maximum degrees Celsius, generated from hourly temperature recording from a Hobo U-22 data logger. Flow is provided in daily average cubic feet per second (cfs) generated from quarter hour preliminary data collected at the USGS 11149400 Nacimiento River below Nacimiento dam near Bradley, CA stream flow gage. Temperature is provided in daily average from the MCWRA weather station located near Nacimiento Dam approximately 13.1 km southwest of Site 10. The averages were generated from hourly data in Celsius.

The Hobo U-22 temperature logger deployed to satisfy the Biological Opinion collected continuously with downloads occurring on June 17 and 24, July 8 and 25 and August 20. The data represented in Figure 20 includes June 5, 2014 to August 20, 2014. The USGS adjusted preliminary (as of August 27, 2014) flow data based upon field measurements, therefore, they will not match data that was provided in the June and July monitoring reports. The correction does not significantly alter the hydrograph.

Figure 20: Daily temperature data collected at Site 10.

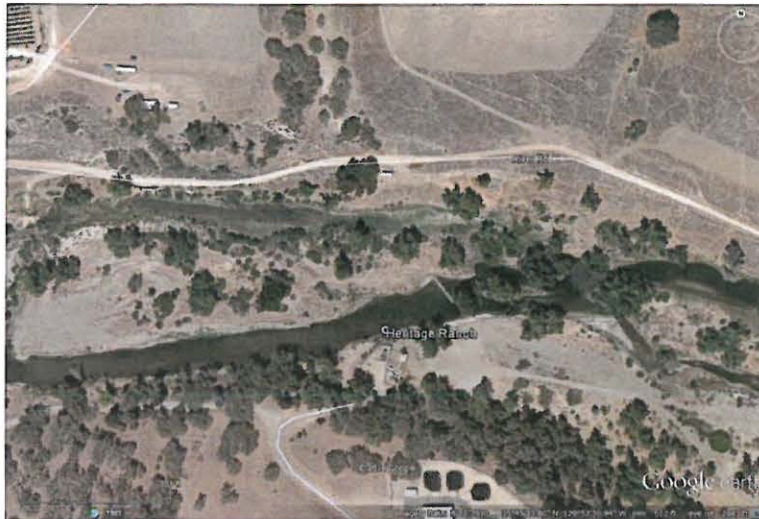
Figure 26: Heritage Ranch Site aerial image

Instantaneous temperature data is collected once daily at the Heritage Ranch intake structure. This data is collected by Heritage Ranch Staff and is not regulated or evaluated by MCWRA staff. The temperature is of the water drawn from the Nacimiento River approximately 0.64 km (0.42 miles) downstream of the outlet (Figure 26). Temperature readings are collected at variable times daily. All data provided to MCWRA is presented in the table below (Figure 27).

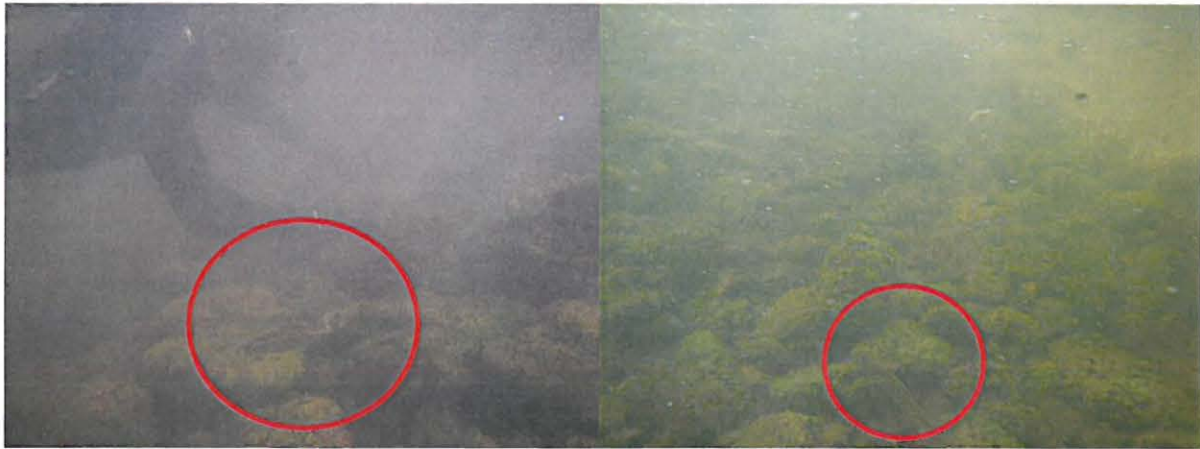
A total of 25 *O. mykiss* were observed during the survey. This exceeded the July survey effort substantially. Twenty-four of the *O. mykiss* were observed between 2.92 and 4.52 km downstream of the dam. All *O. mykiss* were positively identified (Figure 2 and 3). The water temperature ranged between 18.4°C and 21.1°C with dissolved oxygen levels between 9.88 mg/L and 10.31 mg/L. Twenty-two of the *O. mykiss* were estimated at 50-100 mm, and two were 100-150 mm. *O. mykiss* were observed at three sites that they were not observed at in the July sampling effort.

Figure 3: *O. mykiss* observed 4.52 km downstream of the dam.

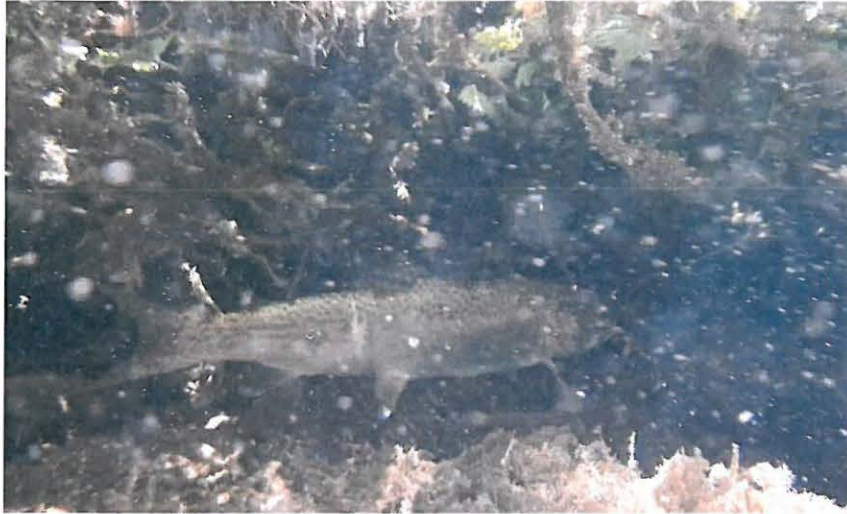
One other *O. mykiss* was observed 12.5 km downstream of the dam (Figure 4). This was in the same location that four fish were observed during the July survey. The fish's length estimate was categorized as greater than 150 mm, but the actual length estimate was 300 mm. The location and length estimate are consistent with the adult that was observed in July, providing evidence that this was the same fish persisting in the area. At the time of observation the water temperature was 27.01°C and dissolved oxygen was 11.45 mg/l. The fish did not show signs of stress (gassing or lethargy), and it was observed suspended in an undercut bank. The fish showed a strong flight response when approached.

Figure 4: *O. mykiss* adult observed 12.5 km downstream of the dam.
