Kennedy/Jenks Consultants
 September Ranch
 Carmel Valley, California
Site Setting and Site Vicinity Map

Kennedy/Jenks Consultants
September Ranch
Carmel Valley, California
Site Hydrogeology

September Ranch
 Carmel Valley, California

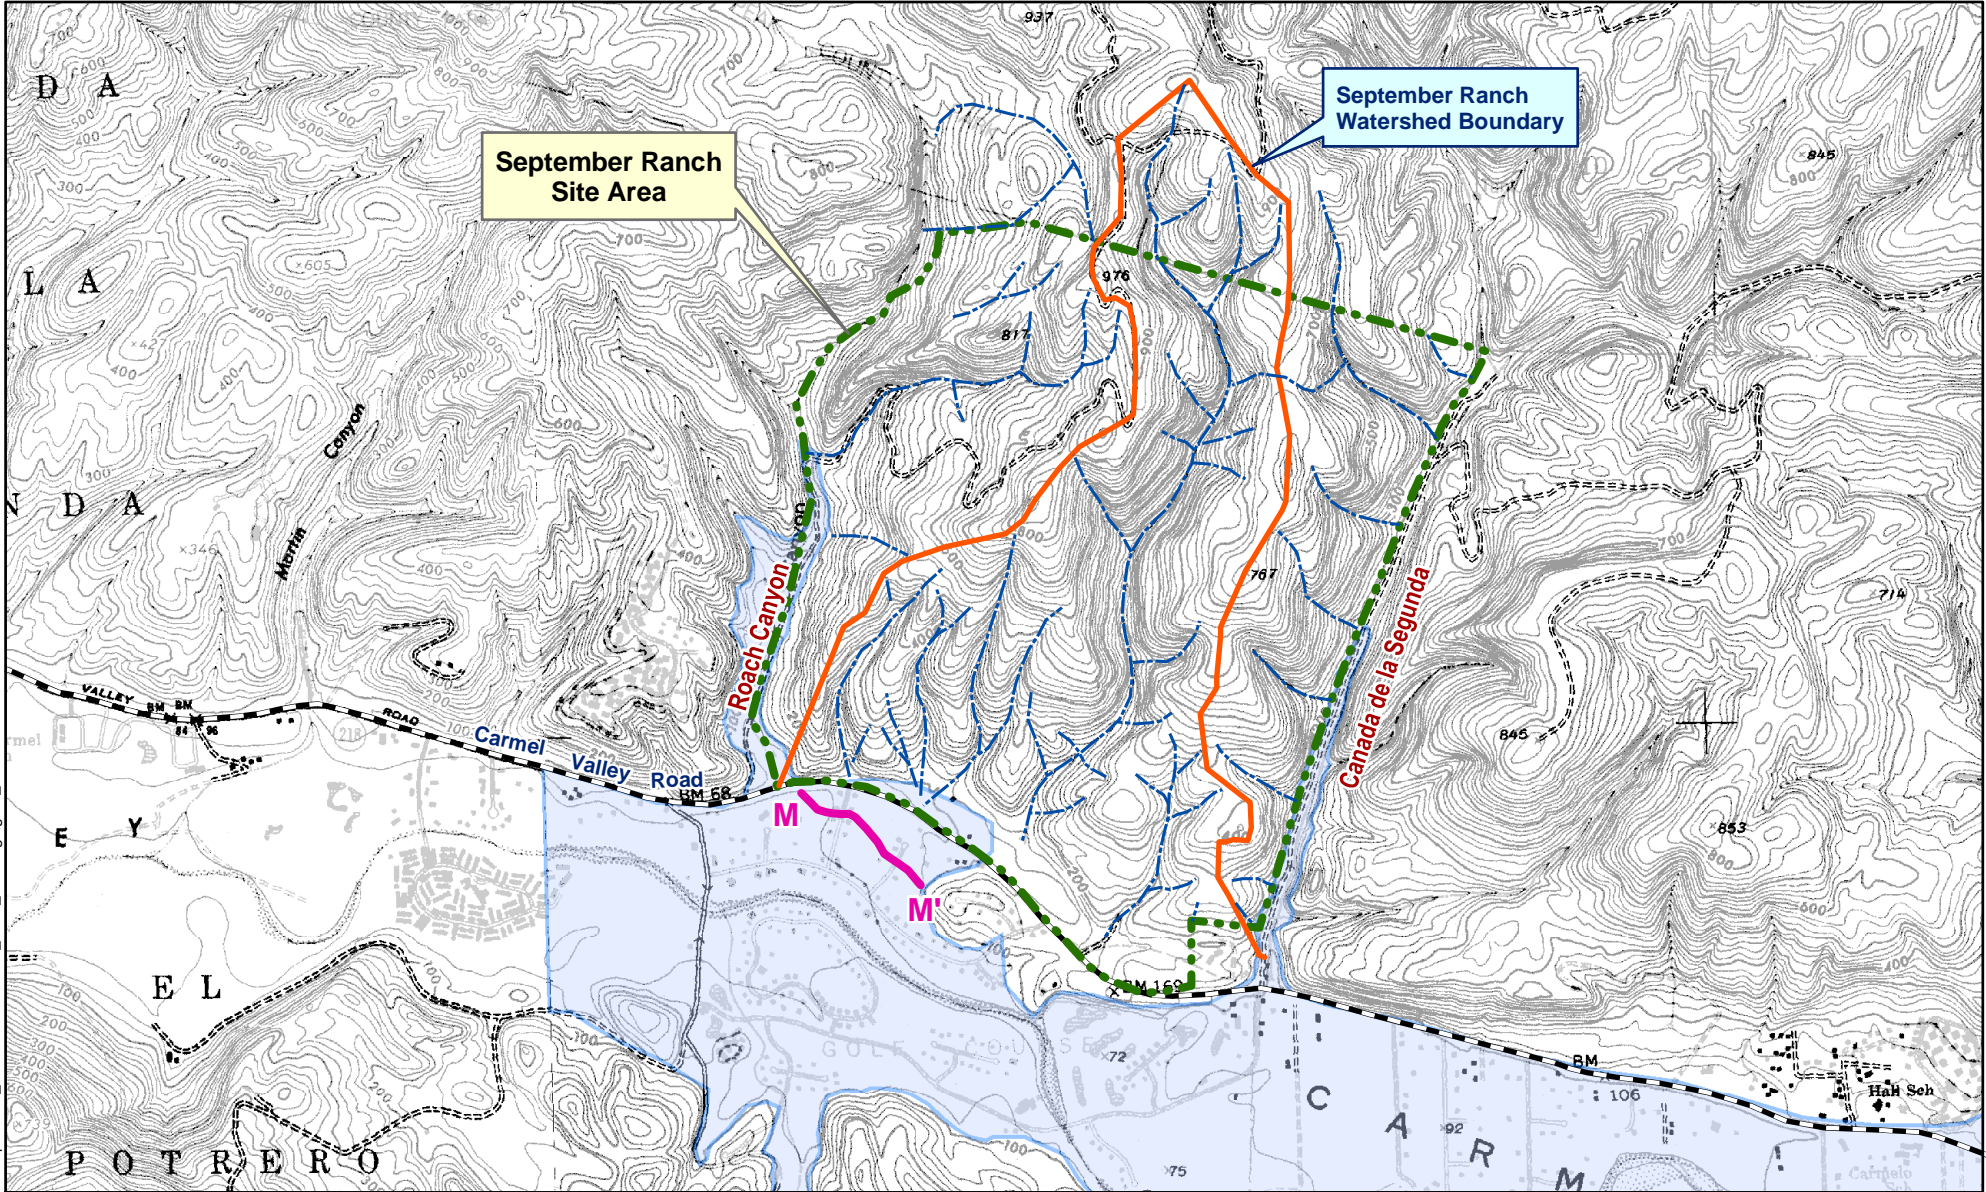
034813.03
 March 2004
Figure 1

- Explanation**
- September Ranch drainage system
 - Cross-section trace M-M'
 - Carmel Valley Aquifer Subunit 3

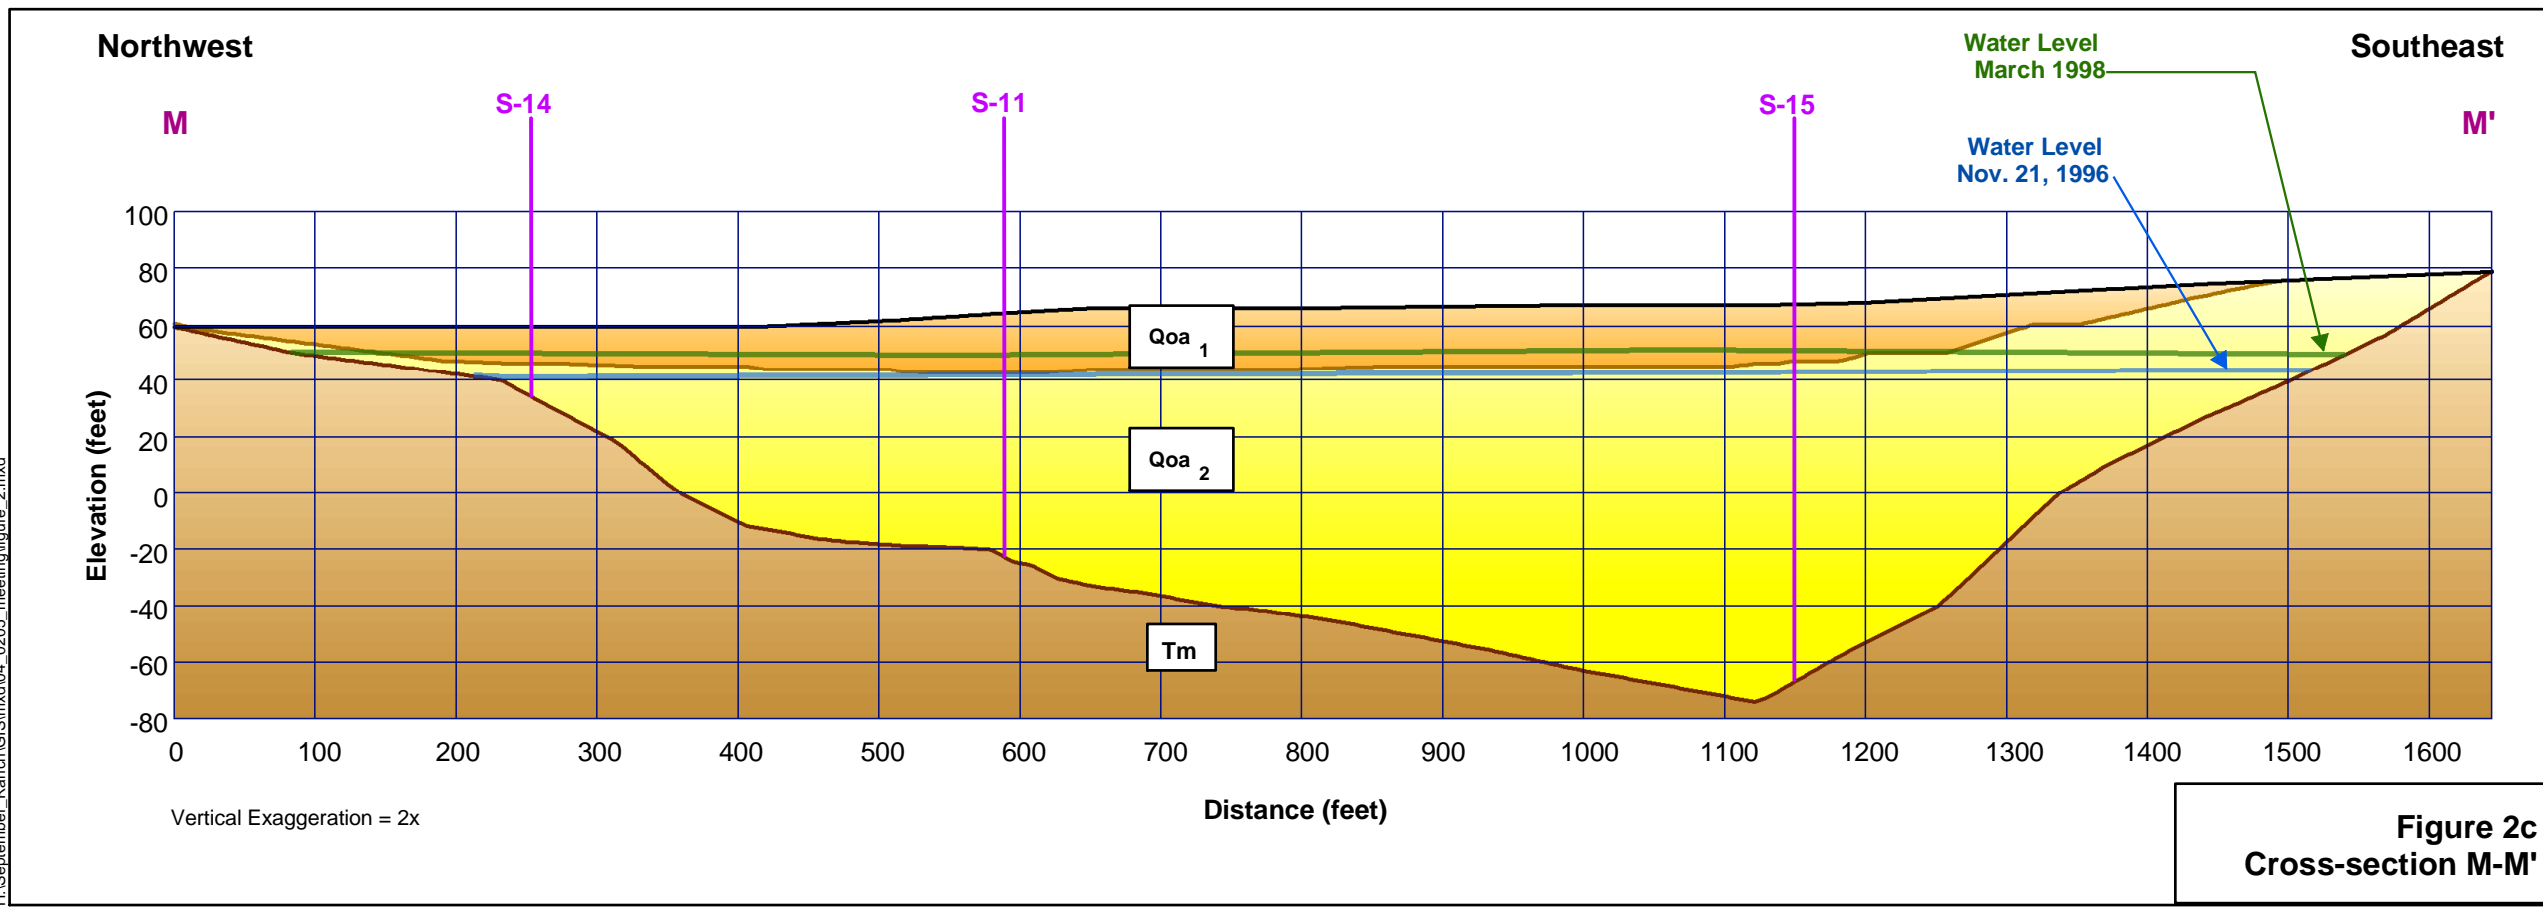
Figure 2c
Cross-section M-M'

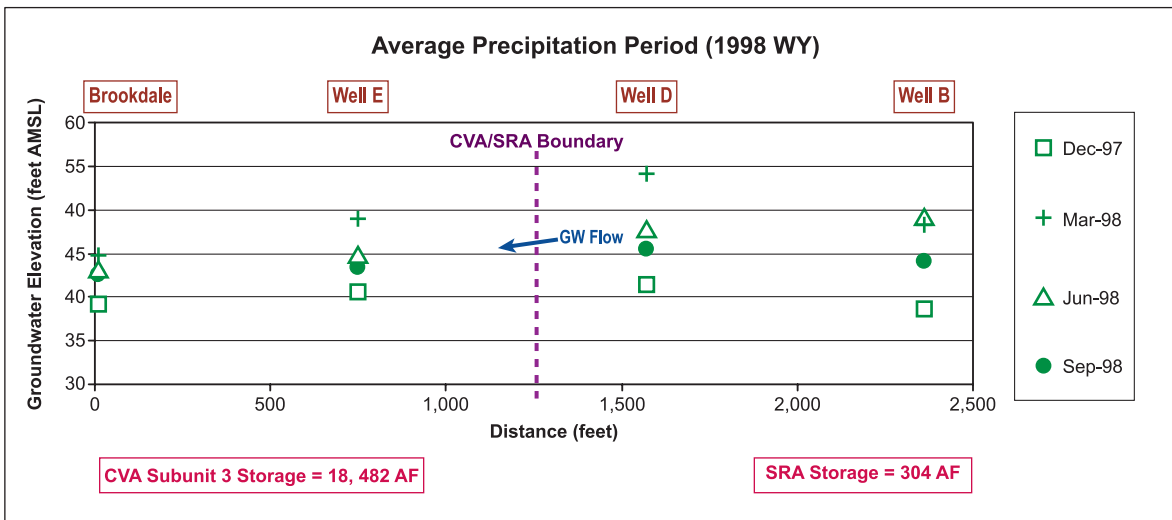
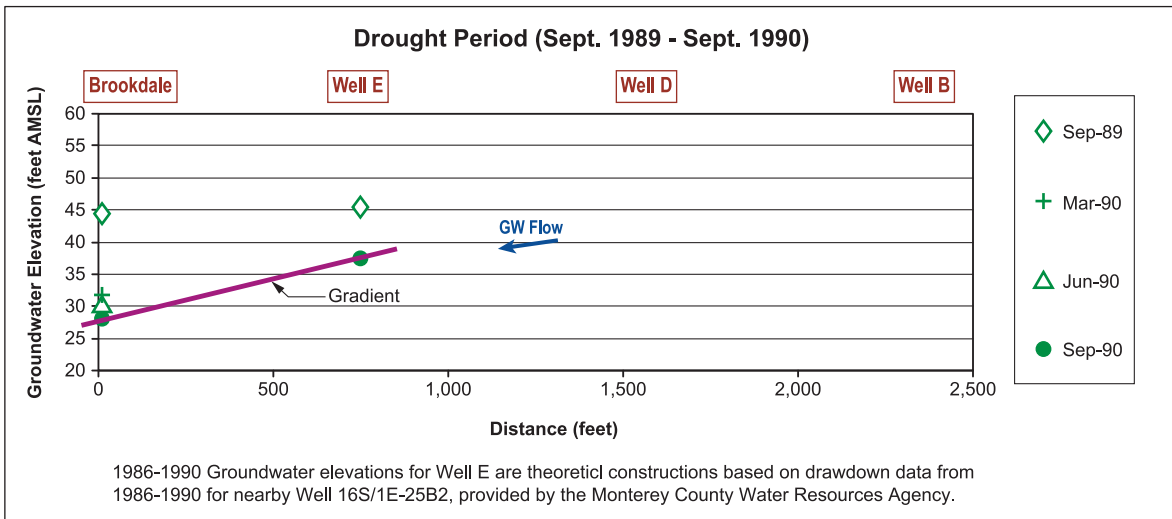
Figure 6

- Explanation
- CVA** Carmel Valley Aquifer
 - SRA** September Ranch Aquifer
 - GW** Groundwater

Groundwater Gradients Across Cross-section M-M'

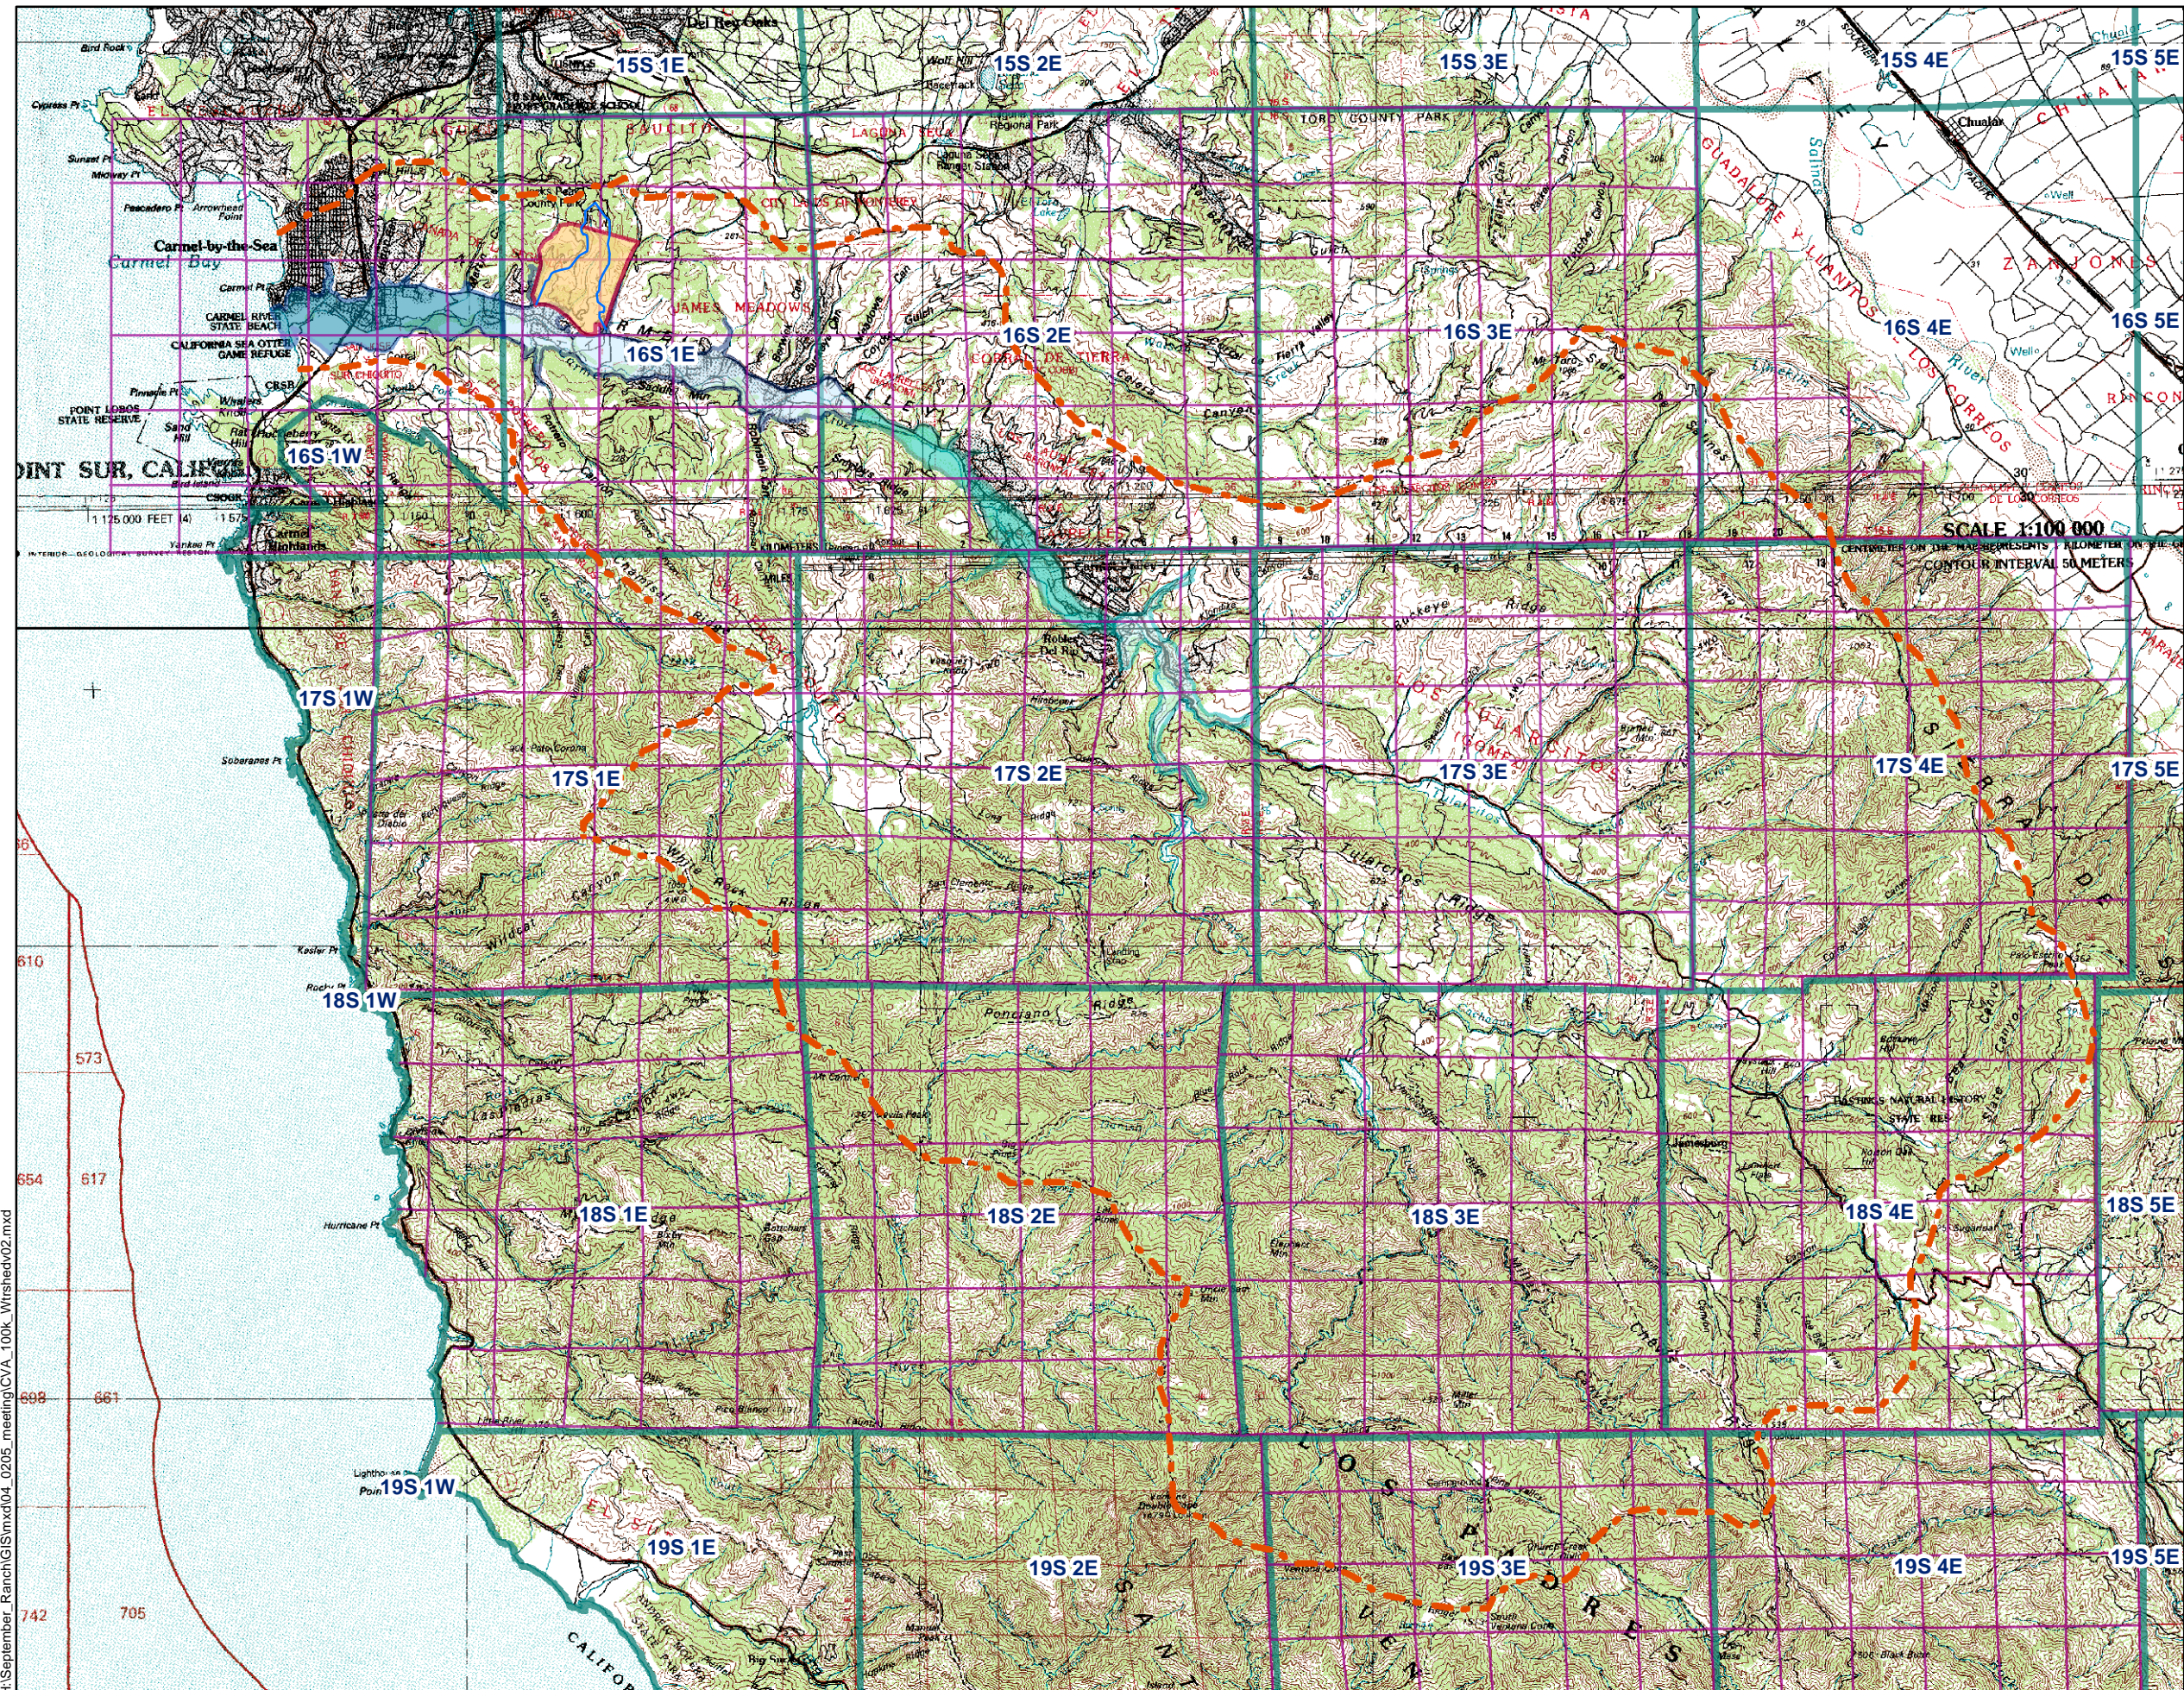
Figure 7

- September Ranch Site Area
- September Ranch Watershed Boundary
- Carmel River Watershed Boundary
- Carmel Valley Groundwater Basin Subunit 1
- Carmel Valley Groundwater Basin Subunit 2
- Carmel Valley Groundwater Basin Subunit 3
- Carmel Valley Groundwater Basin Subunit 4
- Township/Range Boundary
- Section Boundary

Carmel River Watershed
