**ENVIRONMENTAL  
CONSULTING LLC**

Subject: Mold Inspection of the Single Family Home Located at 1170 Signal Hill Road in Pebble Beach, California  
M<sup>3</sup> Project Number: 13444.0 Task 1

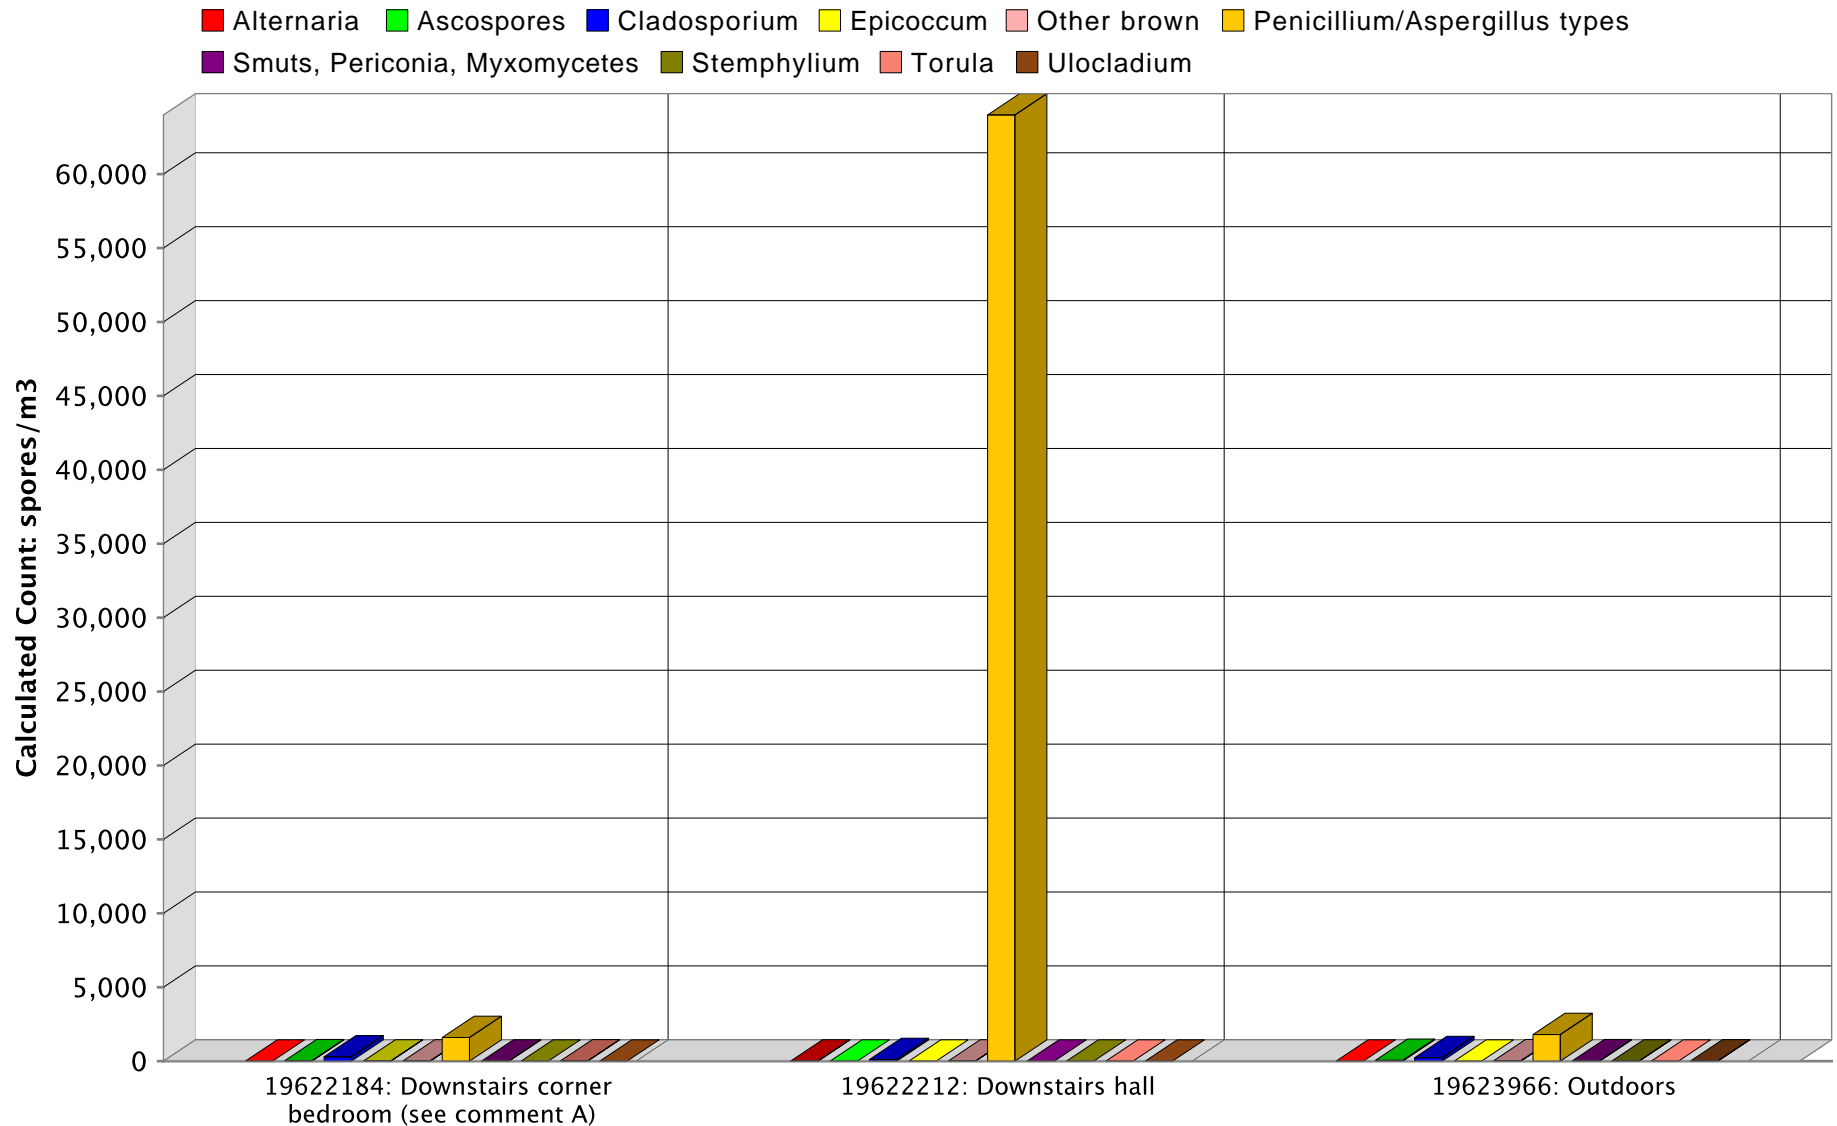
**SPORE TRAP REPORT: NON-VIABLE METHODOLOGY**

Location:	19622184: Downstairs corner bedroom		19622212: Downstairs hall		19623966: Outdoors	
Comments (see below)	A		None		None	
Lab ID-Version‡:	5003402-1		5003403-1		5003404-1	
Analysis Date:	09/09/2013		09/09/2013		09/09/2013	
	raw ct.	spores/m3	raw ct.	spores/m3	raw ct.	spores/m3
Alternaria			1	7		
Ascospores	1	27			2	53
Basidiospores						
Chaetomium						
Cladosporium	11	290	2	110	9	240
Curvularia						
Epicoccum	1	7				
Fusarium						
Myrothecium						
Nigrospora						
Other brown	1	7	1	7	4	27
Other colorless						
Penicillium/Aspergillus types†	79	1,600	1,146	64,000	69	1,800
Pithomyces						
Rusts						
Smuts, Periconia, Myxomycetes	1	7			4	27
Stachybotrys						
Stemphylium					1	7
Torula	2	13				
Ulocladium					2	13
Background debris (1-4+)††	2+		4+		2+	
Hyphal fragments/m3	13		20		20	
Pollen/m3	< 7		< 7		< 7	
Skin cells (1-4+)	1+		2+		< 1+	
Sample volume (liters)	150		150		150	
<b>§ TOTAL SPORES/m3</b>		<b>1,900</b>		<b>64,000</b>		<b>2,200</b>

**Comments:** A) 27 of the raw count *Penicillium/Aspergillus* type spores were present as a single clump.

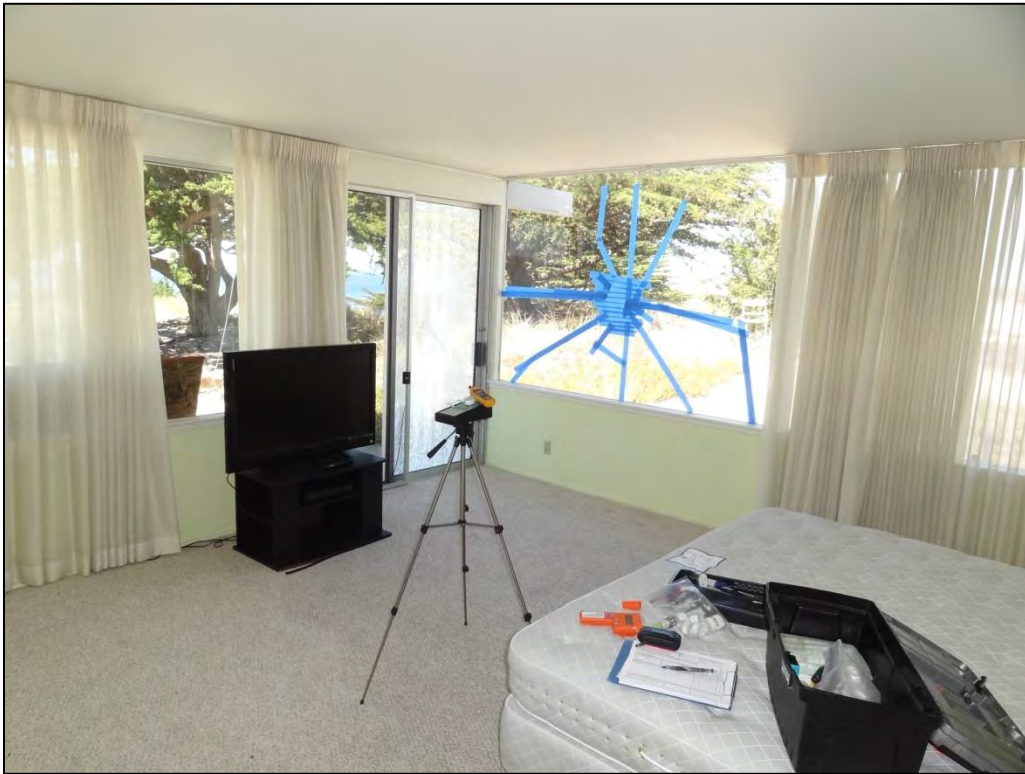
Sample	Location	Spores/m <sup>3</sup>	Predominant Spore Types
19622184	Downstairs master bedroom	1,900	<i>Aspergillus/Penicillium</i> – 82% <i>Cladosporium</i> – 15%
19622212	Downstairs Hallway	64,000	<i>Aspergillus/Penicillium</i> – 100%
19623966	Outdoors (ambient)	2,200	<i>Aspergillus/ Penicillium</i> – 83% <i>Cladosporium</i> – 11%

**Air sampling in the downstairs master bedroom**

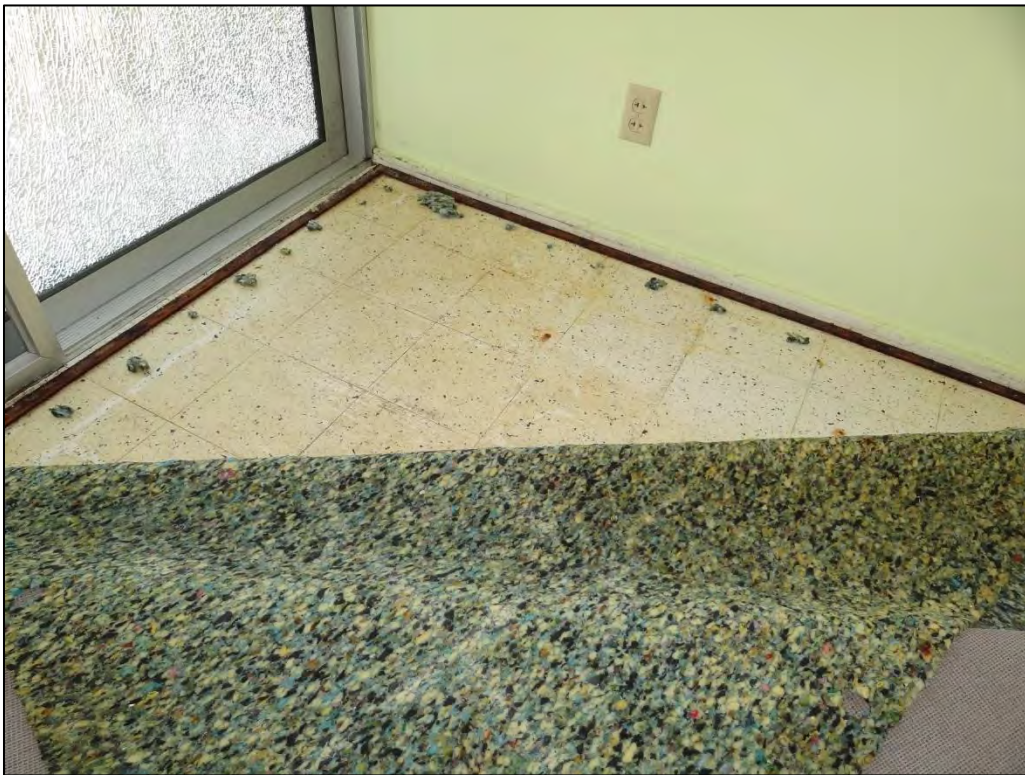
**Floor tile under carpet in master bedroom**

- The carpet should be removed from the master bedroom.
- The vinyl floor tile should be removed from the master bedroom.
- The suspect mold growth on the building exterior should be cleaned with a soap and water solution.

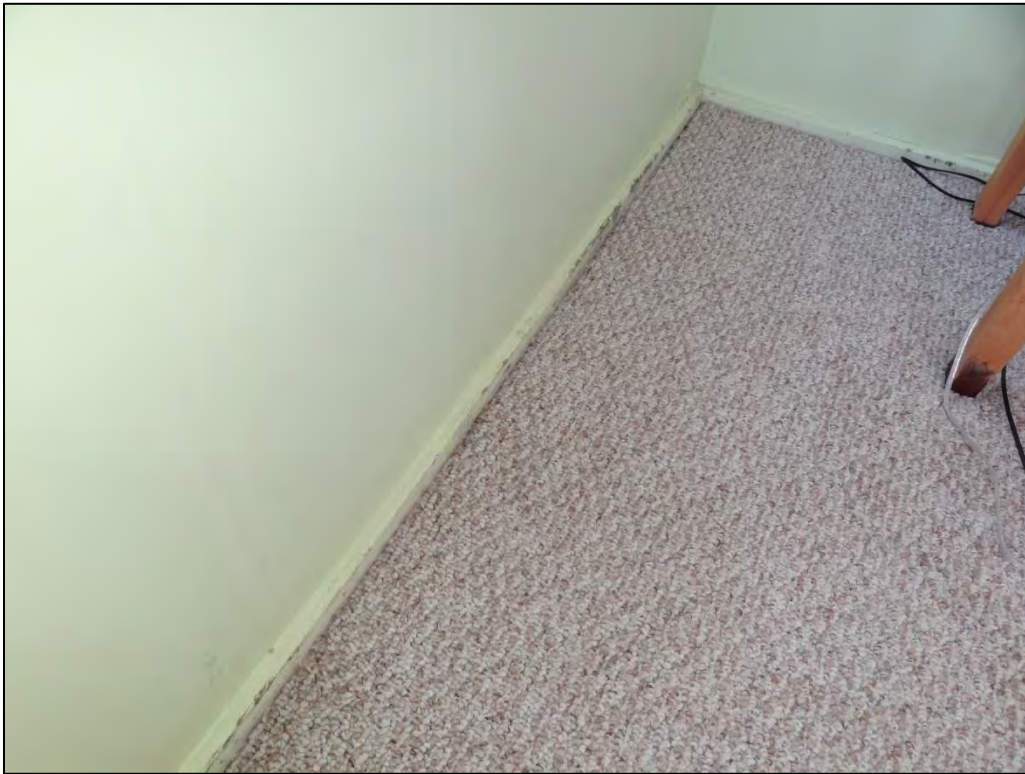
Sample	Location	Spore types and density
S-1	Master bedroom - baseboard	<i>Cladosporium</i> – 4+ <i>Penicillium</i> – 2+

**Mold growth on baseboard in master bedroom**

- The deck, sliding door and window should be repaired.
- The wallboard walls and ceiling in the master bedroom should be removed and the cavities inspected for water damage and mold growth. Any damage or growth should be removed.

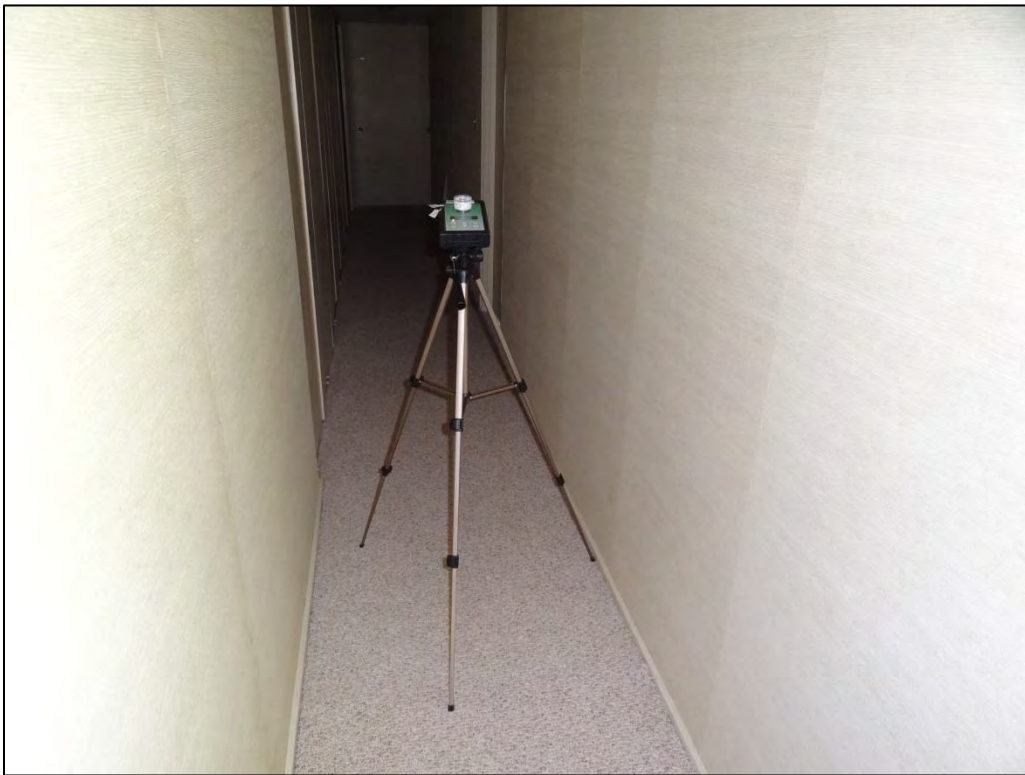
**Air sampling in lower hallway**

- HEPA-filtered air scrubbers should be run inside the lower level of the home to lower the ambient spore concentration.
- The heating duct system should be cleaned.

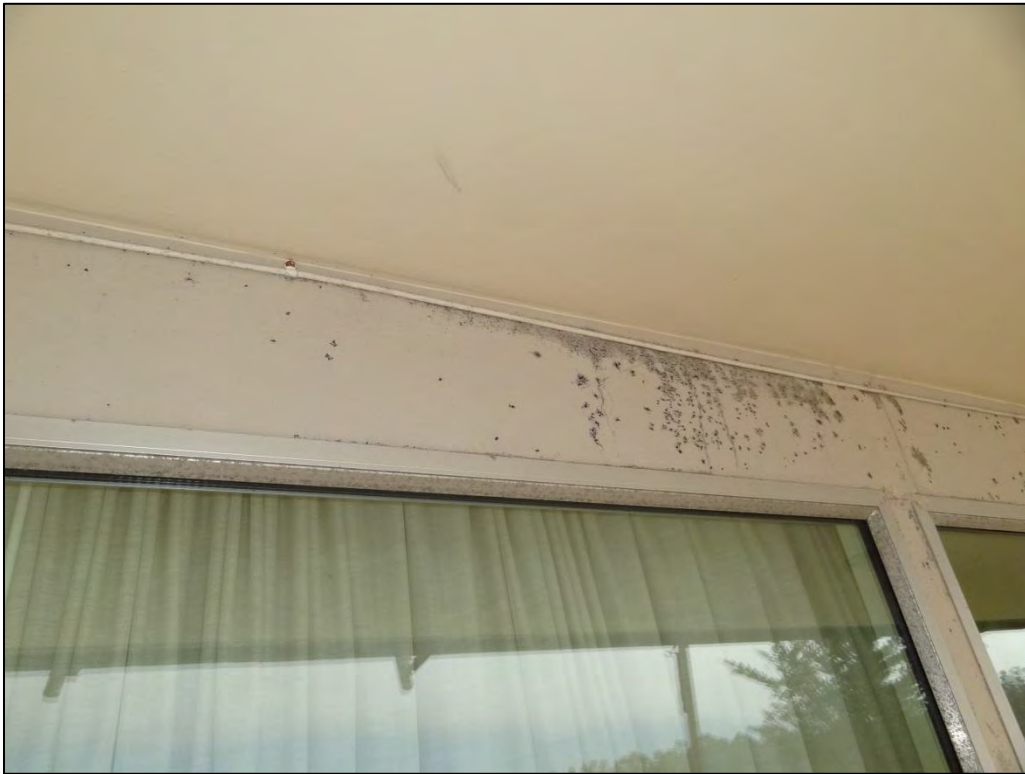
**Suspect mold growth on outside of bedroom wall**

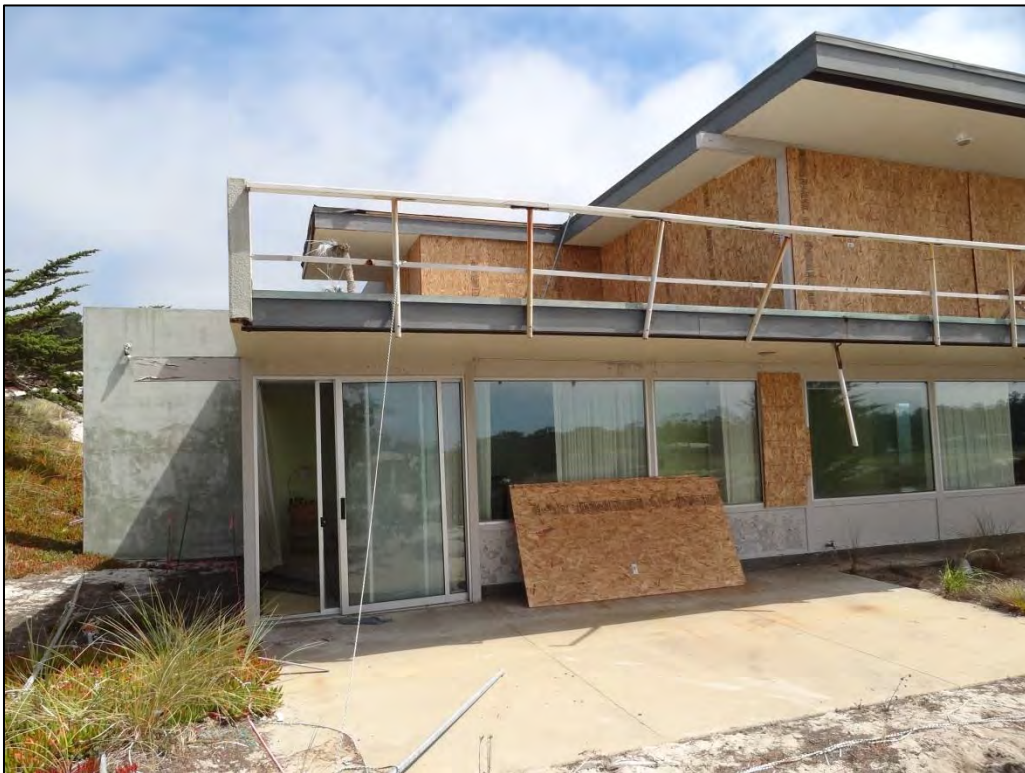
- There was a moldy odor noted upon entry to the lower level of the home.
- The indoor temperature was 73 °F with a relative humidity of 59%
- The exterior sliding glass door in the master bedroom was open upon arrival and the screen was closed. M<sup>3</sup> closed the door for testing.
- The door glass was broken and there was a hole in the window that had been taped up.
- The carpet in the room was wet to the touch.
- The moisture content (MC) of the wood baseboard was saturated at greater than 40 percent (>40%). Normal MC for wood is <16%.
- Mold growth was noted on the wood baseboards.
- The MC of the wallboard ceiling and walls was up to 2.1%. Normal MC for wallboard is <0.5%.
- The mattress base was damp to the touch.
- There was visible suspect mold growth around the perimeter eave of the deck.

**Master bedroom (under deck)**
