**Salinas River
Stream Maintenance Program
2017 Work Season**

Annual Report

United States Army Corps of Engineers

Regional General Permit 20, Corps File # 1996-22309S, Effective September 28, 2016

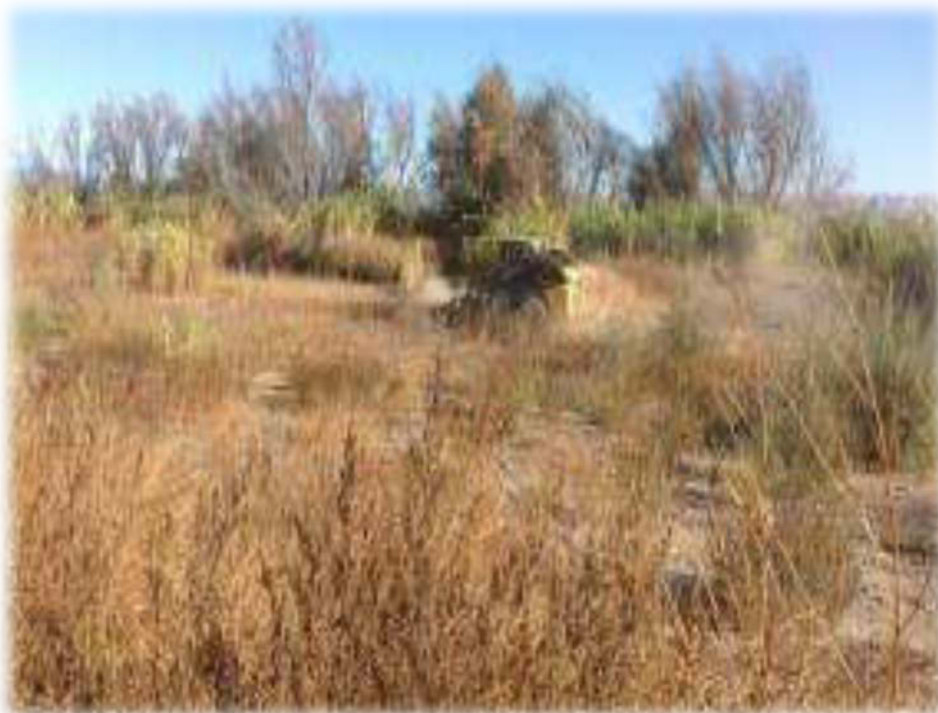
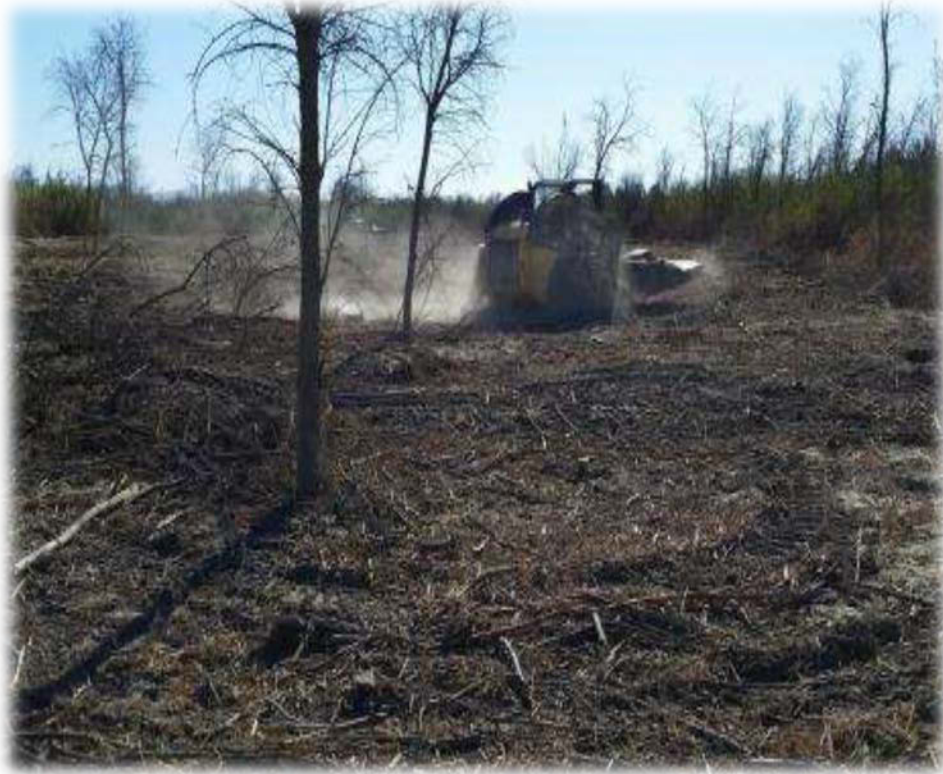
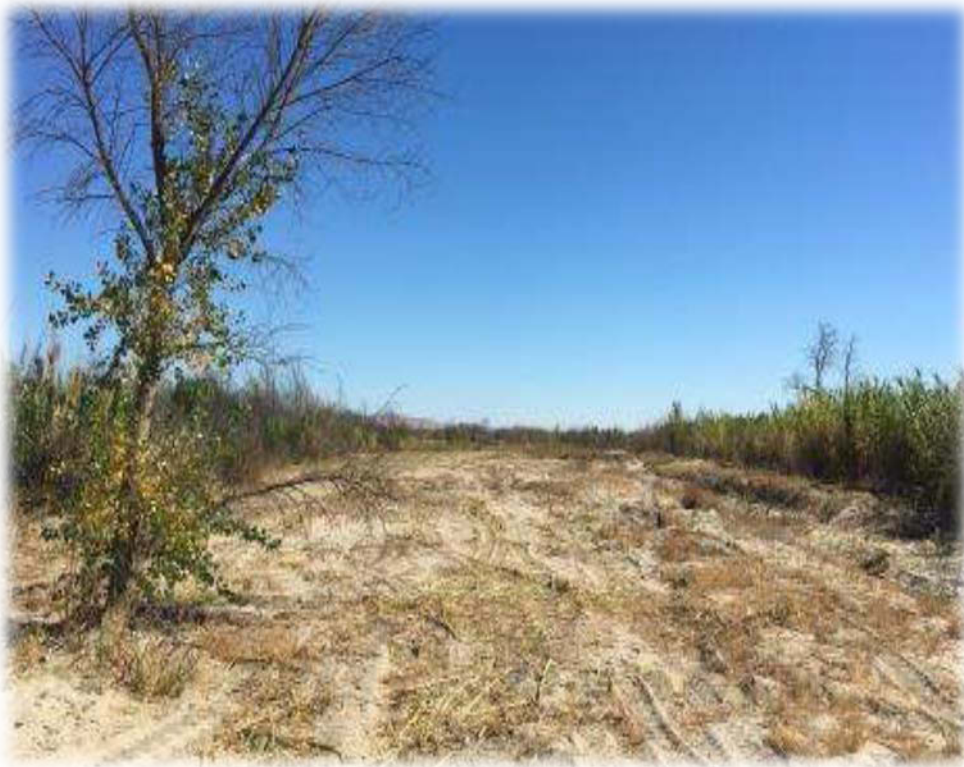
Vegetation Removal

Native vegetation was removed within the designated maintenance areas. Disturbance of emergent vegetation did not occur in areas with suitable habitat for California red-legged frogs or for tidewater gobies. All new impacts associated with vegetation removal are quantified in the tables below by vegetation types for each maintenance area, each RMU, and the Program Area. This includes expansion of previously treated areas. Retreatment of native vegetation is included in the total area column but not under the vegetation type columns. Those impacts were addressed in the annual report following the initial removal.

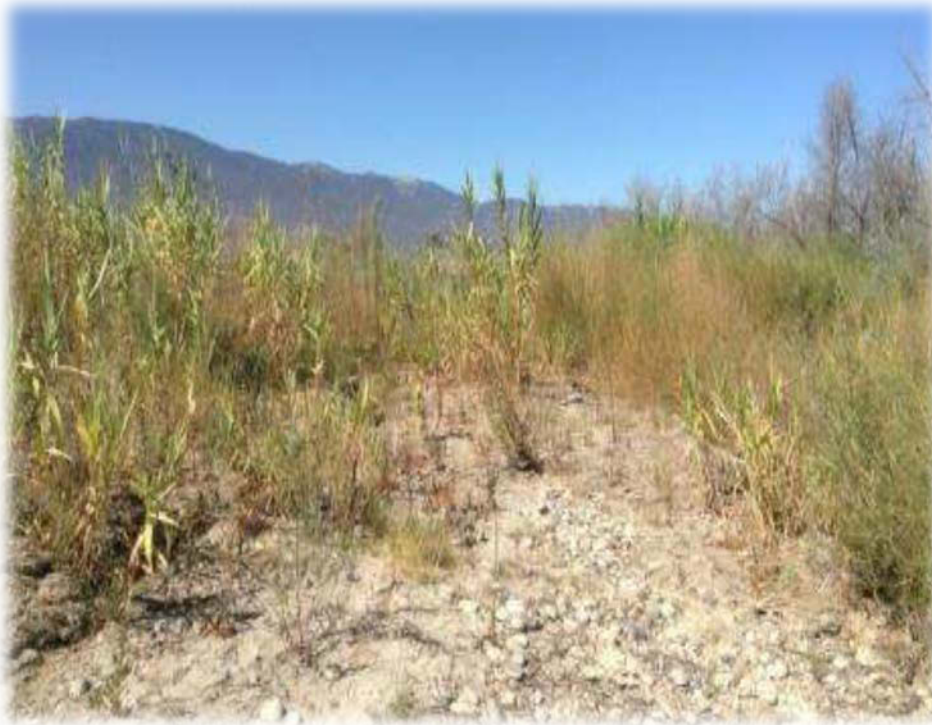
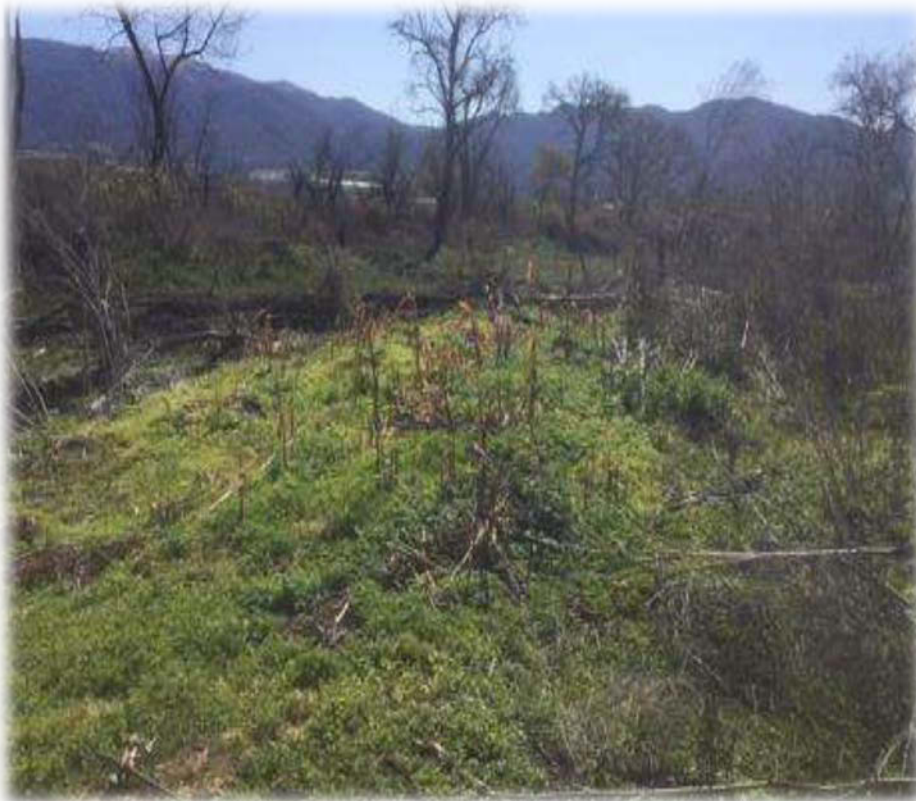
Arundo Removal

This maintenance season followed a multi-year drought and most plant species were water stressed or dead. The targeted invasive species for removal is arundo. The browning arundo was removed through mowing and mulching. Limited herbicide application was utilized during this maintenance season due to the dryness of the vegetation. Previous arundo removal areas were re-mowed as necessary.

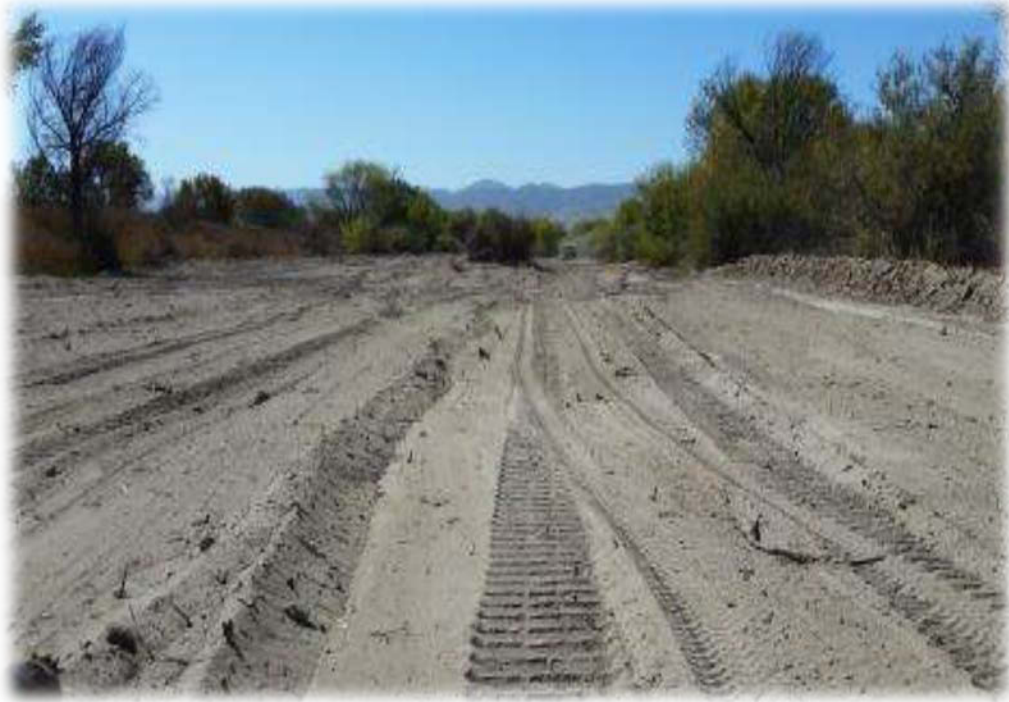
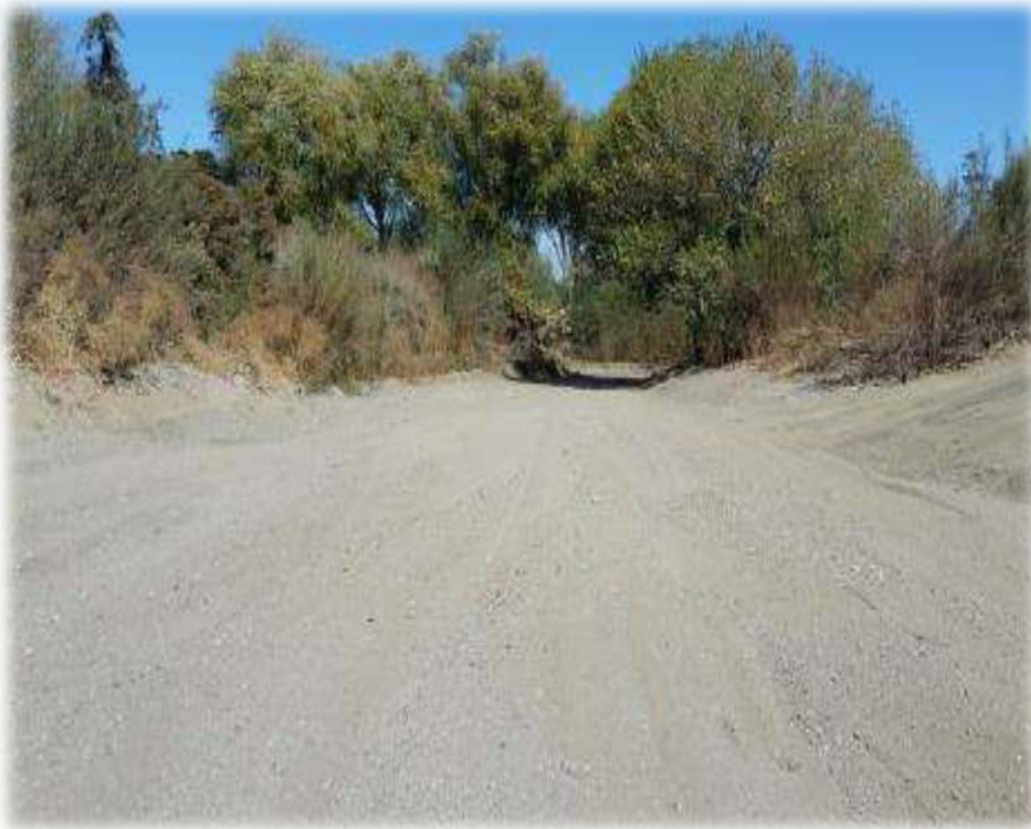
Grading & Sediment Removal

Limited grading and sediment removal occurred during the maintenance season. One stockpile location was established in the approved location outside of jurisdictional area. No open trenches or other excavations with a 6 inch depth were made during the maintenance season. The grading and excavation activities performed within the maintenance areas are shown in the tables below.

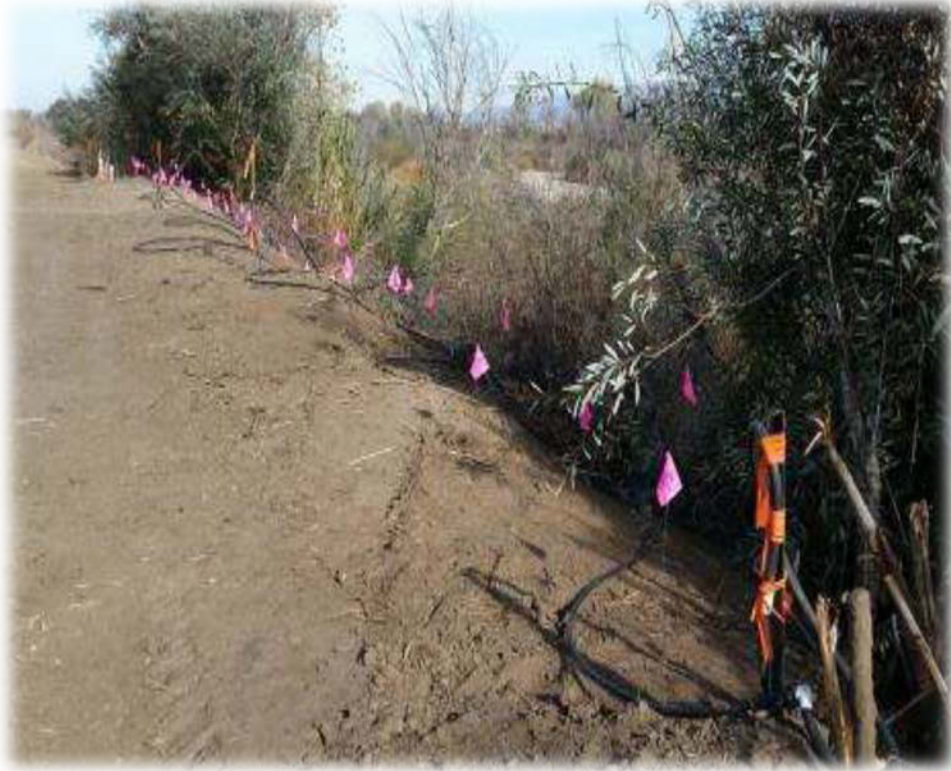
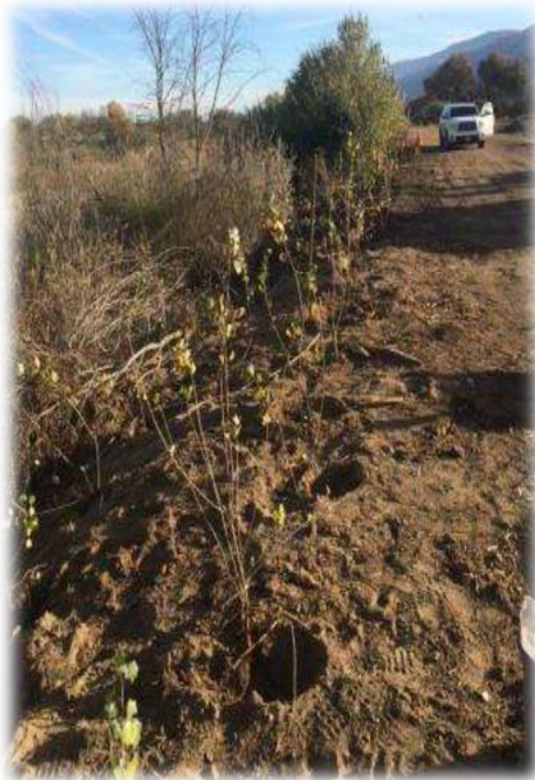
Tree Planting

Native trees are typically planted during the rainy season to enhance their rate of success. There had been a delay in tree planting due to the extended drought period, though some trees have recently been planted in RMUs 4 and 5. The success of native tree species plantings will be monitored in future years. Photos of the tree planting are in Section 5.
