**Salinas River  
Stream Maintenance Program  
2018 Work Season**

**Annual Report  
To  
Central Coast Regional Water Quality Control Board**

Water Quality Certification Number 32716WQ02, Dated August 31, 2016

Monterey County Water Resources Agency  
P.O. Box 930  
Salinas, CA 93902

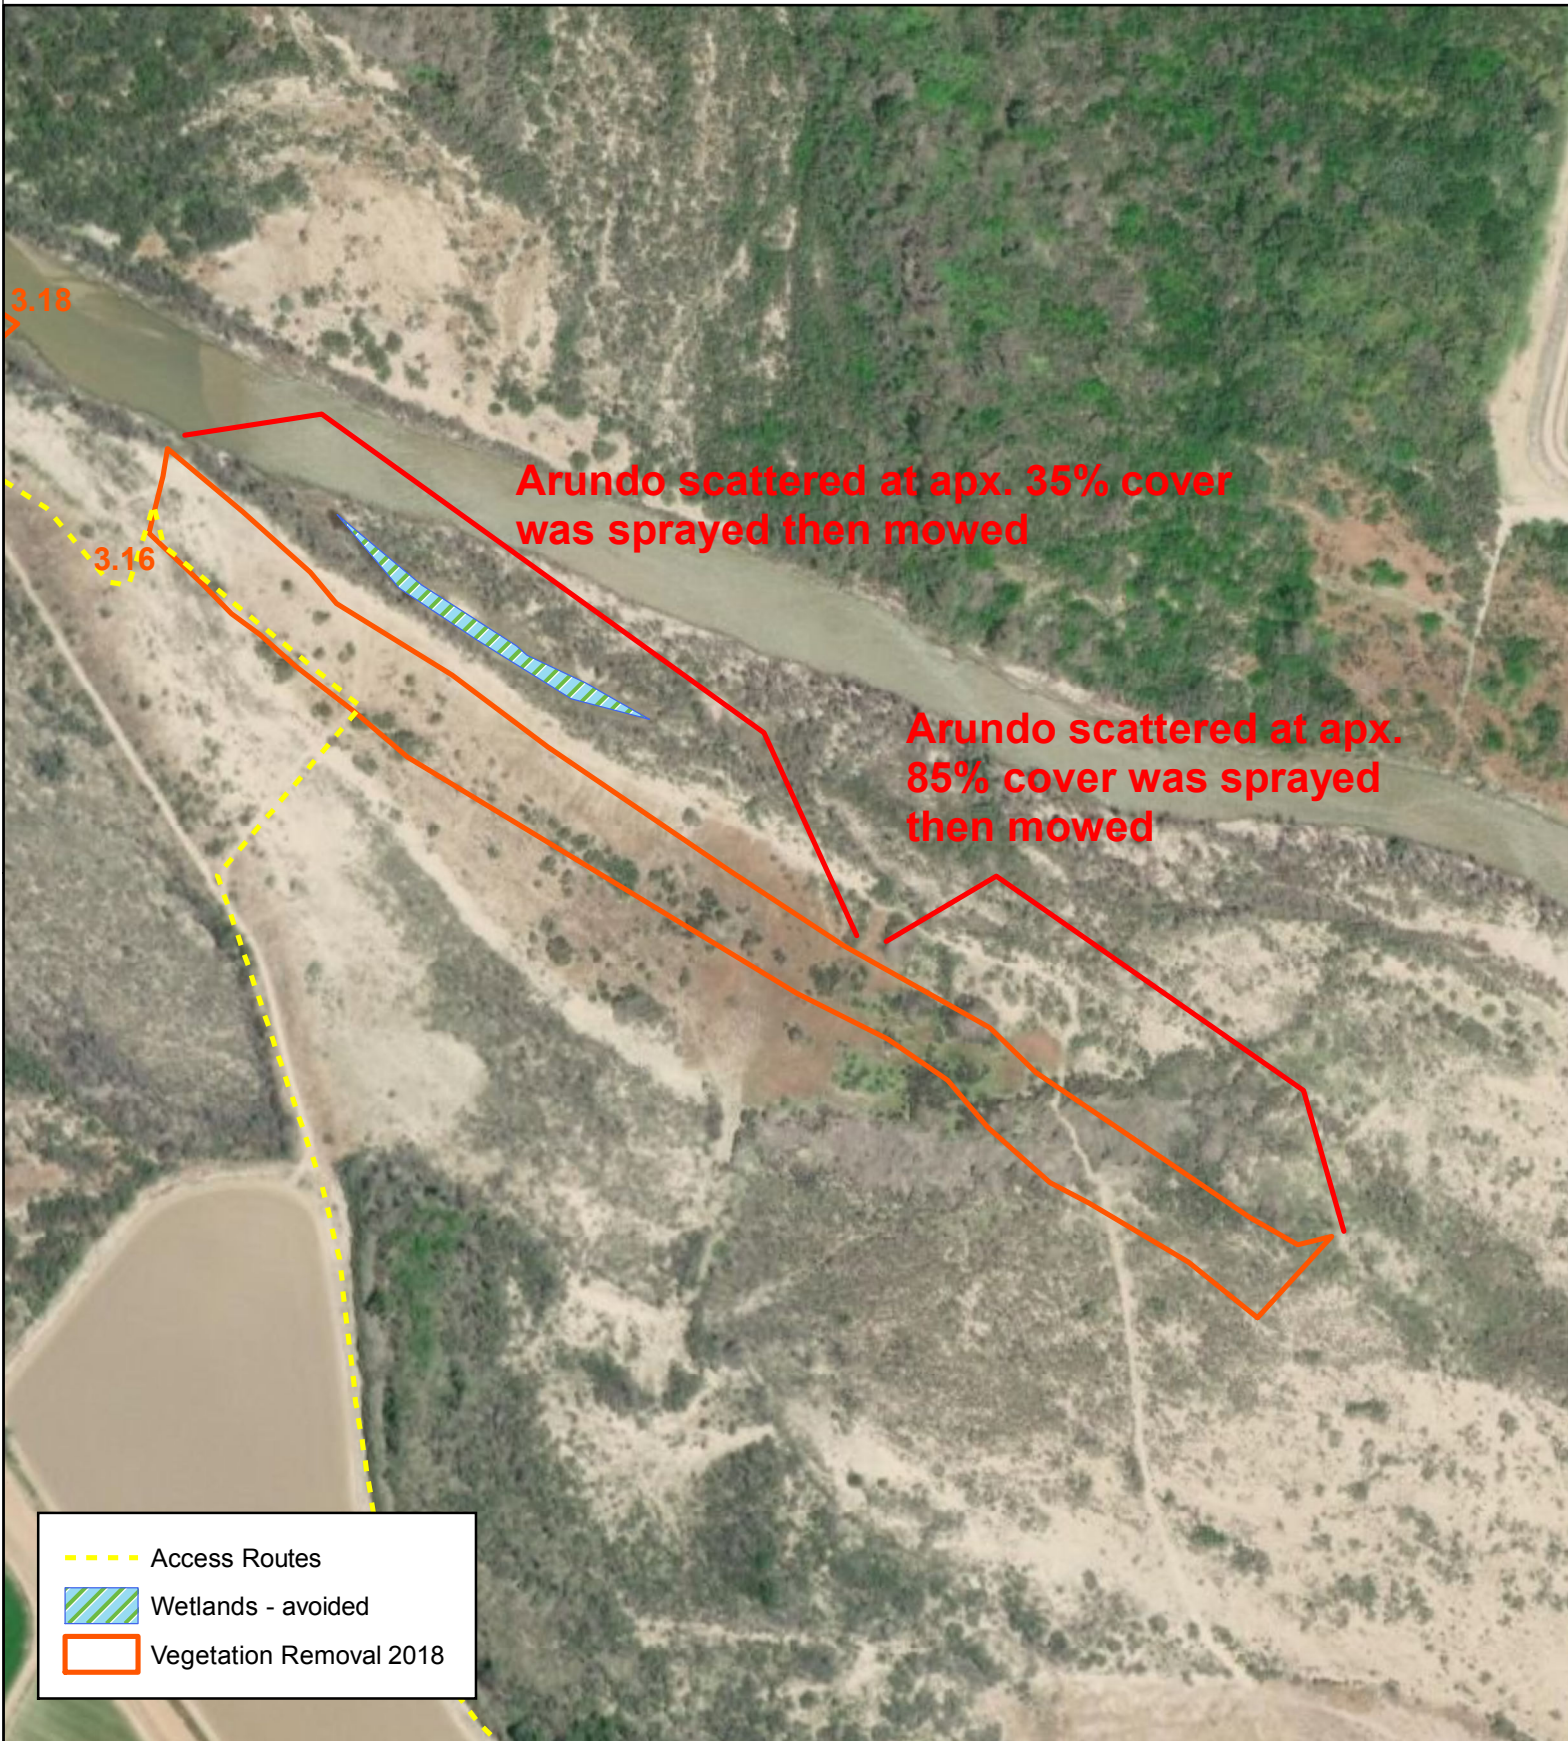
# 2018 SMP Project Activities: VRF # 0046, 0059 Maintenance Area 3.16

<b>Maintenance Area #</b>	<b>Wetlands Identification Results</b>
1.03 and access route	Maintenance work was not performed in 2018
3.16	Maintenance work was limited in scope and avoidance measures were observed.
3.18 and access route	Maintenance work was limited in scope and avoidance measures were observed.
5.02	Maintenance work was not performed in 2018
6.10	Maintenance work was limited in scope and avoidance measures were observed.
6.12	Maintenance work was limited in scope and avoidance measures were observed.

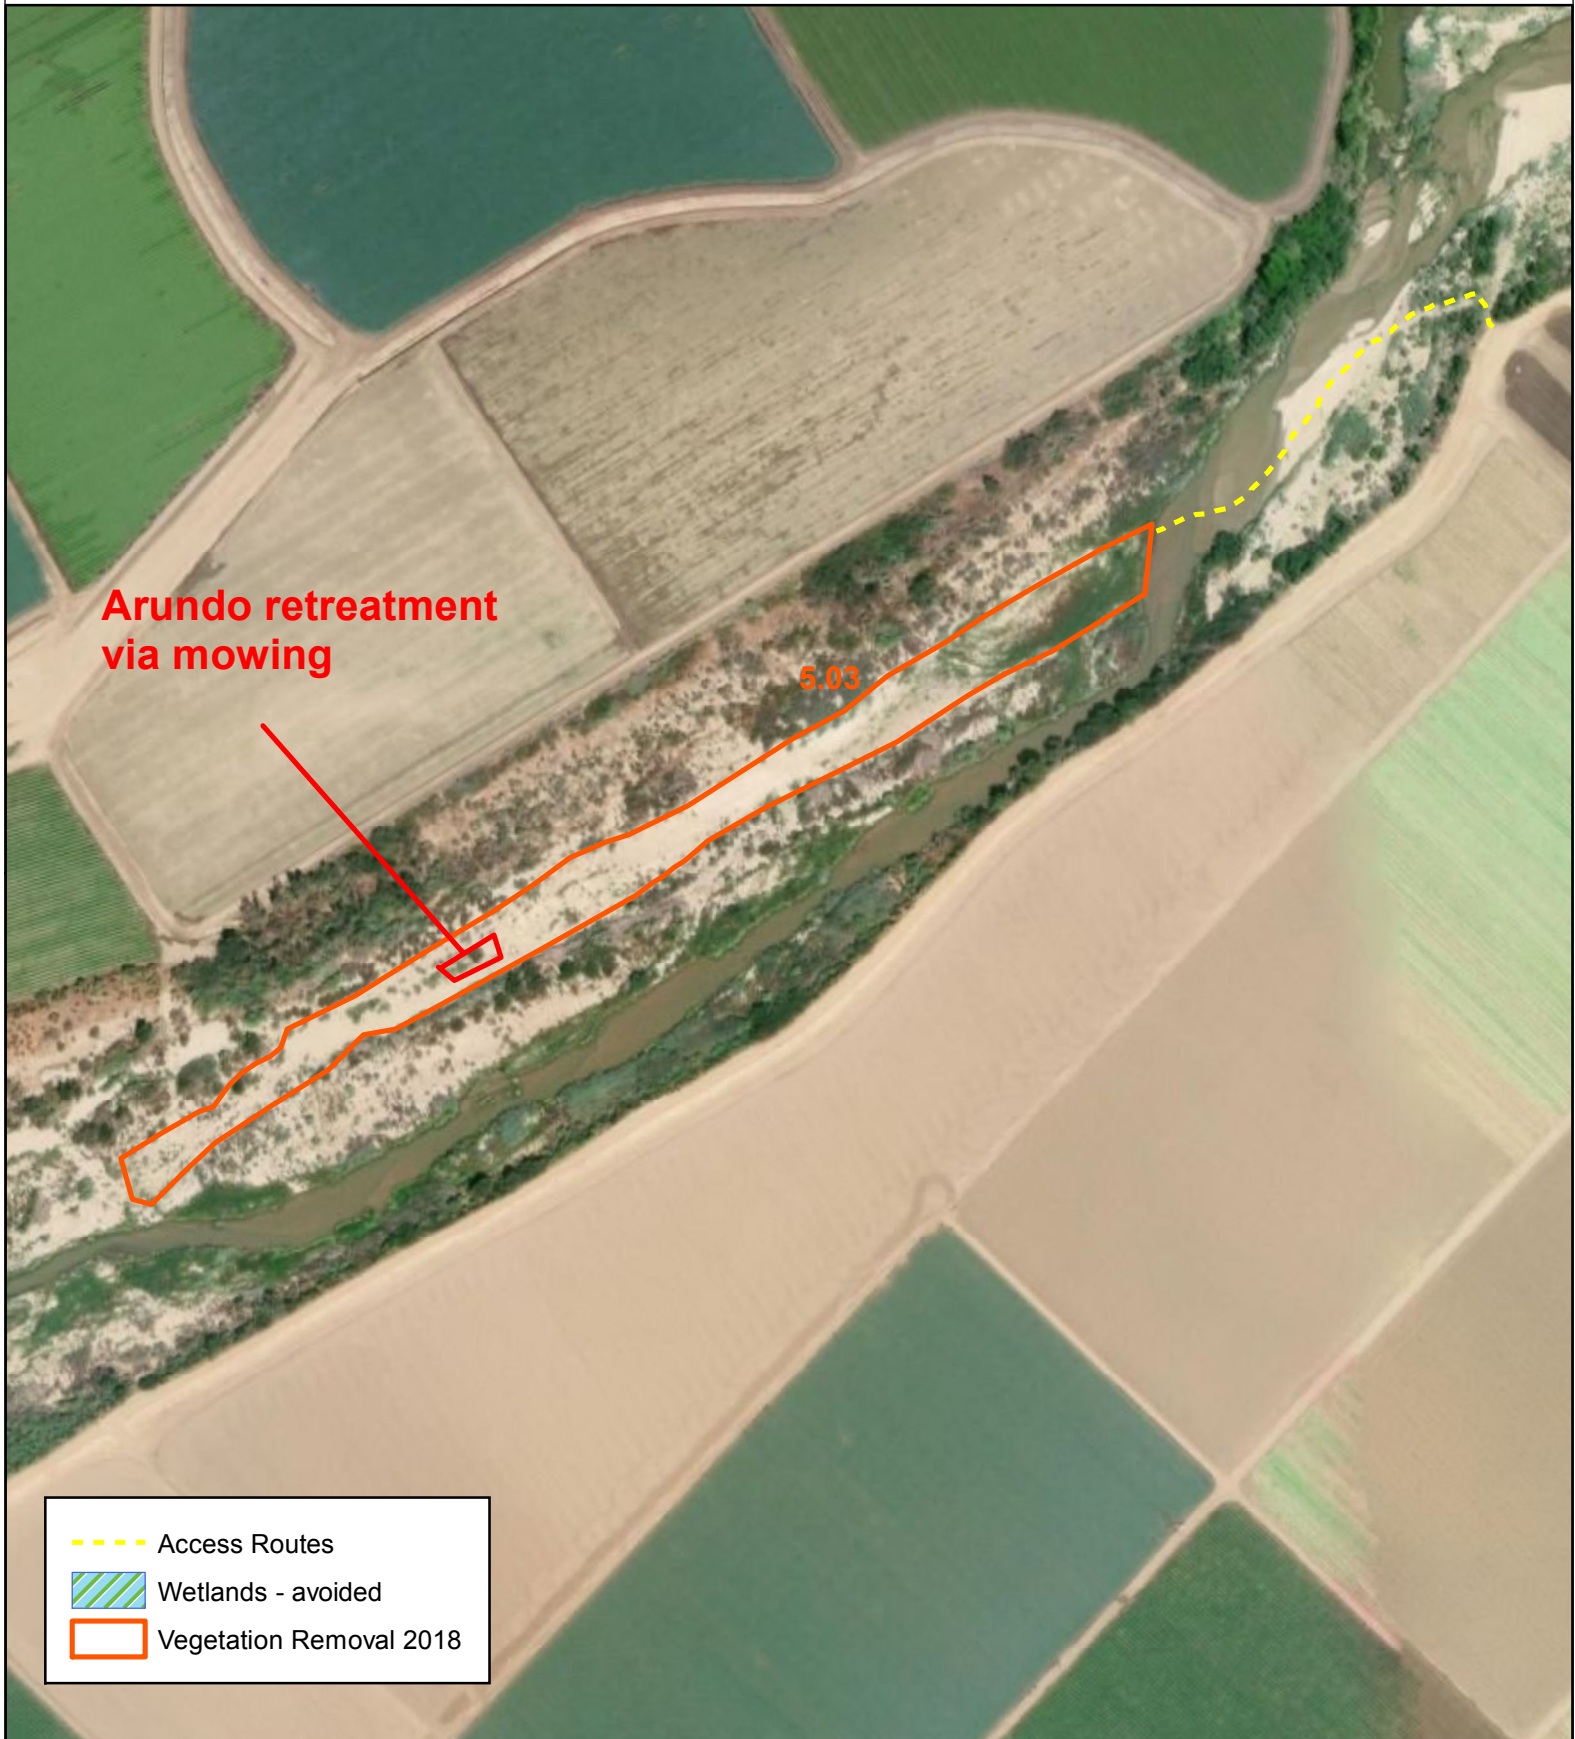
# 2018 SMP Project Activities: VRF # 0071 Maintenance Area 5.03

**Arundo retreatment  
via mowing**
