4.2 GEOLOGY AND SOILS

4.2.1 Environmental Setting

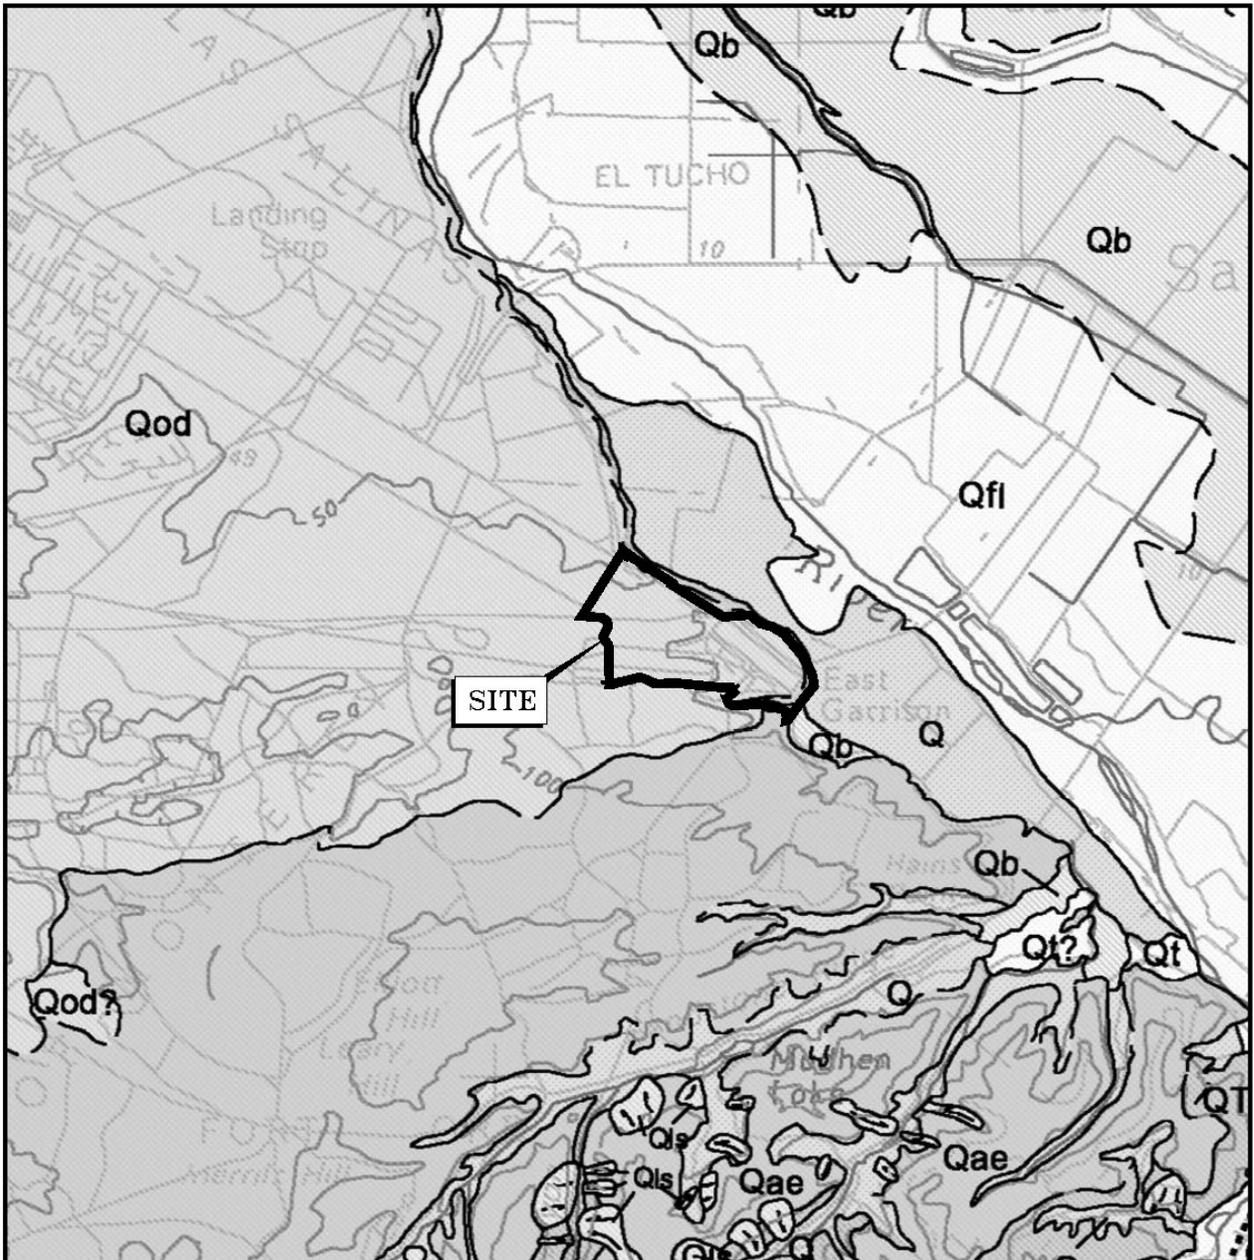
Exhibit 4.2-1
Regional Geologic Map

Regional geologic mapping by Wagner et al. (2002) indicates that the site is underlain by late Pleistocene older dune sand (Qod) deposits (see Exhibit 4.2-1). Dibblee (1973) similarly maps the site as being underlain by Pleistocene older dune deposits and Plio-Pleistocene Aromas Sand (older dune deposits). Bedding in the region, as mapped by Dibblee, dips to the northeast at inclinations of 3 to 5 degrees.

EXPLANATION

- Q** ALLUVIUM
- Qfl** FLOOD PLAIN DEPOSITS
- Qb** BASIN DEPOSITS
- Qod** OLDER DUNE SAND
- Qae** AROMAS EOLIAN FACIES

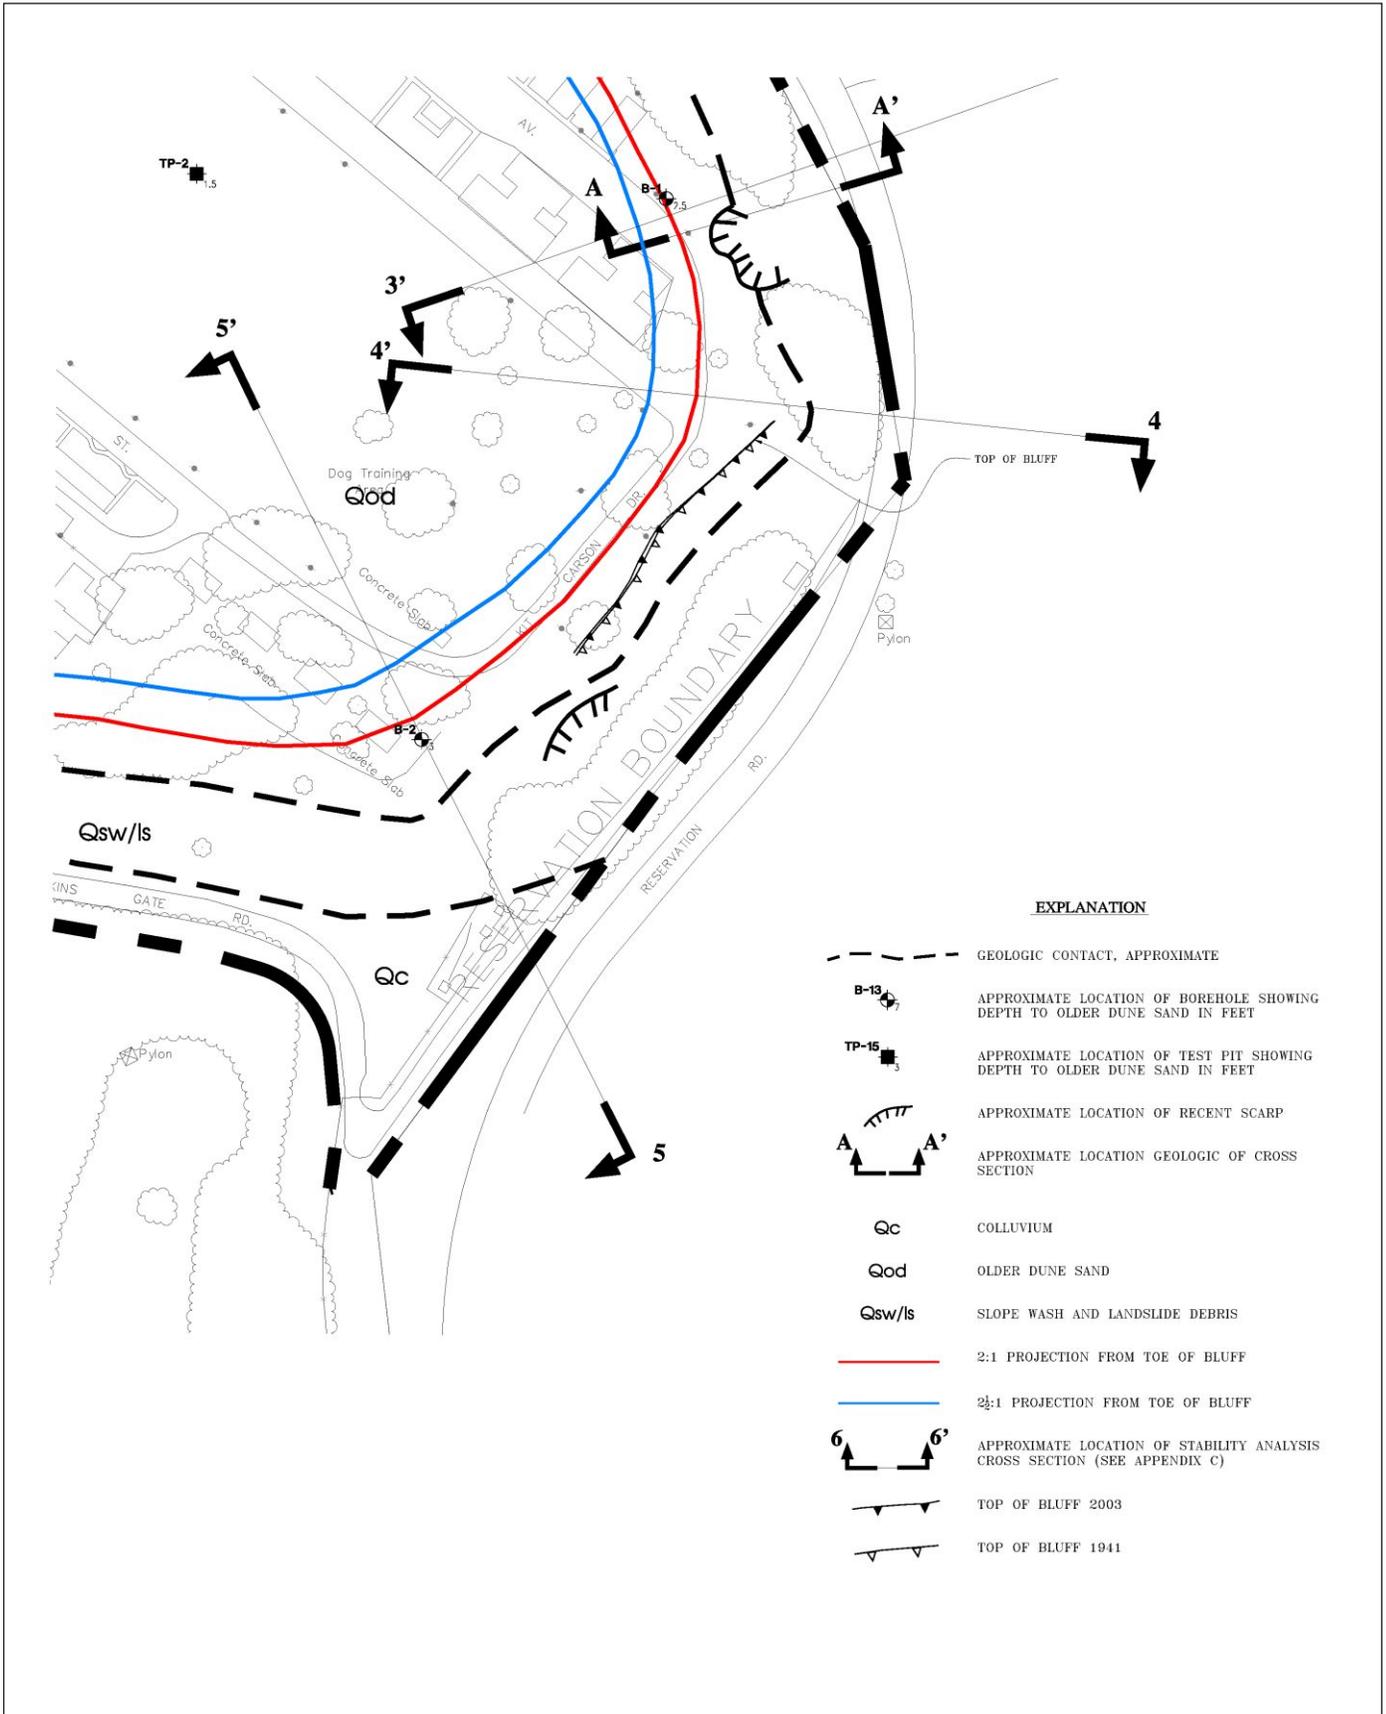
A geotechnical field exploration was conducted in April 2003, and consisted of drilling 13 borings and excavating 17 test pits distributed across the EGSP area to characterize the project site's subsurface conditions.

Source: Urban Design Associates, March 2003 (base map source). ENGEO Incorporated, July 2003.
