This section of the Draft EIR analyzes geologic or seismic-related factors that could affect development or restrict use of the project site. This section of the Draft EIR is primarily based on the *Preliminary Geologic, Geotechnical, Hydrogeologic, Erosion, Drainage and Environmental Phase I Assessment, Proposed Ferrini Ranch Subdivision, Monterey County, California*, prepared by Kleinfelder (July 14, 2008). As recommended in the preliminary analysis, Soil Surveys prepared the *Geotechnical Investigation for Proposed Residential Subdivision Off Highway 68 Between San Benancio Road and River Road Near Salinas, California*, for the property including additional subsurface investigations to assess the landslide potential in several specific areas identified in the Kleinfelder report. The geologic, geotechnical, soils, and erosion sections of this assessment are summarized herein. The two reports are included as **Appendix E** of the Draft EIR.

3.5 GEOLOGY AND SOILS

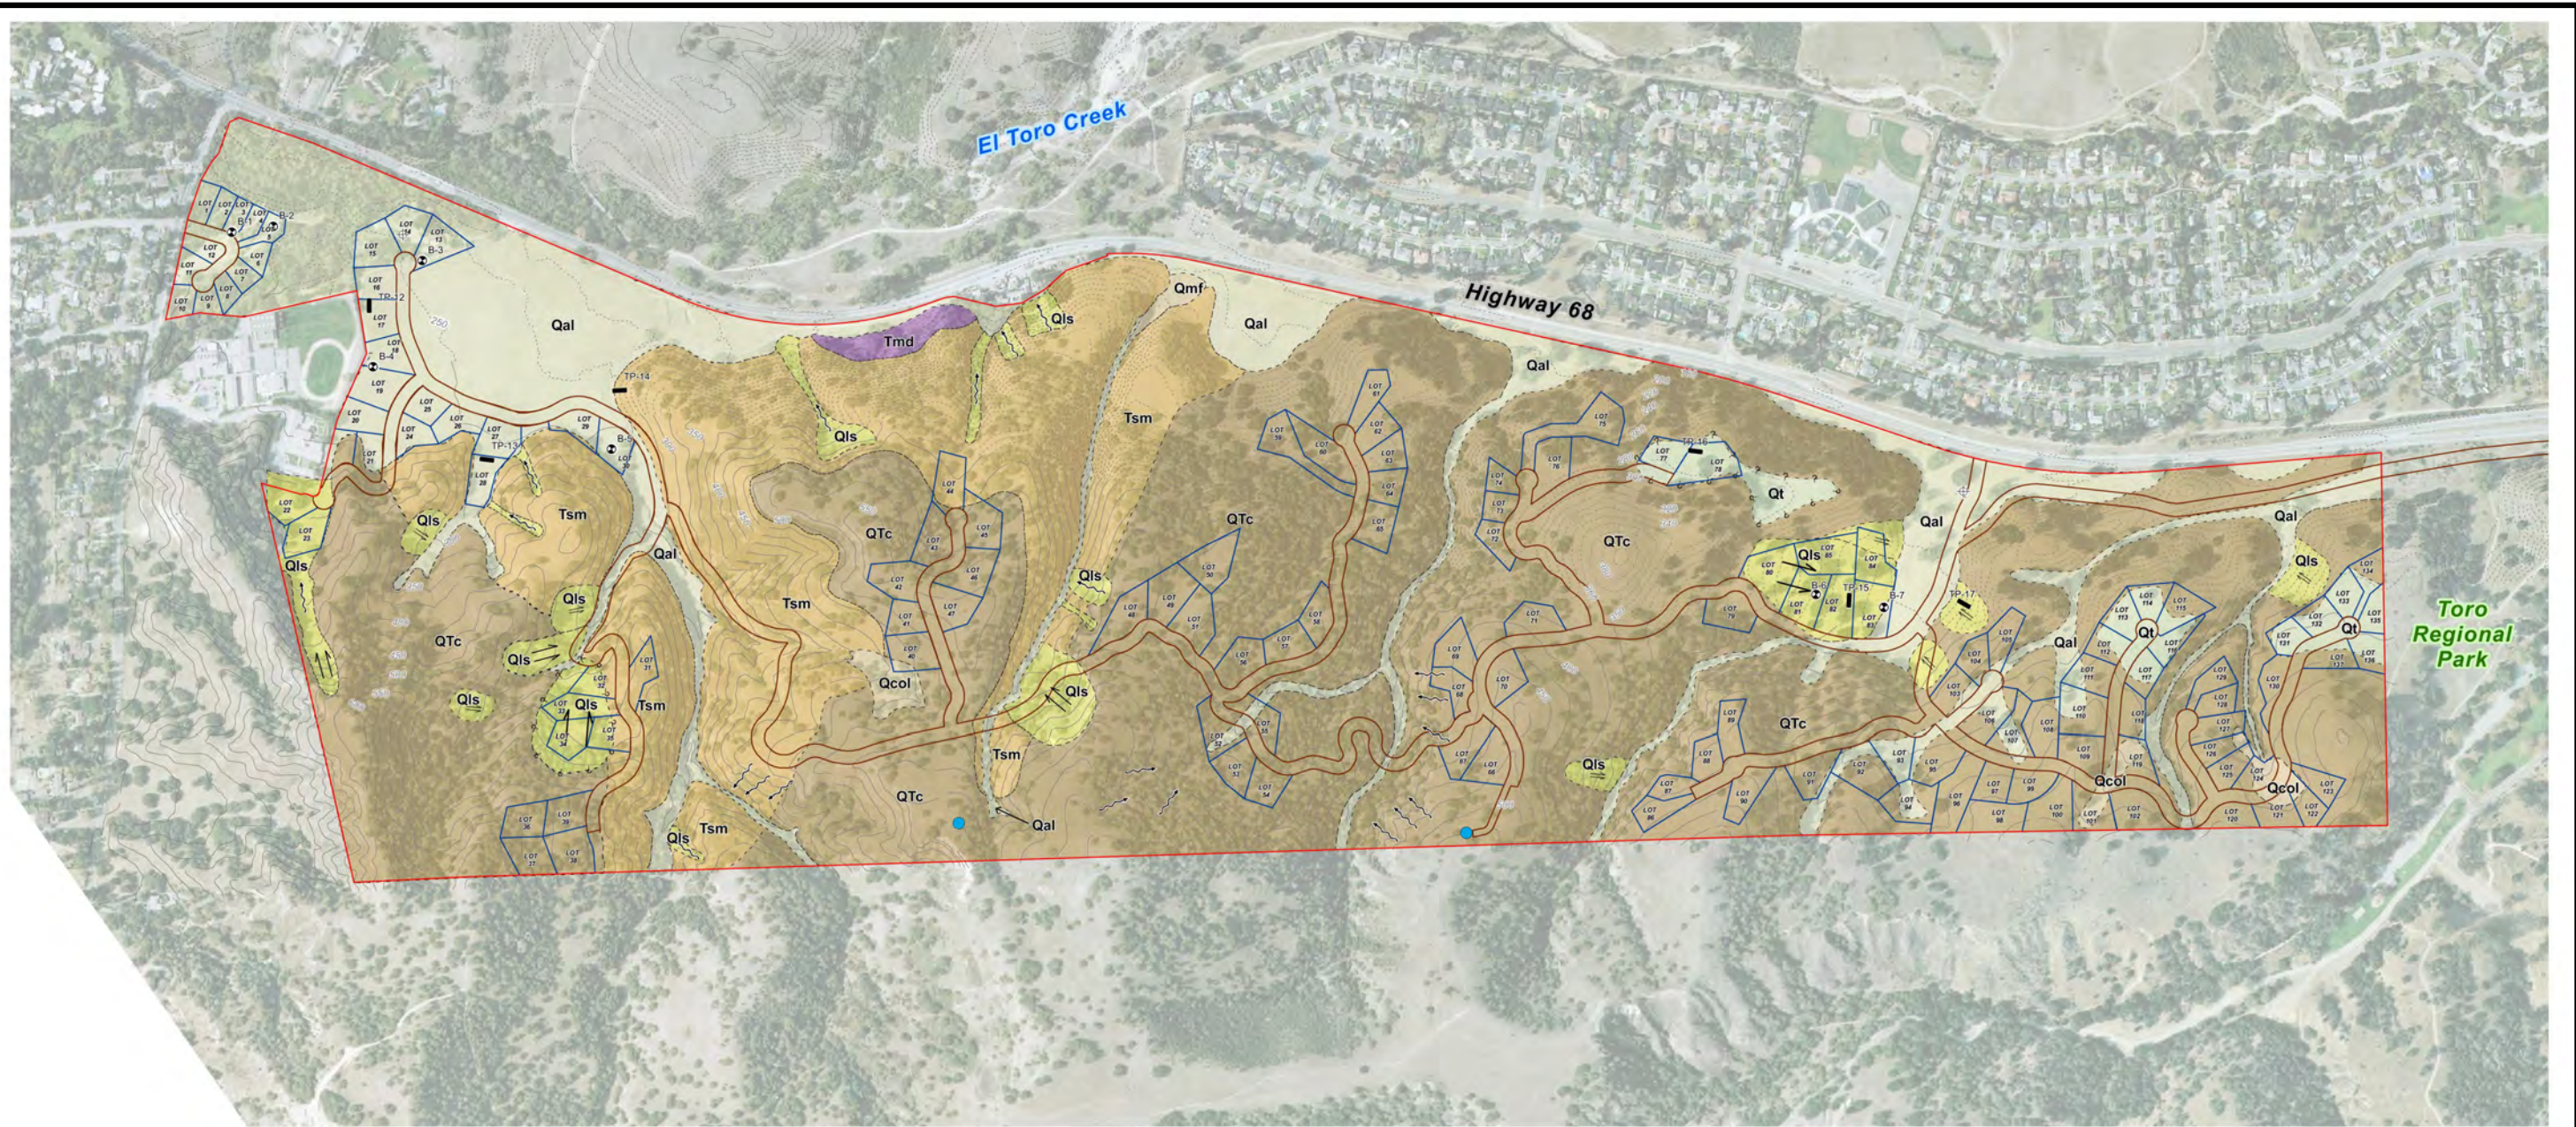
LEGEND		
— Lot Boundaries - showing lot numbers	Geologic Feature	Site Geology
⊕ Existing Groundwater Well	— Landslide - showing direction of movement, queried where uncertain	af - Artificial Fill (Historic)
● Proposed Water Tanks	~ Surficial Landslide - showing direction of movement	Qal - Alluvium (Holocene)
— Proposed Roads	⊕ Spring	Qcol - Colluvium (Holocene)
--- Contours - 10 Foot Interval	↘ Bedding Attitude - showing dip	Qmf - Mudflow Deposits (Holocene)
--- Contours - 50 Foot Interval	↗ Joint Attitude - showing dip	Qls - Landslide Deposits (Quaternary)
□ Project Boundary	Geologic Contact	Qof - Older Flood-Plain Deposits (Holocene)
⊕ B-1 Boring - approximate location	— Dashed where approximate	Qt - Terrace Deposits (Pleistocene)
⊕ TP-1 Test Pit - approximate location	(queried where uncertain)	QTc - Continental Deposits (Pleistocene-Pliocene)
		Tsm - Santa Margarita Sandstone (Miocene)
		Tuss - Unnamed Sandstone (Miocene)

Tmd - Monterey Formation (Miocene)

The geology of the project site consists of deformed sedimentary bedrock overlain by various types of younger surficial deposits. The rolling hillsides that dominant the eastern portions of the property are underlain by marine and non-marine sedimentary bedrock units that are broadly folded and steeply inclined in some areas. These bedrock units include the Miocene Monterey Formation and Santa Margarita Sandstone and Plio-Pleistocene continental deposits, and are mantled by soil and localized deposits of landslide debris. The adjoining hillside drainages are underlain by Holocene alluvium and older floodplain deposits. Pleistocene terrace deposits underlie the elevated plains on the

Landslide debris is a rough mixture of unconsolidated, heterogeneous deposits of moderately to poorly sorted silt, sand, and angular rock fragments also deposited by down-slope mass movement but driven by the weight of the mass. An older landslide formed more than 11,000 years ago may be considered dormant, whereas a landslide formed during Holocene time may still be subject to movement depending on present conditions and disturbance of the area. Landslides from both eras exist on the project site. The locations of existing landslides on the project site were presented previously in **Figure 3.5-2a** and **Figure 3.5-2b**.

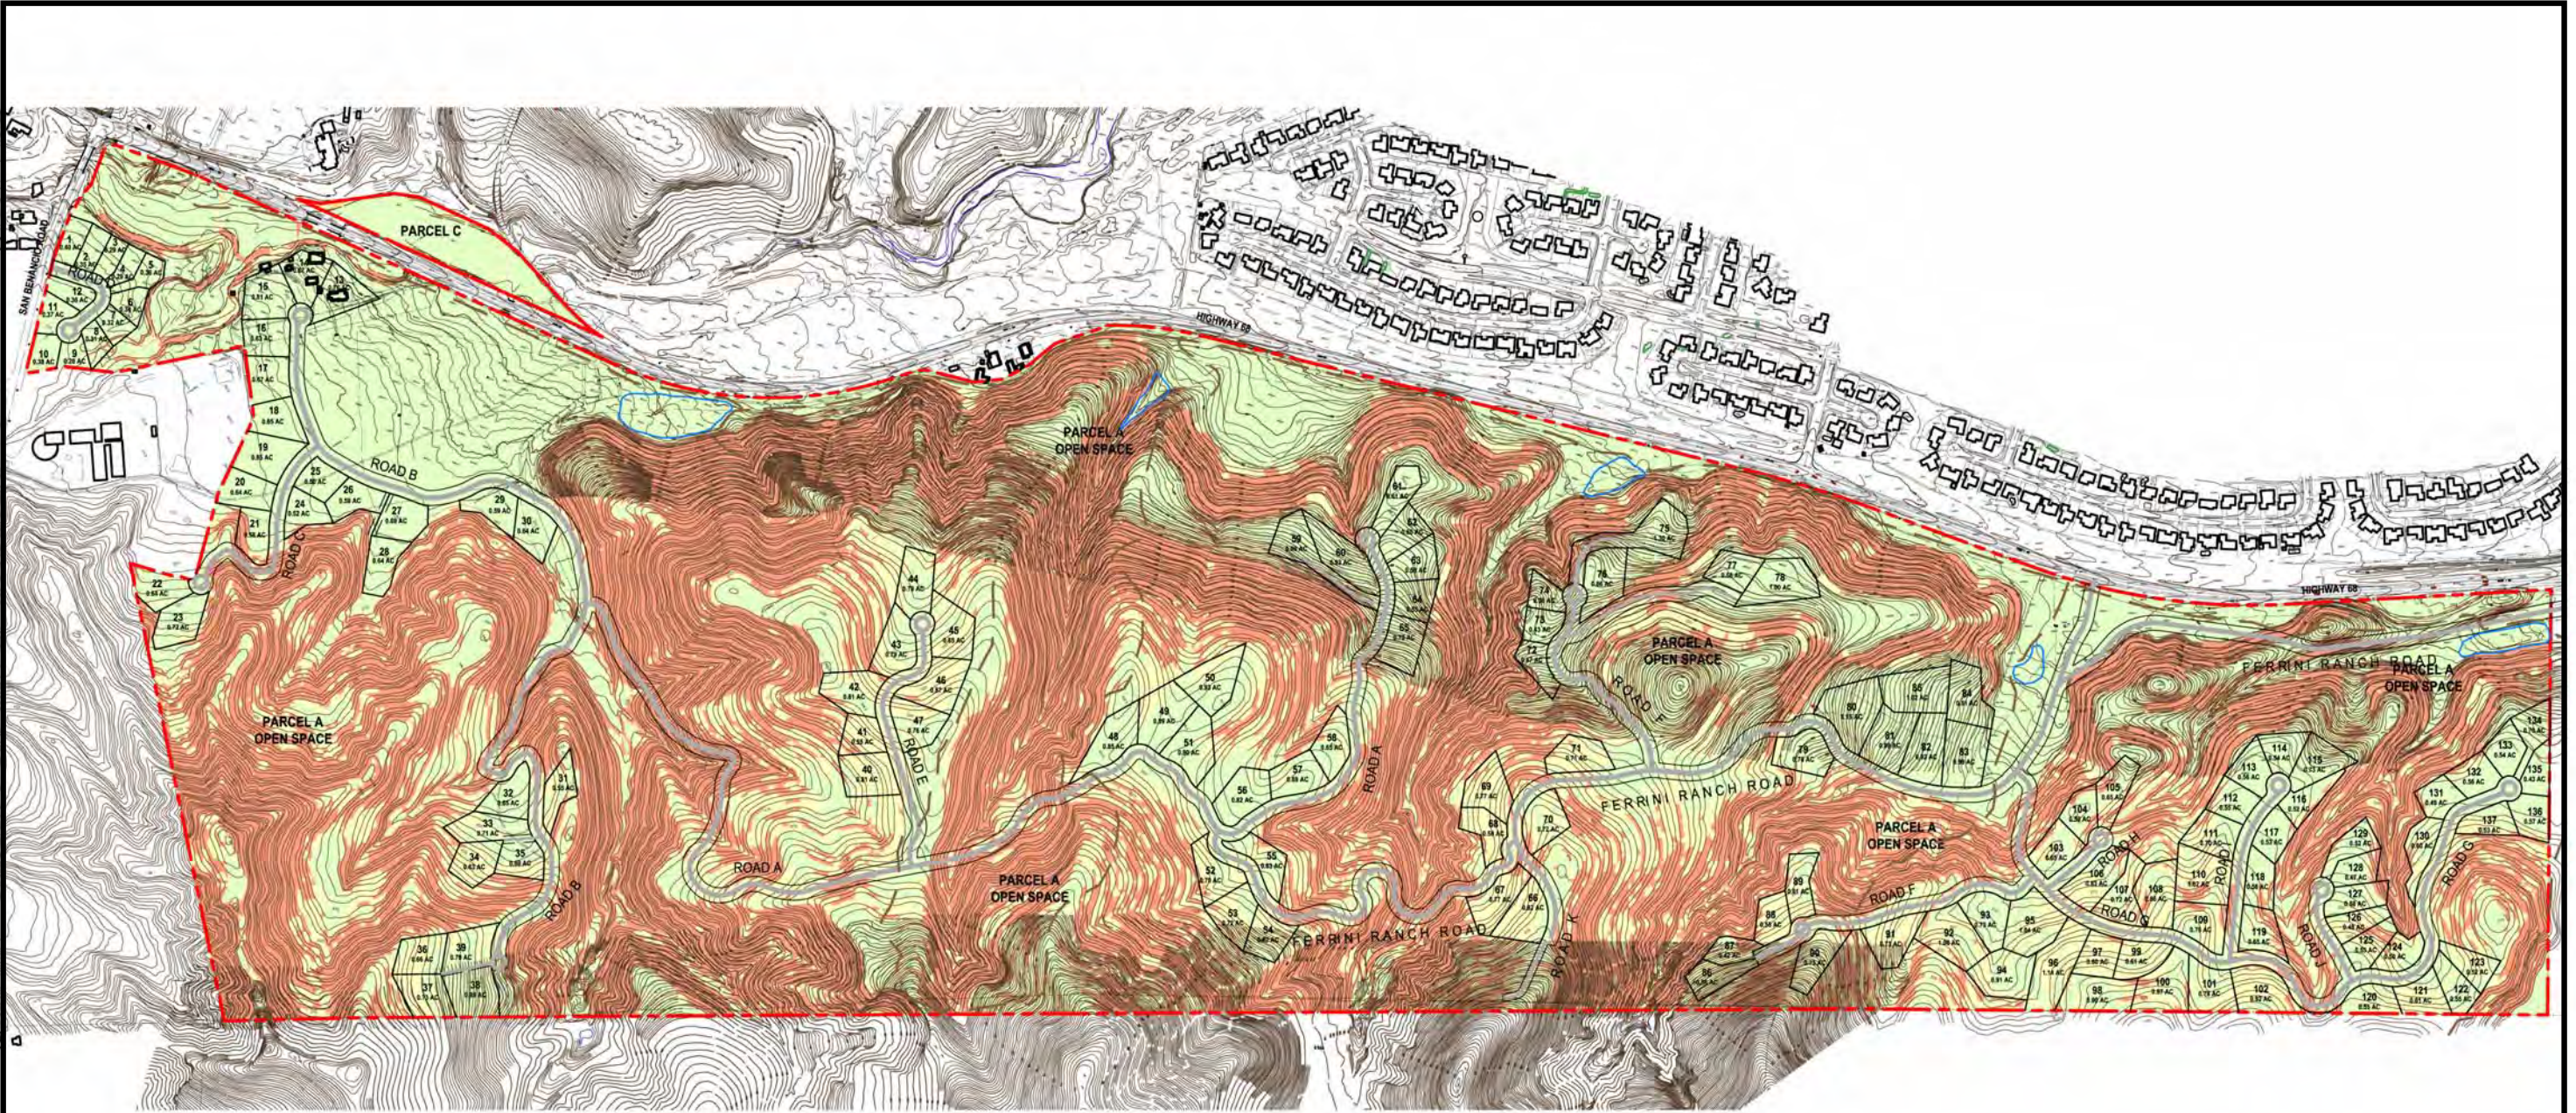
SLOPE ANALYSIS

Color	Range Beg.	Range End	Percent	Area
Light Green	0.00%	19.9%	33.8	294.4 ac
Yellow	20.0%	29.9%	21.5	186.7 ac
Orange	30.0+%		44.7	388.7 ac

According to the *Toro Area Plan* (Monterey County 1983), geologic hazards such as landslides and erosion susceptibility at the project site are considered high. This is in part due to approximately 45 percent of the project site having slopes greater than 30 percent as shown in **Figures 3.5-5a** and **3.5-5b**. Areas with steep slopes are subject to relatively
