APPENDIX E – GEOLOGY AND SOILS

**GEOLOGICAL AND GEOTECHNICAL
FEASIBILITY STUDY
PROPOSED ENCINA HILLS SUBDIVISION
MONTEREY COUNTY, CALIFORNIA**

**Subject: Geological and Geotechnical Feasibility Study for the Proposed Encina Hills
Subdivision in Unincorporated Monterey County, California**

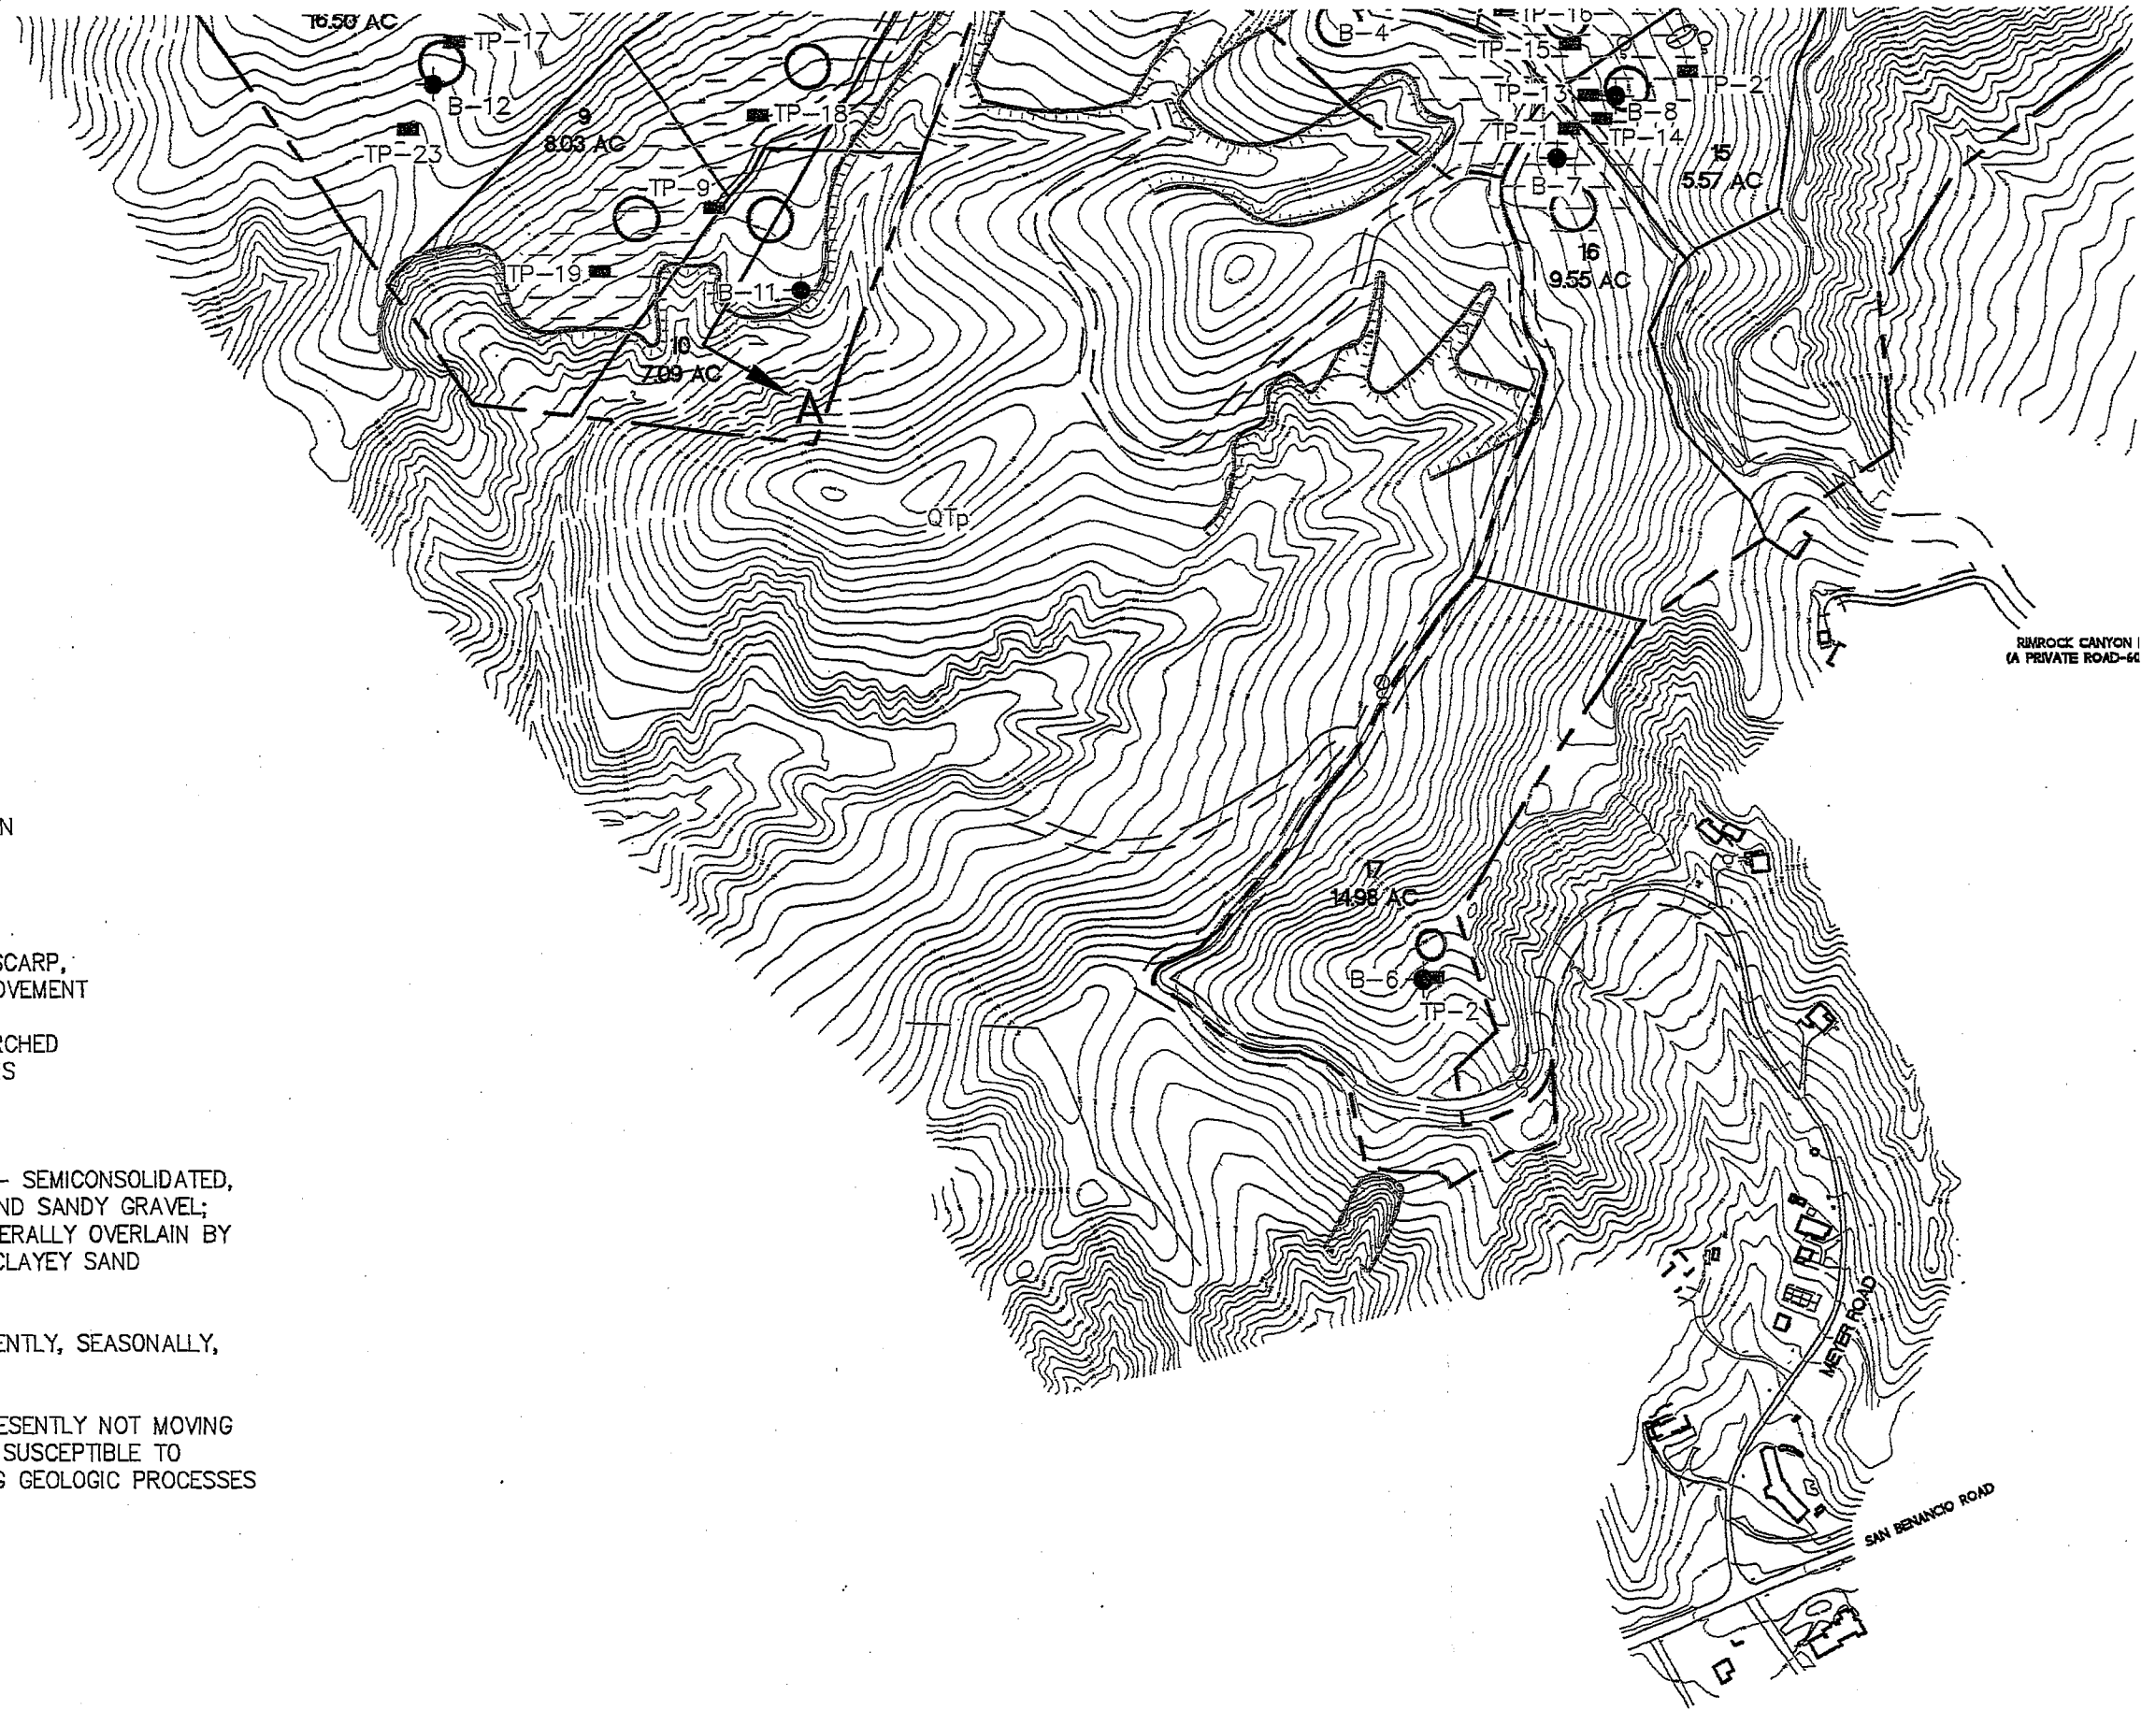
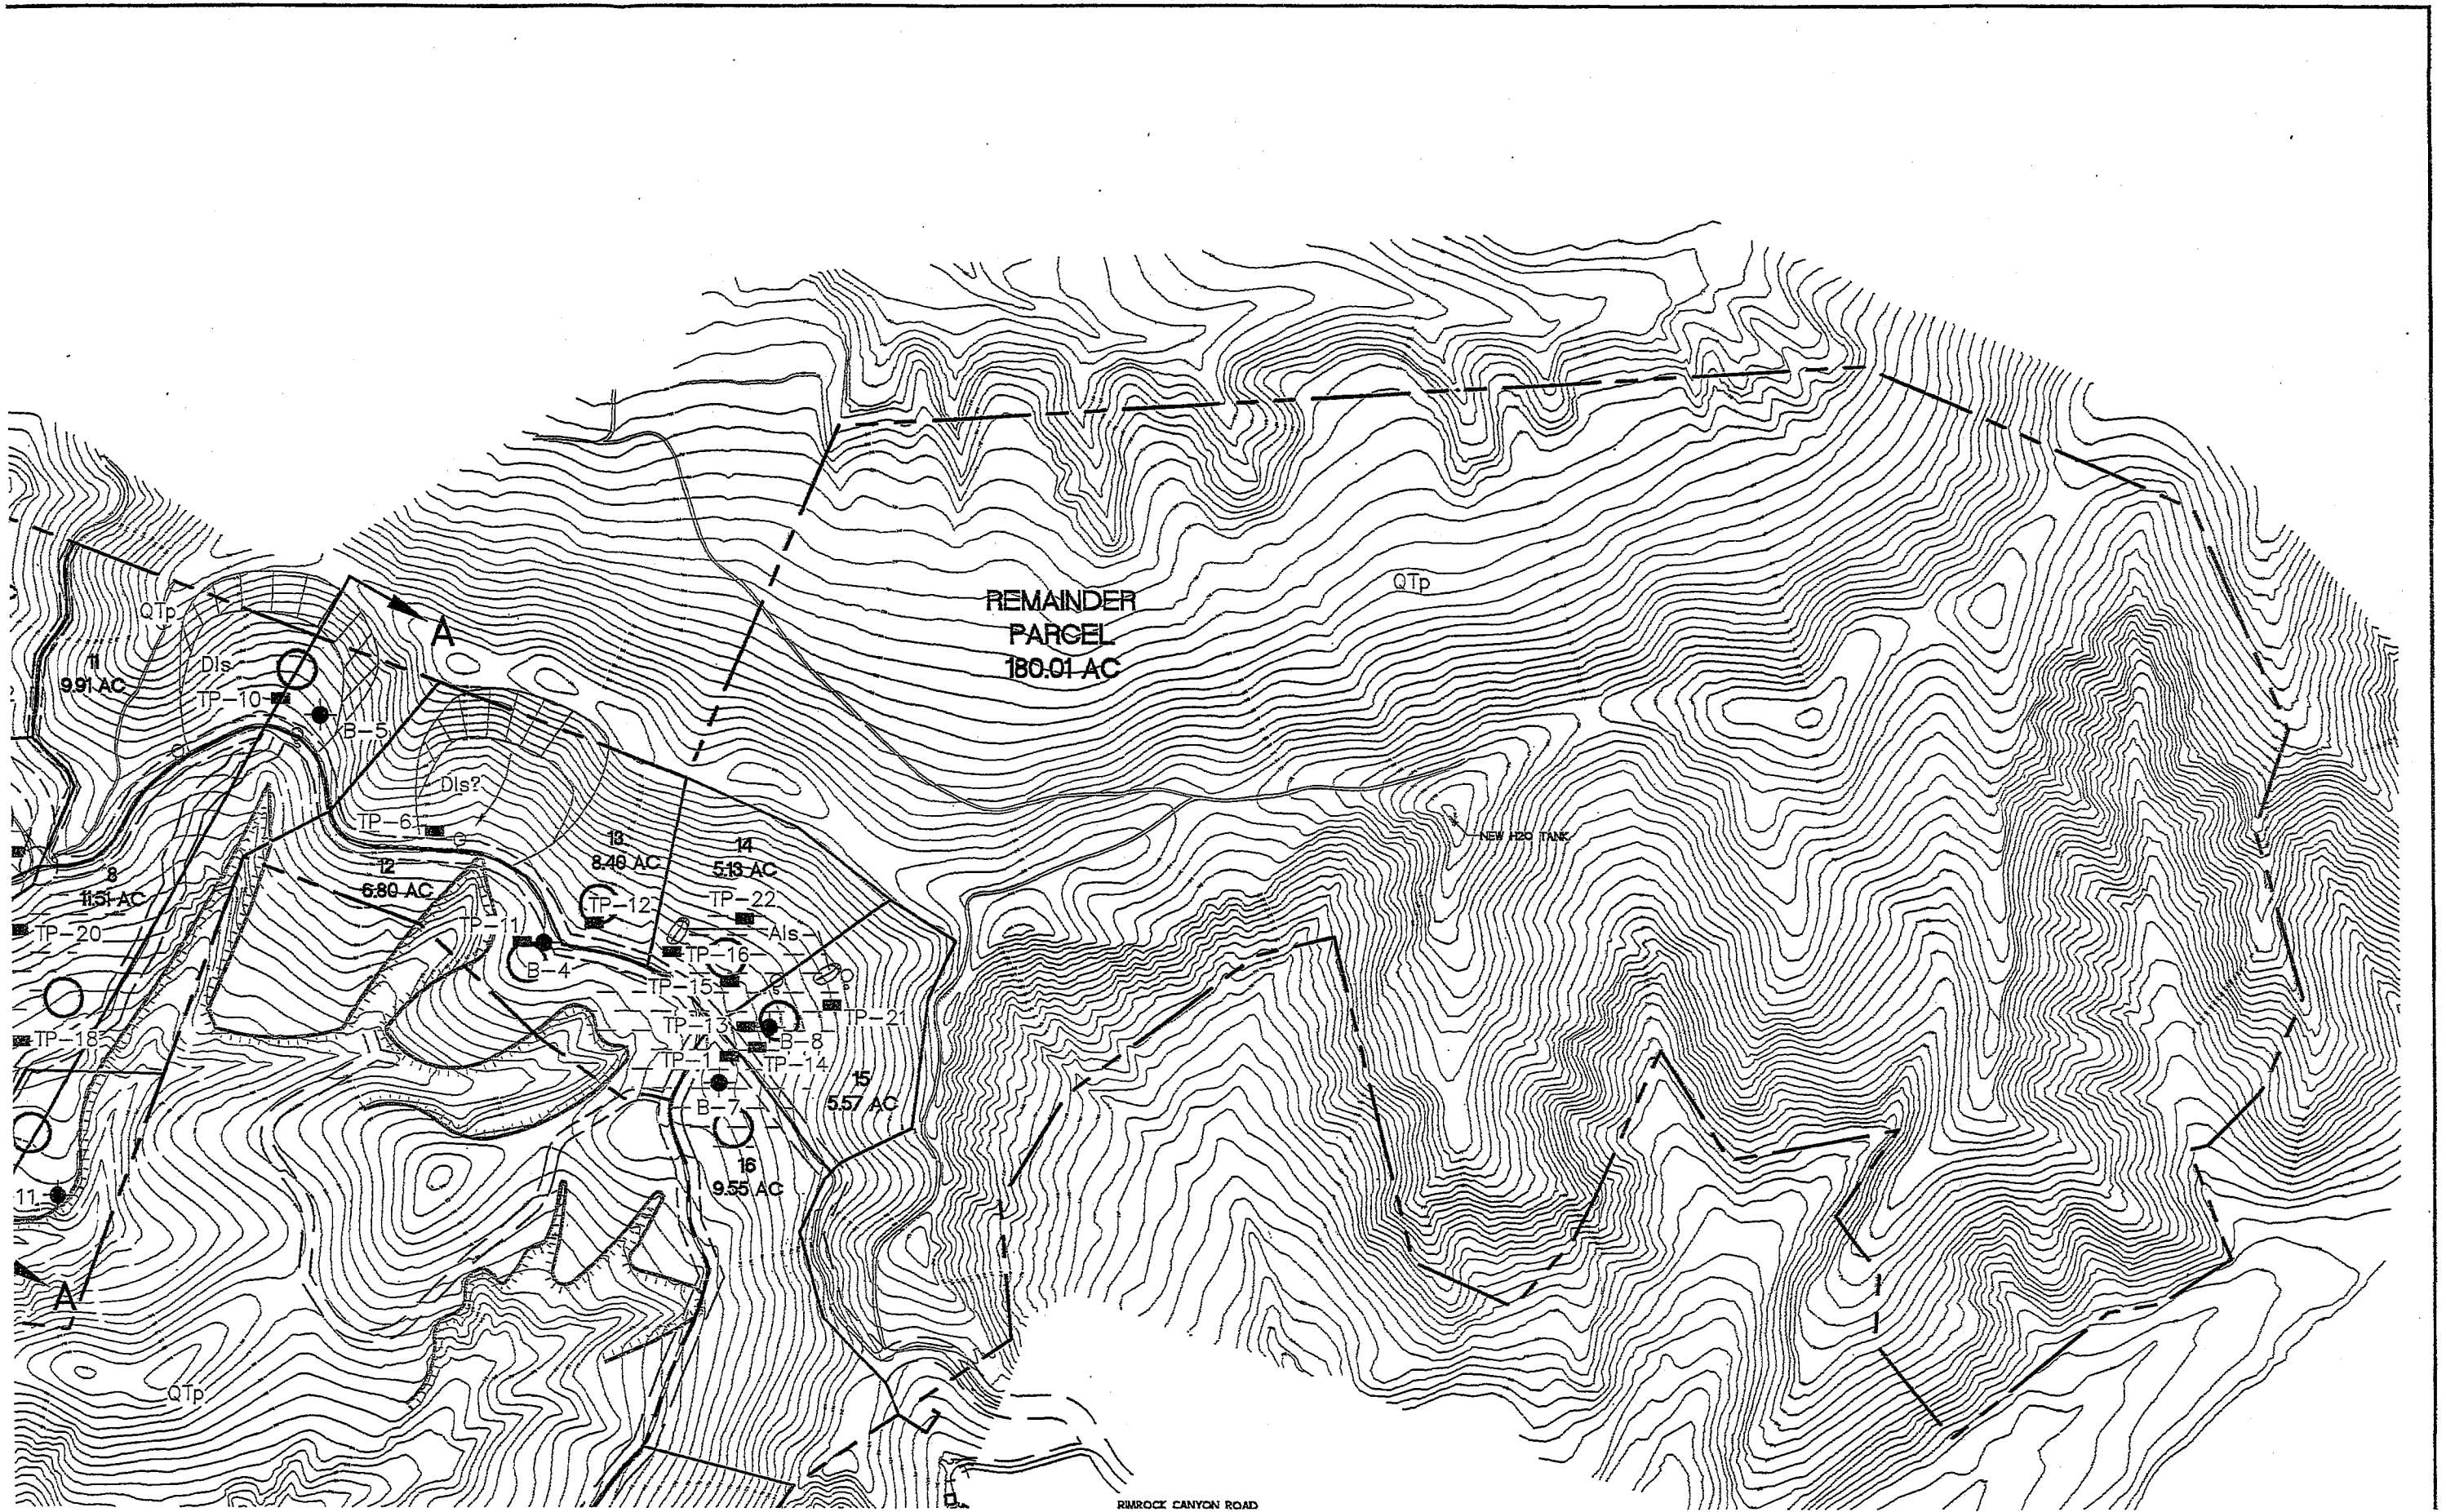
- Qls - Quaternary Landslides
- Qc - Quaternary Colluvium
- Qof - Quaternary Older Fill
- Qtc - Paso Robles Formation
- Tsm - Tertiary Santa Margarita Sandstone
