APPENDIX F

LANDSET GEOTECHNICAL REPORT

**GEOLOGIC HAZARDS REPORT
AND
SOIL ENGINEERING FEASIBILITY INVESTIGATION
FOR
RIVER VIEW AT LAS PALMAS
(APN 139-211-035)
END OF WOODRIDGE COURT
MONTEREY COUNTY, CALIFORNIA
PROJECT 1272-01**

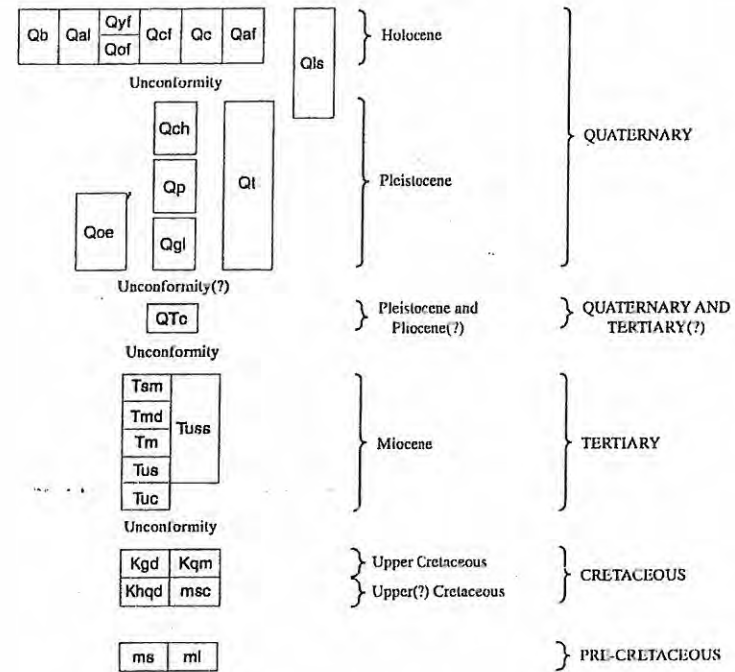
FIGURE
4
PROJECT
1272-01

- Contact—Dashed where approximately located or gradational, dotted where concealed, queried where questionably located
- Fault—Dashed where inferred, dotted where concealed, queried where doubtful. U, relatively upthrown side; D, relatively downthrown side
- Fold—Dashed where approximately located, dotted where concealed. Showing direction of plunge
- Anticline
- Syncline
- Strike and dip of beds**
- Horizontal
- Inclined
- Overturned
- Vertical
- Ash Bed
- Foliation
- Water well
- Dry hole drilled for hydrocarbon exploration
- Landslide—Arrows show general direction of movement. Query indicates that identification of feature as a landslide is in doubt
- Spring
