Recommend the Board of Directors Receive a Report on Dam Breach Inundation Maps for Nacimiento and San Antonio Dams

# Embankment Breach at Full Reservoir (water at spillway crest)

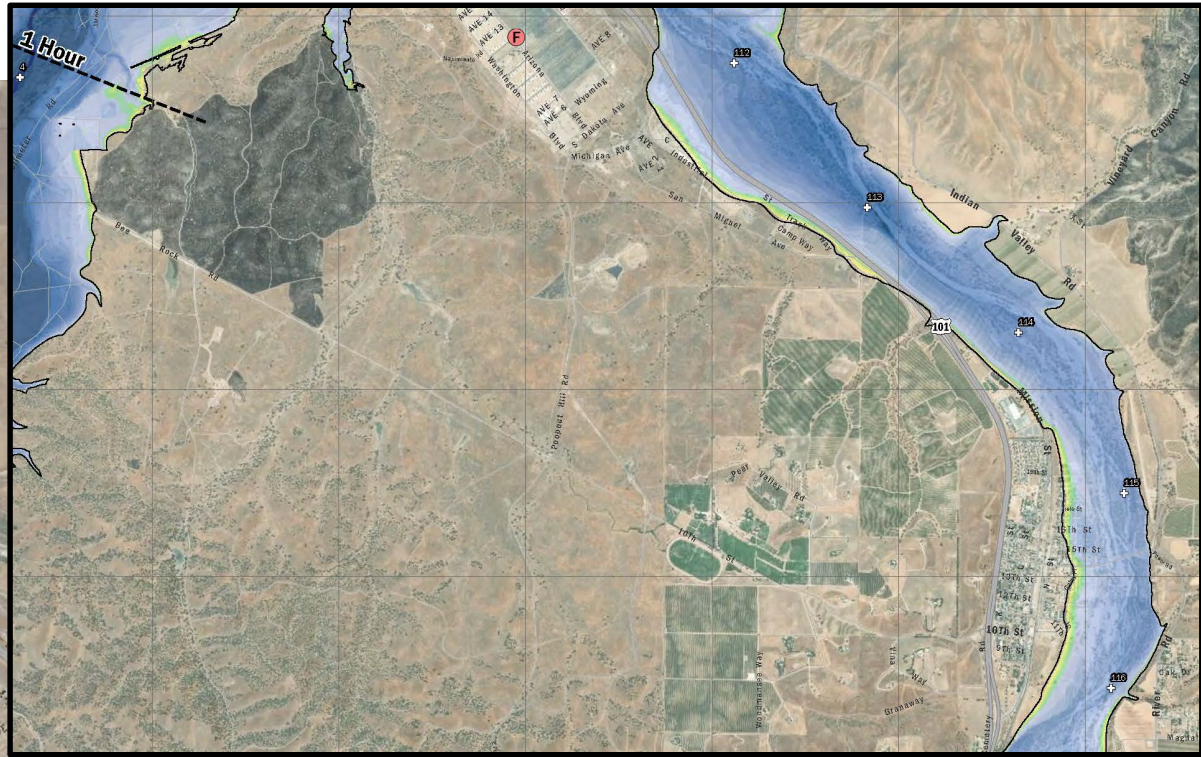
“BACKWATER”

# Embankment Breach at Full Reservoir (water at spillway crest)

Note: Map shows areas of flooding greater than one foot. Shallow flooding less than one foot deep may occur between areas that are shown as disconnected.

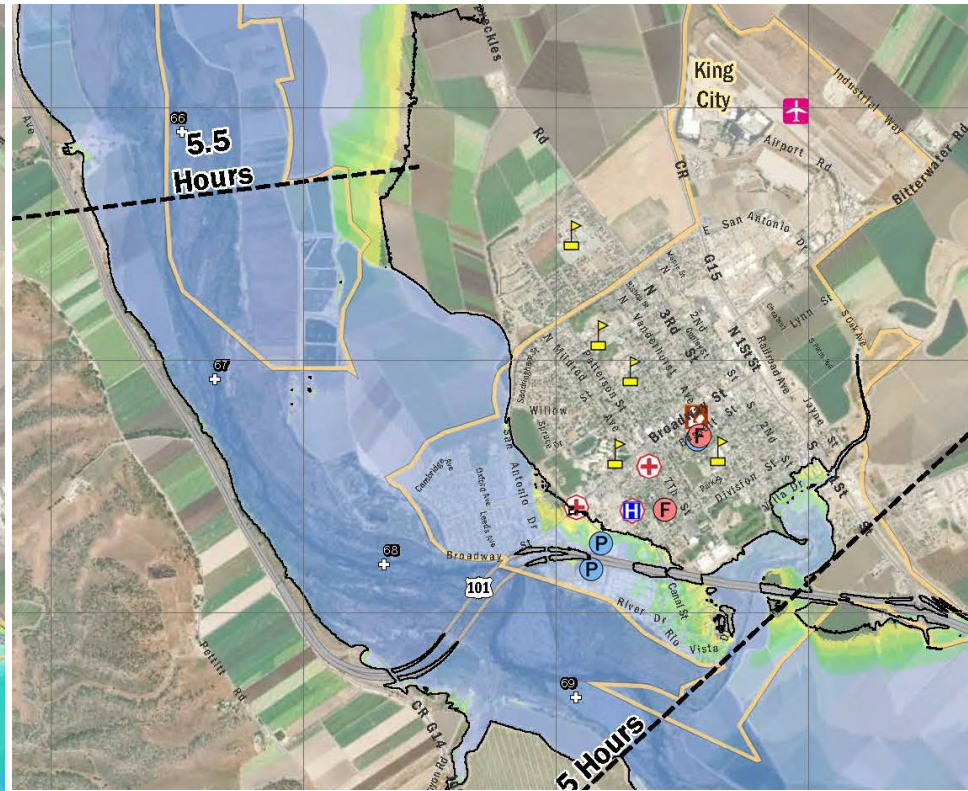
San Antonio                      **KING CITY**                      Nacimiento

# Embankment Breach at Full Reservoir (water at spillway crest)

Note: Map shows areas of flooding greater than one foot. Shallow flooding less than one foot deep may occur between areas that are shown as disconnected.

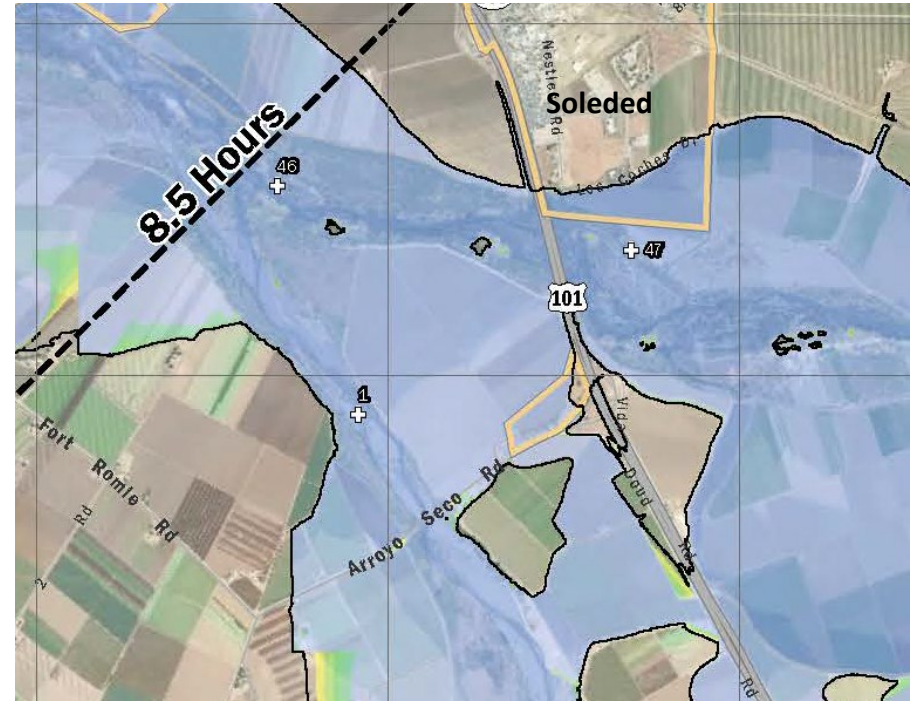
San Antonio                      **SOLEDAD**                      Nacimiento

# Embankment Breach at Full Reservoir (water at spillway crest)

Note: Map shows areas of flooding greater than one foot. Shallow flooding less than one foot deep may occur between areas that are shown as disconnected.
