PACIFIC GROVE SEWAGE SPILL

SUMMARY

May 18 Sanitary Sewer Overflow

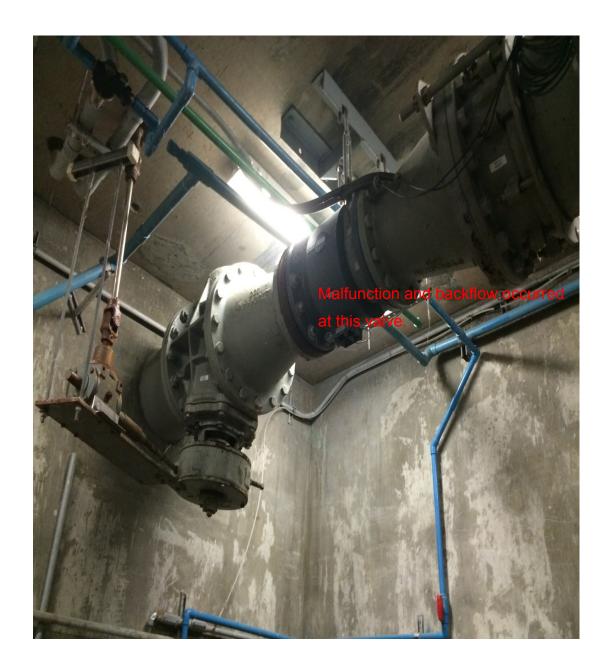
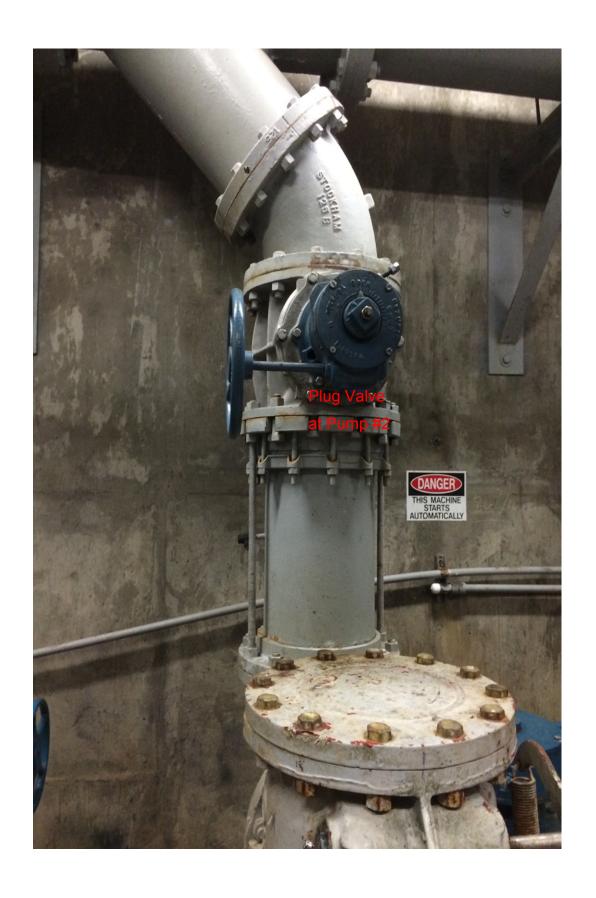
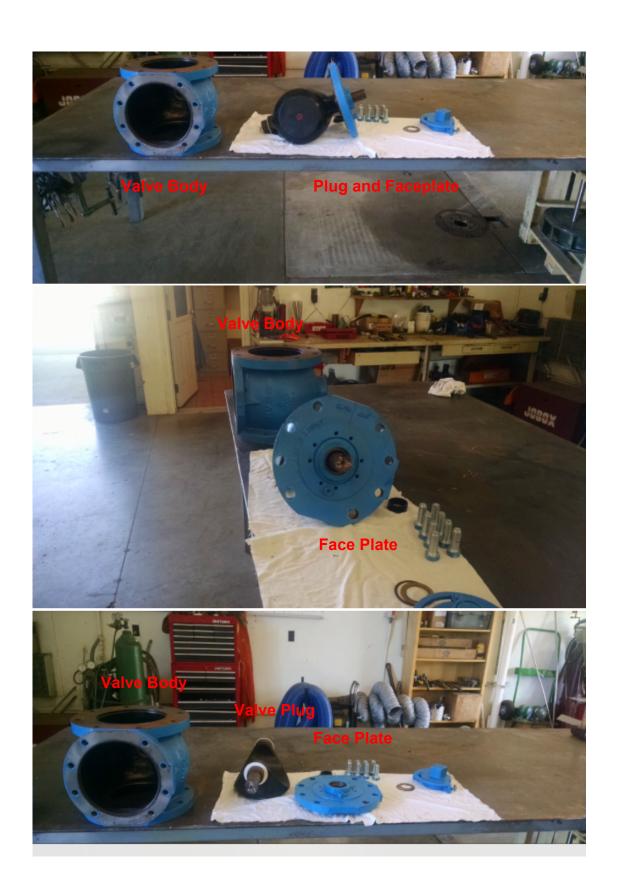
Appendix C: Pictures of Pump Station 13 on Fountain Ave

The May 18 SSO occurred because of a false pressure reading during repairs to the pump station at Fountain Avenue in PG. MRWPCA maintenance personnel began repairs on the pump station. After pressure readings on pump #2 revealed no pressure in the system, they unbolted the plug-valve 10 for that pump. This in turn released an unexpected backflow of sewage that began to flood the pump station. Following protocol, MRWPCA reacted to the fast flooding pump station. Every agency on their list was called for assistance, and Vactor trucks (each capable of pumping and holding 1 to 3 thousand gallons at a time) were dispatched to the pump station. Realizing that the use of Vactor trucks would be insufficient to stem flooding in the pump station, MRWPCA diverted sewage directly into the Monterey Bay. The alternative would have allowed overflowing from the pump station. This flow would have spilled across the recreation trail and ended up in the Monterey Bay.

- R1. MRWPCA implement staff training to account for and manage situations of false equipment readings.
- R2. The City of Pacific Grove prioritize sewer projects based on severity of pipe degradation and public need.
- R3. The City of Pacific Grove annually budget for sewer projects using Proposition 218 funds and other funds as they become available.
- R4. The City of Pacific Grove actively seek matching funds for the sewer projects.
